# POUDRE SCHOOL DISTRICT

## RIFFENBURGH ELEMENTARY SCHOOL

### FACILITY CONDITION ASSESSMENT

OCTOBER 2023

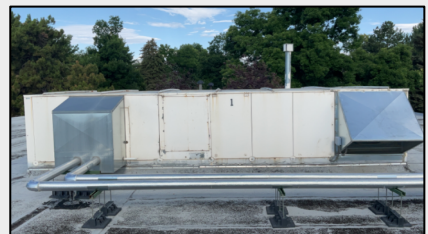
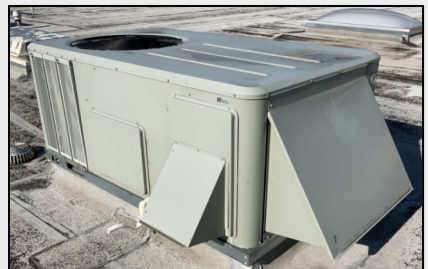
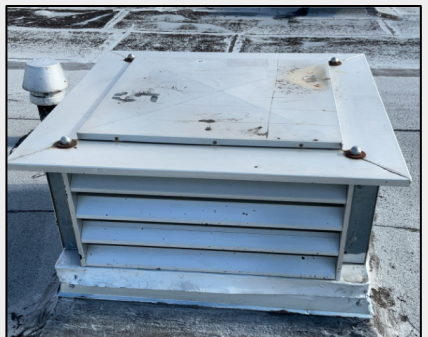
### 1. Replace Outdated HVAC Equipment

A number of the buildings HVAC assets were originally installed in the 1990s, or earlier, [REDACTED]. This includes many of the building's rooftop exhaust fans. Note, this measure includes several rooftop air handling units. While these assets were refurbished approximately 10 years ago; they will likely require some refurbishment or replacement during this period depending on component conditions.

- RTU-1 (FCAID-500067)
- RTU-2 (FCAID-500068)
- RTU-3 (FCAID-500069)
- RTU-4 (FCAID-500070)
- RTU-1 (FCAID-500066)
- Rooftop Unit (FCAID-500113)
- Condensing Unit M41 (FCAID-500084)
- (10) Exhaust Fans (FCAIDs vary)
- Unit Heater (FCAID-500114)
- CW Air Separator (FCAID-500074)
- HW Air Separator (FCAID-500075)
- Glycol Feeder (FCAID-500108)

**Priority Level:** 2  
**Estimated Cost:** \$809,060  
**Remaining Life:** 2-7 years

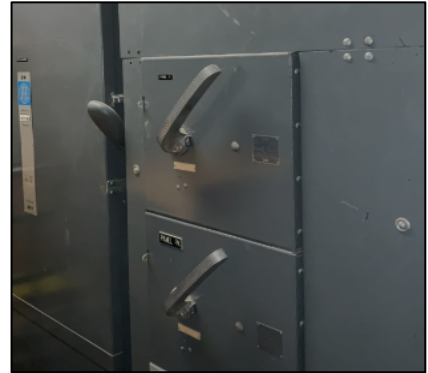
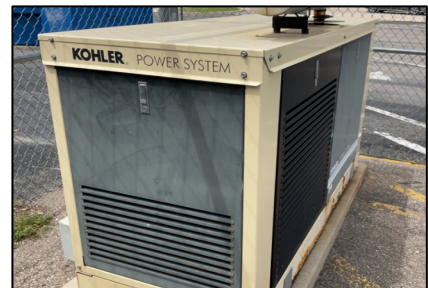
## 2. Replaced Outdated Electrical Assets

- Main Switchboard, Section 1 (FCAID-500155)
- Main Switchboard, Section 2 (FCAID-500156)
- Backup Generator (FCAID-500124)
- Panel A (FCAID-500135)
- Panel B (FCAID-500136)
- Panel K (FCAID-500142)
- Panel L (FCAID-500143)
- Panel LAP (FCAID-500144)
- Panel MM (FCAID-500148)
- ATS (FCAID-500123)

**Priority Level:** 2  
**Estimated Cost:** \$141,570  
**Remaining Life:** 3-5 years

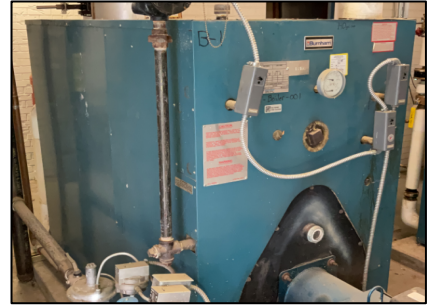
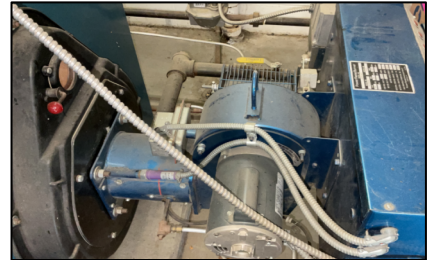
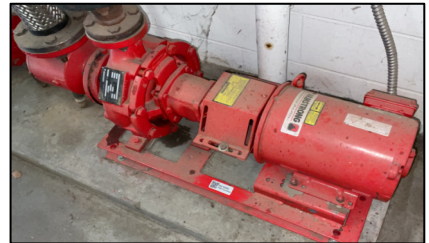
## 4. Prepare for Boiler Replacement

While the building's two boilers are currently functional, they are now nearly 30 years old. Typical boilers are manufactured with a lifespan of around 35 years. Plan for replacement or substantial refurbishment of the heating water system within the next 5-7 years to ensure that is operating efficiently, and as designed.

- Boiler B-1 (FCAID-500102)
- Boiler B-2 (FCAID-500103)
- P-1 (FCAID-500110)
- P-2 (FCAID-500111)
- ET-1 (FCAID-500099)
- ET-2 (FCAID-500101)

**Priority Level:** 3  
**Estimated Cost:** \$164,040  
**Remaining Life:** 5-7 years

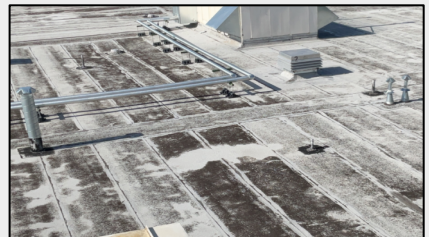
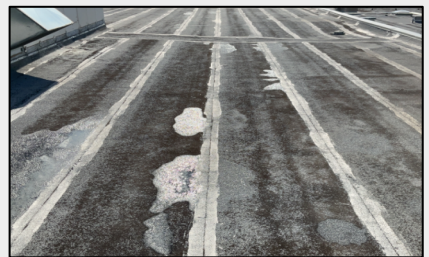
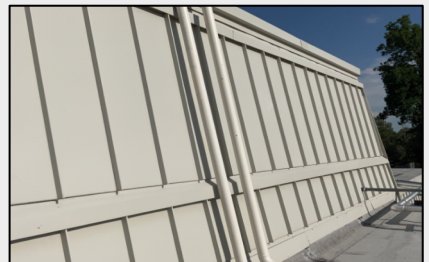
## 5. Replace or Refurbish the Roofing

The building's roofing was noted [REDACTED] with areas of cracking and degradation of the reflective top coating. Plan for substantial repairs of the roofing surface within the next 7 years to ensure a water tight envelope.

- Roofing, Rolled Asphalt (FCAID-500022)
- Roofing, Metal Standing Seam (FCAID-500024)
- Roofing, Metal Flashing (FCAID-500021)
- Roofing, Rolled Asphalt, Gym Addition (FCAID-500023)

**Priority Level:** 3  
**Estimated Cost:** \$634,220  
**Remaining Life:** 4-7 years
