# POUDRE SCHOOL DISTRICT STOVE PRAIRIE ELEMETNARY SCHOOL

## FACILITY CONDITION ASSESSMENT

BELLVUE, CO

OCTOBER 2023

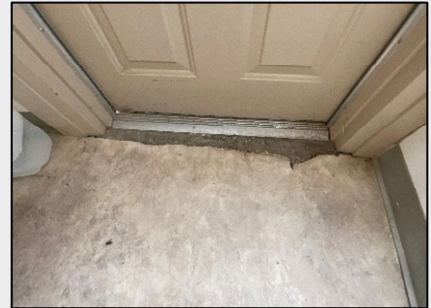
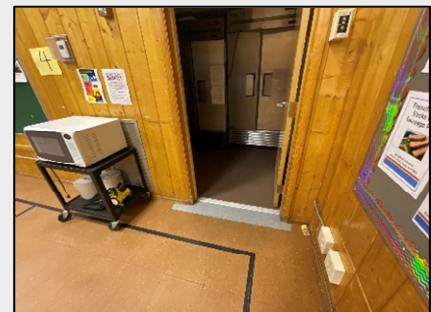
##### Replace VCT Flooring

The VCT flooring, including tiles and sheet vinyl, has surpassed its industry life expectancy and is in poor condition. It is recommended that these flooring finishes are replaced within the next two years.

FCAID-540025, FCAID-540026

| Priority Level: | 2 |
| Estimated Cost: | \$15,600 |

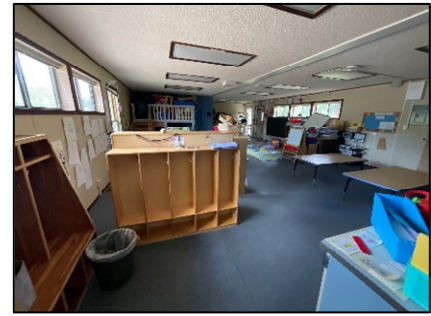
## Replace Carpeting

The areas of carpeting installed in 1998 have surpassed their useful life by approximately 15 years. The carpet in these areas are in poor condition and should be replaced within the next two years.

FCAID-540019

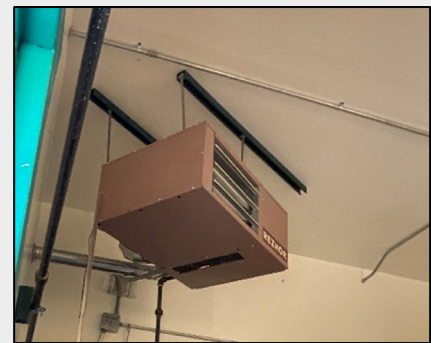
## Replace Gas Unit Heater

The gas unit heater serving the facilities room has surpassed its life expectancy and should be replaced within the next three years.

FCAID-540043

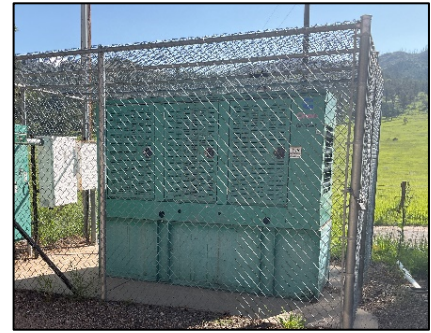
## Replace Emergency Generator

The emergency generator [REDACTED] should be replaced within four years.

FCAID-540045

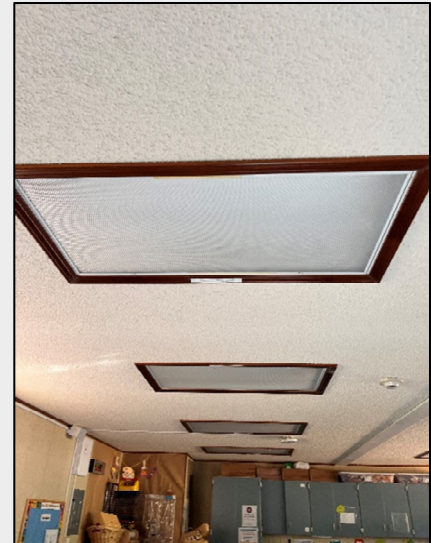
## Replace Lighting Fixtures

FCAID-540050

| Priority Level: | 3 |
| Estimated Cost: | \$94,770 |
