RED FEATHER  
ELEMENTARY  
SCHOOL

FACILITY CONDITION ASSESSMENT

RED FEATHER LAKES, CO

OCTOBER 2023

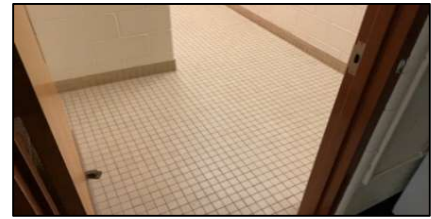
## Replace 1985 Ceramic Tile Flooring

The 1985 ceramic tile flooring located in the restrooms is 13 years past expected life. Replace within three years.

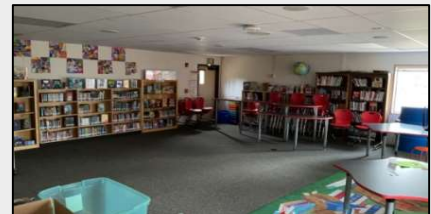
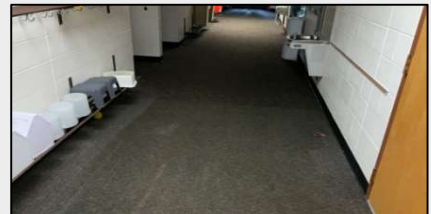
## Replace 2013 Carpeting

Though replaced in 2013, the carpeting will be due for replacement again in approximately three years.
