# POUDRE SCHOOL DISTRICT

## SHEPARDSON STEM ELEMENTARY SCHOOL

### FACILITY CONDITION ASSESSMENT

FORT COLLINS, CO

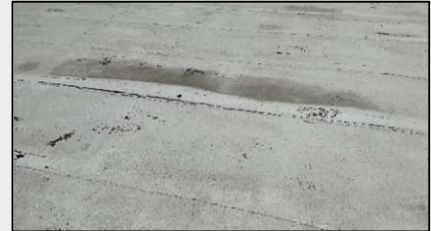
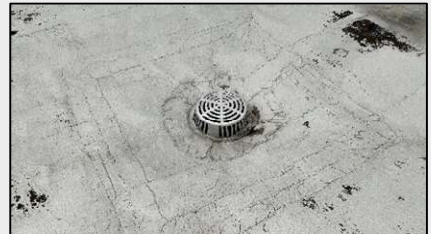
FCAID-520012

The coated asphalt roofing is [REDACTED] reaching the end of its industry life expectancy. The roof will need to be recoated or replaced soon.

**Priority Level:** 2  
**Estimated Cost:** \$339,000  
**Remaining Life:** 6 years
