POUDRE SCHOOL  
DISTRICT  
TAVELLI  
ELEMENTARY  
SCHOOL

FACILITY CONDITION ASSESSMENT

FORT COLLINS, CO

OCTOBER 2023

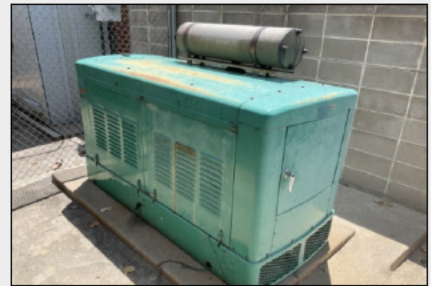
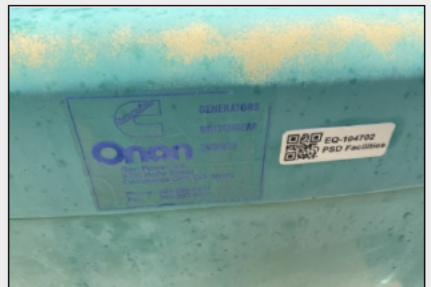
##### Replace Back-Up Generator

The Generator dates to 1993 and is 10 years past expected life. Run Hours = 519.1 . Recommend replacement within two years. [REDACTED]

FCAID-550055

| Priority Level: | 1 |
| Estimated Cost: | \$51,270 |

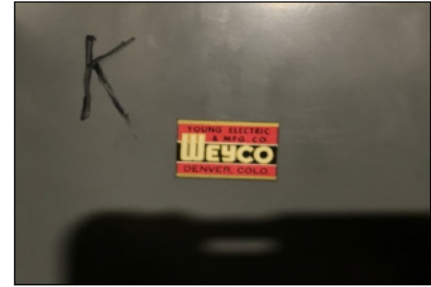
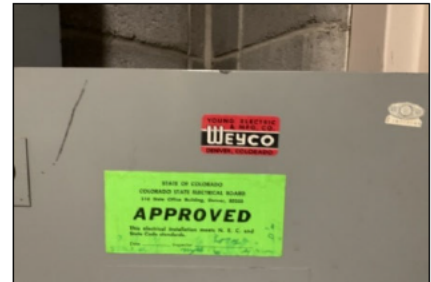
## Replace (4) 1968 Panelboards

[REDACTED] Replace within the year.

FCAID-550151, FCAID-550154 through FCAID-550156

**Priority Level:** 2  
**Estimated Cost:** \$31,280  
**Remaining Life:** one year

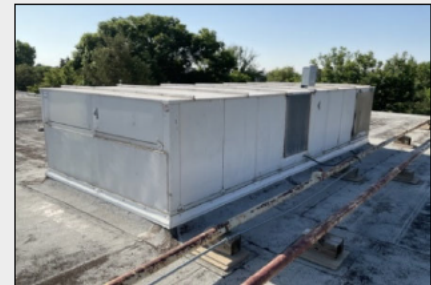
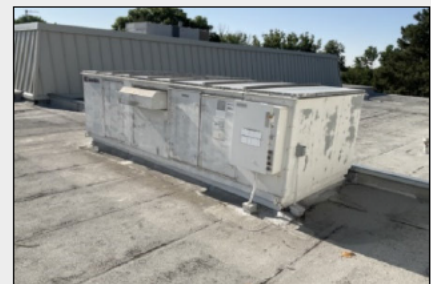
## Replace RTUs 4,5,6,7

RTU-5 and RTU-6 date to 1993 [REDACTED]. RTU-4 and RTU-7 date to 1995 [REDACTED]. These RTUs are 13-15 years past expected life. Replace in 1-2 years.

FCAID-550135 through FCAID-550138

**Priority Level:** 2  
**Estimated Cost:** \$195,880  
**Remaining Life:** 1-2 Years

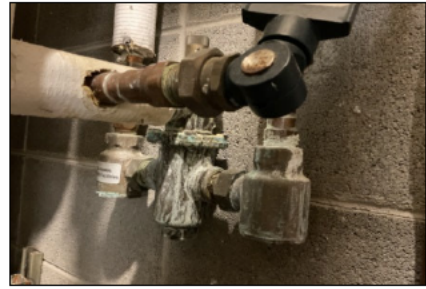
## Replace Thermostatic Mixing Valve

Though the thermostatic mixing valve was replaced in 2017 [REDACTED] and needs to be replaced within the year.

FCAID-550049
