# POUDRE SCHOOL DISTRICT TIMNATH ELEMENTARY SCHOOL

## FACILITY CONDITION ASSESSMENT

TIMNATH, CO  
OCTOBER 2023

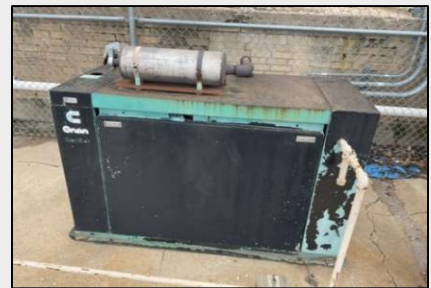
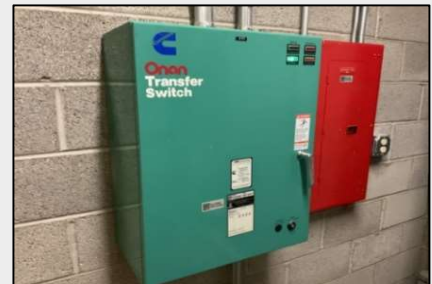
##### Replace Back-Up Generator & ATS-1

The back-up generator serving this building dates to 1992 [REDACTED]  
[REDACTED] Total Run Hours = 753.0 . The associated ATS-1 dates to 1997 and should be replaced at the time that the generator is replaced.

FCAID-560059, FCAID-560161

| Priority Level: | 1 |

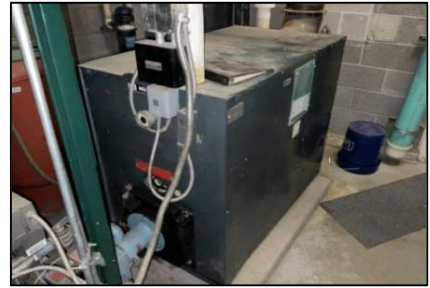
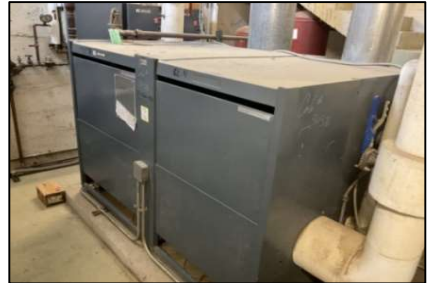
## Replace Boiler-1-North, Boiler-2-North, Boiler-3-South

All three boilers are at expected life and are expected to require replacement within two years. [REDACTED]

FCAID-560106, FCAID-560107, FCAID-560108

**Priority Level:** 2  
**Estimated Cost:** \$231,380  
**Remaining Life:** 2 Years

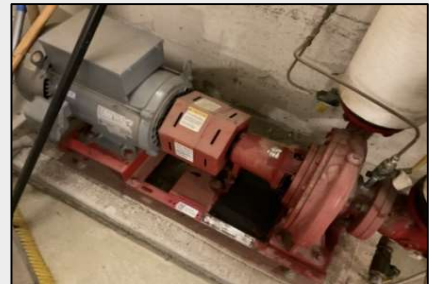
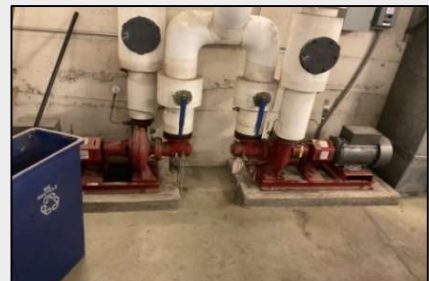
## Replace P-1 & P-2

Heating Water Pumps P-1 and P-2 date to 1992, are 11 years past expected life, and are expected to require replacement within two years.

FCAID-560044, FCAID-560044

**Priority Level:** 2  
**Estimated Cost:** \$23,800  
**Remaining Life:** 2 Years

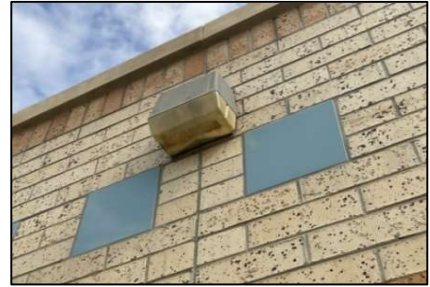
## Replace (17) Incandescent Exterior Wall Packs

FCAID-560163, FCAID-560164

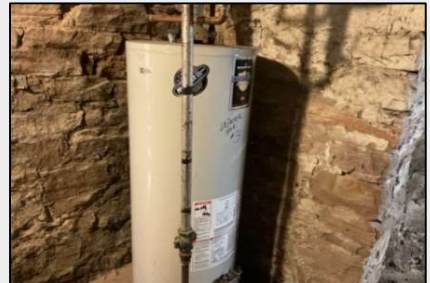
## Replace GWH-3 (Annex)

GWH-3 (located in Annex Building) dates to 2005 [REDACTED] requiring replacement in two years.

FCAID-560052
