# POUDRE SCHOOL DISTRICT ZACH ELEMENTARY SCHOOL

## FACILITY CONDITION ASSESSMENT

FORT COLLINS, CO

OCTOBER 2023

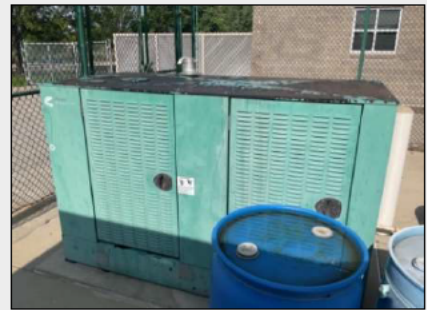
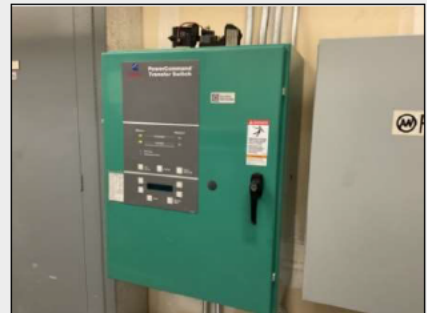
FCAID-630044

#### Replace Back-Up Generator & ATS-1

The back-up generator is original, needing replacement within in 2 years. 2002-built ATS-1 has approximately 4 years of remaining life, but is recommended to be replaced in tandem with the generator. The generator has total run hours of 370.2

| Priority Level: | 1 |
| Estimated Cost: | \$51,270 |

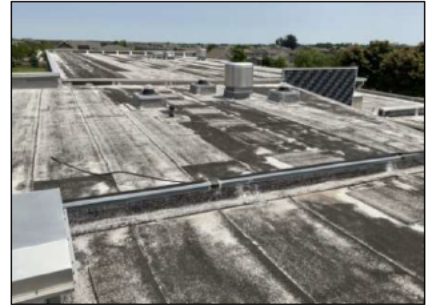
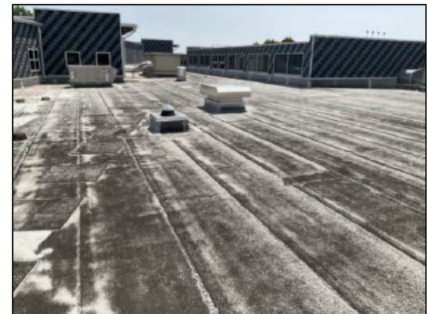
FCAID-630011, FCAID-630012

## Replace Rolled Asphalt Roof & Metal Flashing

**Priority Level:** 2  
**Estimated Cost:** \$346,340  
**Remaining Life:** 2 Years

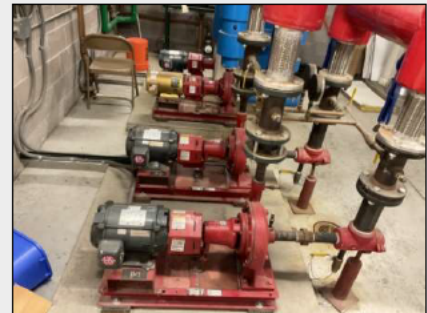
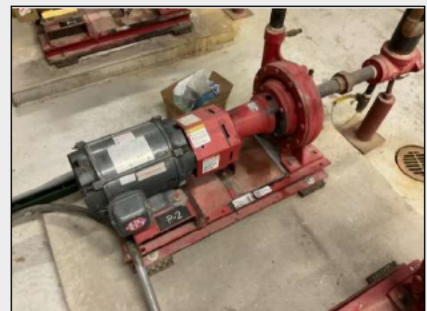
FCAID-630091, FCAID-630096, FCAID-630051, FCAID-630052

## Replace P-1, P-2, P-3, & P-4

P-1 and P-2 (3 Hp, serving Heating Water System) and P-3 and P-4 (5 Hp, serving Chilled Water System) are all 2002-built pumps. Though the motors of all 4 have recently been replaced, the pumps themselves are past expected life [REDACTED]

**Priority Level:** 2  
**Estimated Cost:** \$47,244  
**Remaining Life:** 2 Years

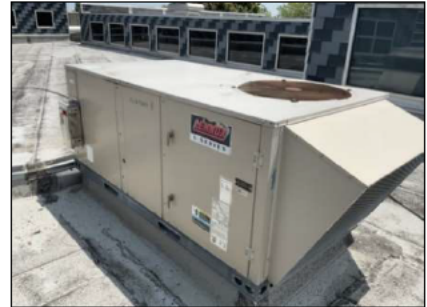
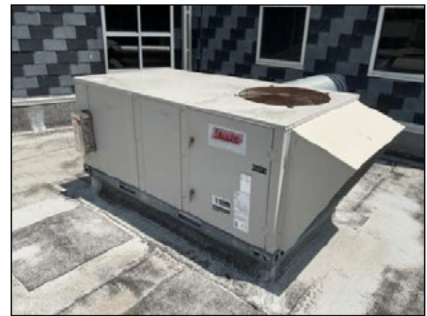
FCAID-630100, FCAID-630101

## Replace CLRTU-1 & CLRTU-2

Serving the Computer Laboratory Rooms, these 2002-built RTUs [REDACTED] are both 6 years past expected life. Recommend replacement within two years. HCFC-22 refrigerant.

| Priority Level: | 2 |
| Estimated Cost: | \$62,320 |

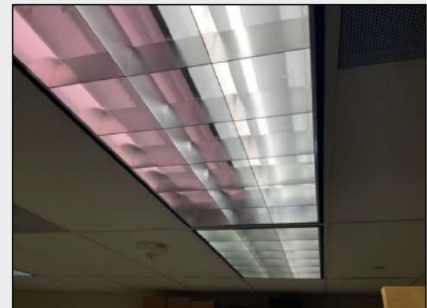
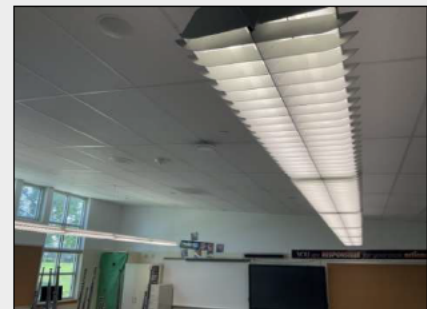
FCAID-630157

## Replace Interior Fluorescent Lighting

Recommend replacement of the original remaining fluorescent lighting fixtures with LED lighting fixtures in approximately 2 years. SF = 59,938

| Priority Level: | 2 |
| Estimated Cost: | \$917,650 |
