# POUDRE SCHOOL DISTRICT TRAUT ELEMENTARY SCHOOL

## FACILITY CONDITION ASSESSMENT

FORT COLLINS, CO

OCTOBER 2023

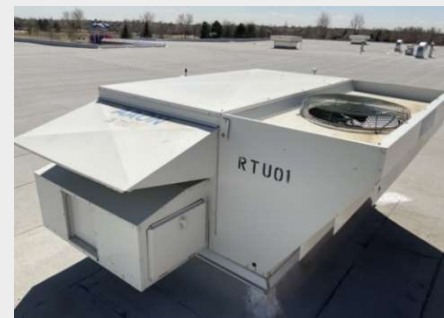
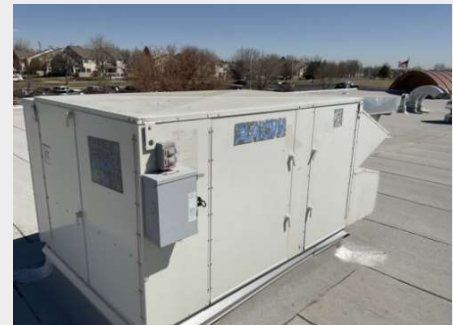
##### Replace RTU-1 & RTU-2

FCAID-580081, FCAID-580082

| Priority Level: | 2 |
| Estimated Cost: | \$87,320 |

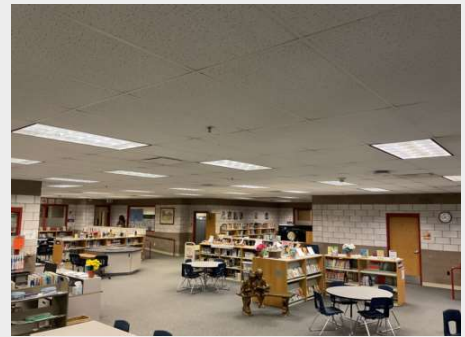
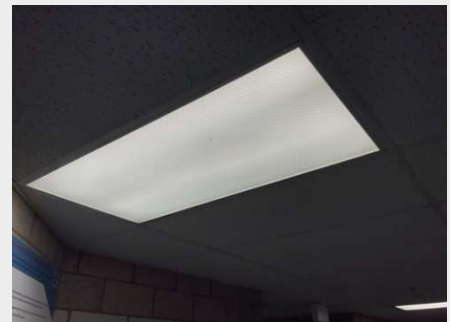
## Replace Interior Fluorescent Lighting

Recommend replacement of the 1998-built fluorescent lighting fixtures with LED lighting fixtures within 2 years. Fluorescent fixtures are 5 years past expected life.

**Priority Level:** 2  
**Estimated Cost:** \$778,840  
**Remaining Life:** 2 Years

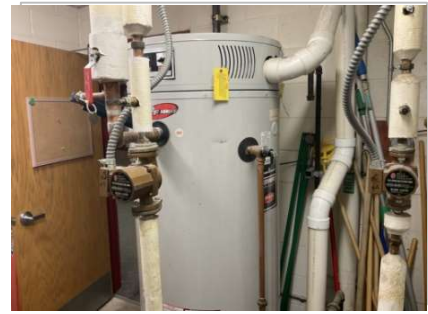
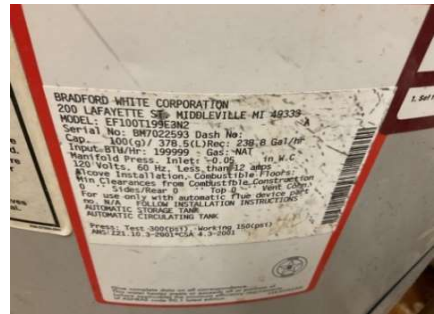
## Replace GWH-1

GWH-1, built in 2005, is 8 years past expected life. Recommend replacement within the next three years.

| Priority Level: | 2 |
| Estimated Cost: | \$10,610 |

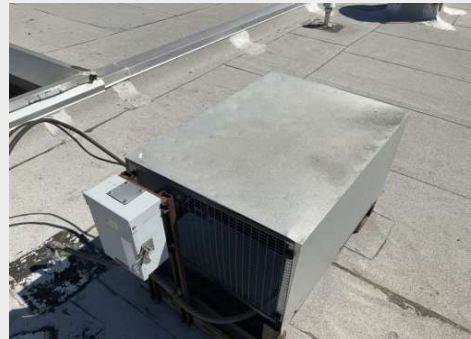
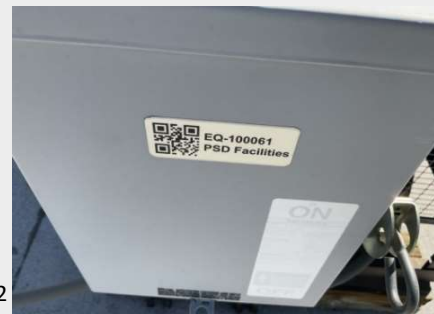
## Replace CU-1-Walk-In Cooler

The Kitchen area is provided an original Walk-In Cooler, but not a Walk-In Freezer. Expect to replace the walk-in cooler in 8 years. However, the single condensing unit associated with the cooler is 10 years past expected life [REDACTED] Replace CU-1-Walk-In Cooler within two years.

The single condensing unit associated with the cooler is 10 years past expected life  
[REDACTED] Replace CU-1-Walk-In Cooler within two years.

| Priority Level: | 2 |
| Estimated Cost: | \$10,050 |
