# POUDRE SCHOOL DISTRICT PUTNAM ELEMENTARY SCHOOL

## FACILITY CONDITION ASSESSMENT

FORT COLLINS, CO

OCTOBER 2023

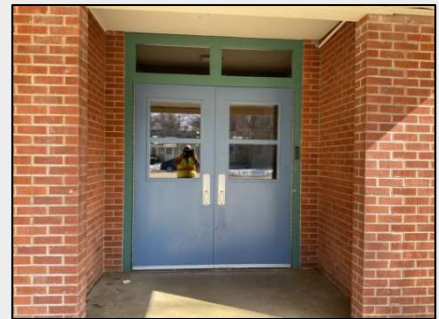
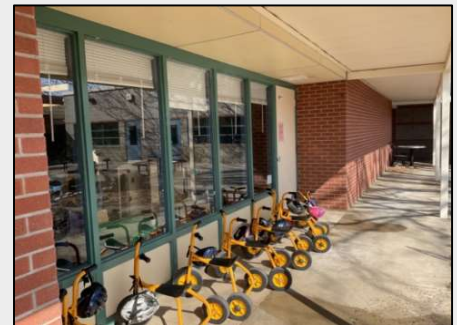
##### Replace Exterior Doors & Windows

FCAID-470001, FCAID-470007, FCAID-470008, FCAID-470011

| Priority Level: | 2 |
| Estimated Cost: | \$474,890 |

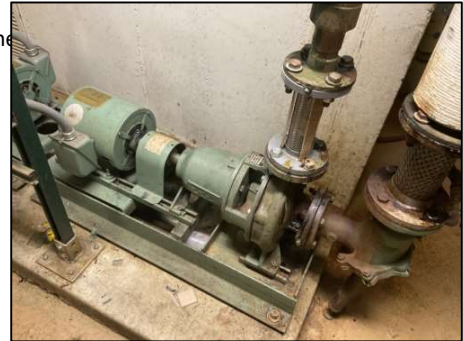
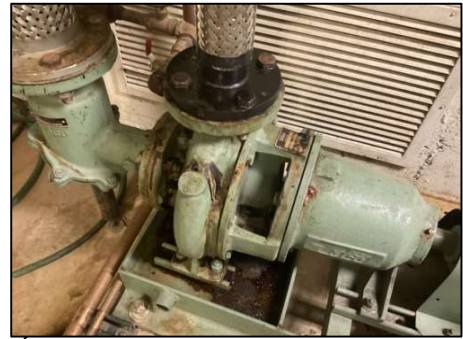
## Replace HWP-1 & HWP-2

Hwp-1 and HWP-2 were installed in 1998 and are now 5 years past expected life. The are both [REDACTED] expected to require replacement within two years.

FCAID-470101, FCAID-470102

**Priority Level:**  
**Estimated Cost:** \$23,800  
**Remaining Life:** 2 years

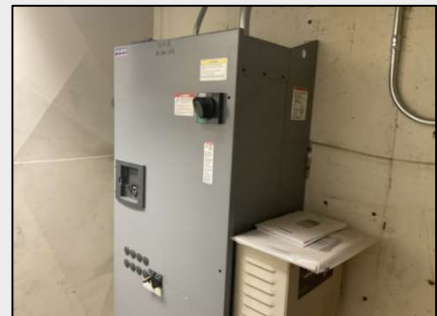
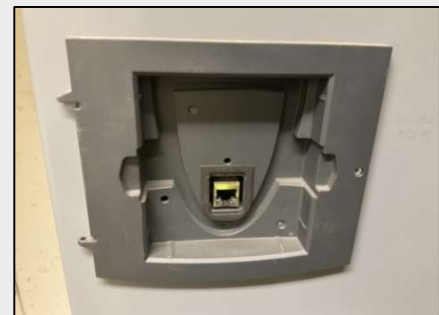
## Repair/Replace VFD-AHU-1-Supply

Though VFD-AHU-1-Supply (10 Hp) was newly installed in 2022, the control module was observed to have been removed at the time of inspection. Recommend repair or replacement of this VFD as soon as possible.

FCAID-470147

**Priority Level:** 2  
**Estimated Cost:** \$5,840  
**Remaining Life:** 1 year
