# POUDRE SCHOOL DISTRICT WERNER ELEMENTARY SCHOOL

## FACILITY CONDITION ASSESSMENT

OCTOBER 2023

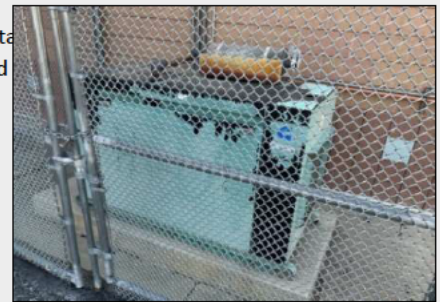
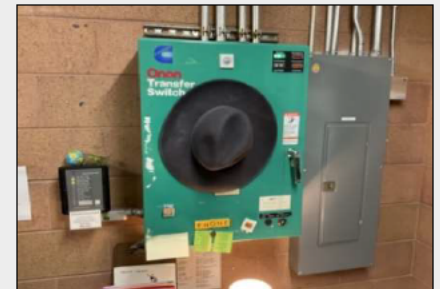
##### Replace Back-Up Generator & ATS-1

The back-up generator is original [REDACTED]. Total Generator Run Hours = 435.1, which is high. The associated ATS-1 is also original and should be replaced when the generator is replaced.

FCAID-620036, FCAID-620127

| Priority Level: | 2 |
| Estimated Cost: | \$66,170 |

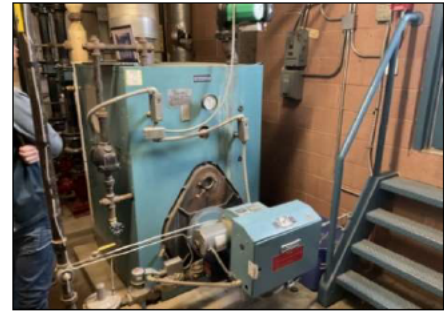
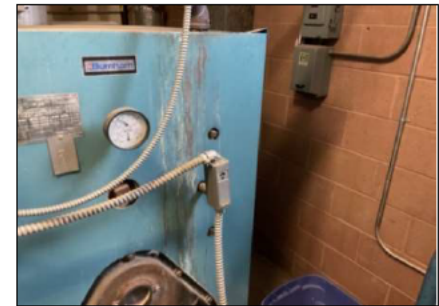
## Replace Boiler-1

Though Boiler-2 was replaced in 2008, Boiler-1 (1,116 MBH) is original [REDACTED]  
[REDACTED] Recommend replacement within 2 years.

FCAID-620069

**Priority Level:** 2  
**Estimated Cost:** \$78,630  
**Remaining Life:** 2 Years

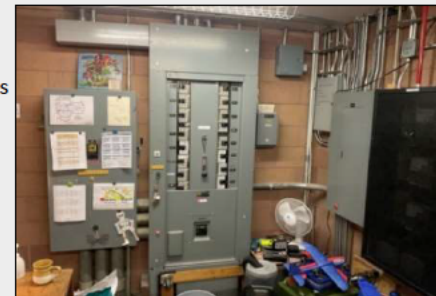
## Replace Panel MDP

Panel MDP (1997-built, 600A) was not replaced in 2012 along with other electrical assets. [REDACTED] Panel MDP is expected to require replacement in 4 years at end of life.

FCAID-620141

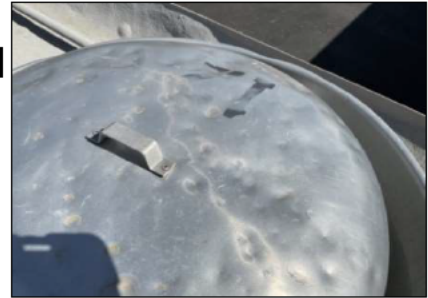
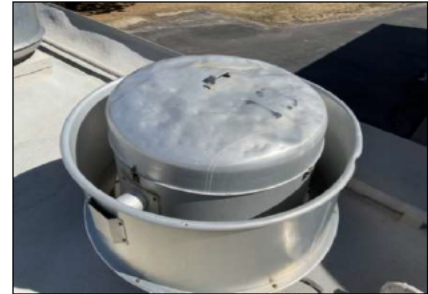
## Replace EF-12 & EF-13

EF-12 and EF-13 (both 2 Hp and serving the Kitchen) are original [REDACTED]. These fans are 16 years past expected life.

FCAID-620048, FCAID-620049

**Priority Level:** 2  
**Estimated Cost:** \$19,180  
**Remaining Life:** 2 Years

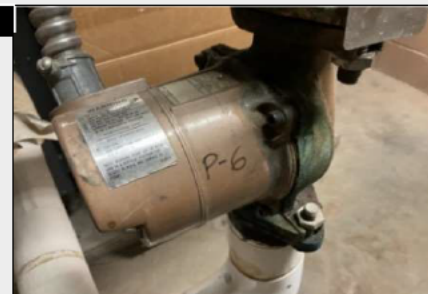
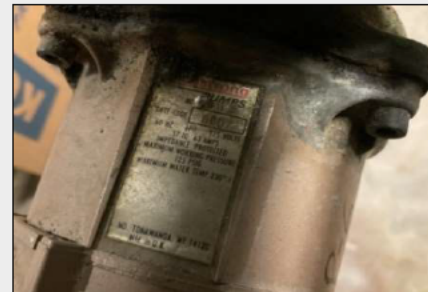
## Replace P-6

P-6 (1/25 Hp and serving the AHU-2 HW Coil) is 17 years past expected life [REDACTED]

FCAID-620079

**Priority Level:** 2  
**Estimated Cost:** \$4,630  
**Remaining Life:** 1 Year
