Cache La Poudre Middle School

CACHE LA POUDRE  
MIDDLE SCHOOL

FACILITY CONDITION ASSESSMENT

OCTOBER 2023

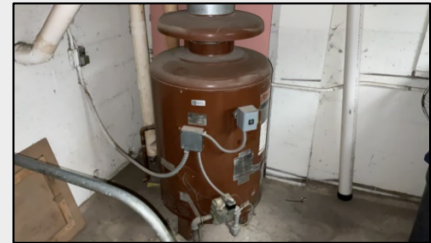
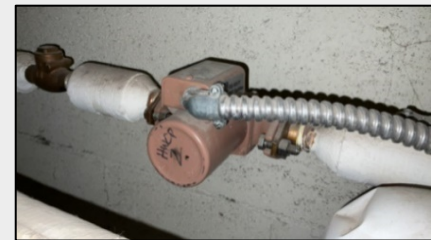
FCAID-140070, FCAID-140066, FCAID-140067

##### **Replace GWH-1, DHWCP-1, DHWCP-2**

GWH-1 was built in 1980 and is 33 years past expected life. DHWCP-1 and DHWCP-2 date to 1994 and are 9 years past expected life. Recommend replacement of these assets within 1-2 years as they are the sole source of domestic hot water in the main school.

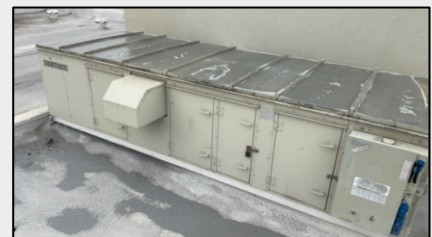
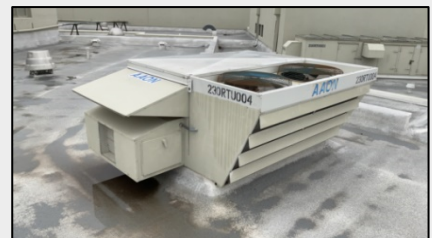
FCAID-140129, FCAID-140130, FCAID-140131

## Replace RTU-2, RTU-3, & RTU-4

RTU-2, RTU-3, & RTU-4 are the remaining units that were installed in 1997. These are well past expected life. [REDACTED]  
[REDACTED]

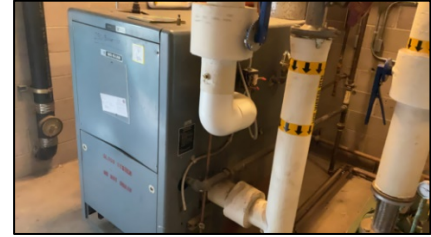
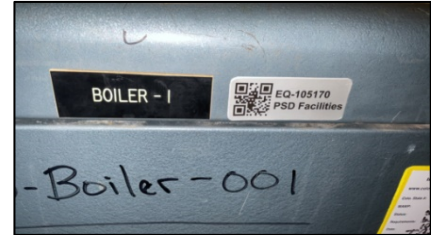
FCAID-140118

## Replace Boiler-1

Boiler-2 was replaced in 1997 and has 9 years of remaining life. Boiler-1 dates to 1984, is 4 years past expected life [REDACTED]

Recommend replacement of Boiler-1 prior to 2024-2025 heating season.

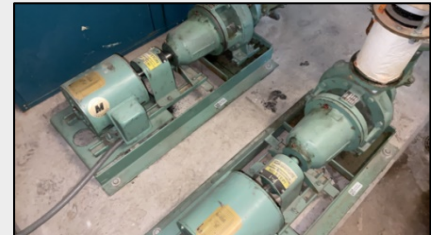
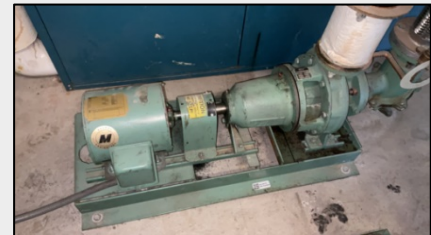
FCAID-140123, FCAID-140124

## Replace P-1 & P-2

Heating Water System P-1 and P-2 (both 5 Hp) are 6 years past due and will require replacement within the year. [REDACTED]
