# POUDRE SCHOOL DISTRICT BLEVINS MIDDLE SCHOOL

## FACILITY CONDITION ASSESSMENT

FORT COLLINS, CO  
OCTOBER 2023

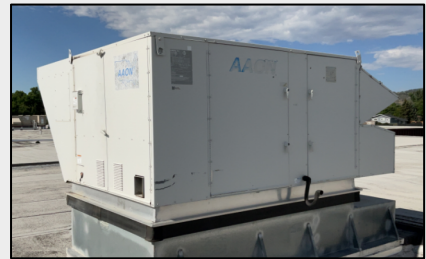
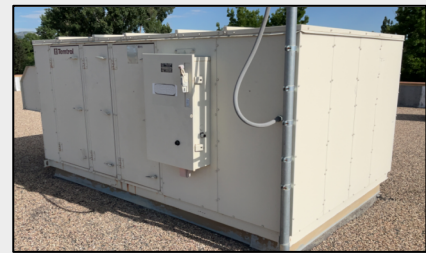
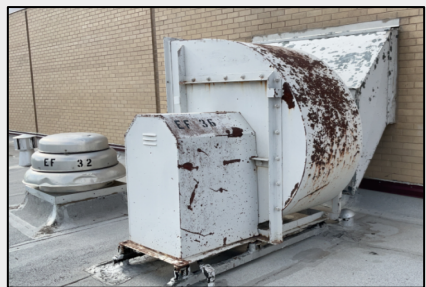
##### 1. Replace Outdated Ventilation Equipment

Several of the building's air handling and exhaust assets have greatly exceeded their industry recommended lifespan, [REDACTED] This includes the gymnasium air handler, as well as the rooftop exhaust fans. [REDACTED]  
[REDACTED]  
[REDACTED]

- HVU-1 (FCAID-050129)
- RTU-7 (FCAID-050149)
- Kiln Hood (FCAID-050133)
- (33) Rooftop Exhaust Fans (FCAIDs vary)

Priority Level: 2  
Estimated Cost: \$382,170  
Remaining Life: 2-5 years

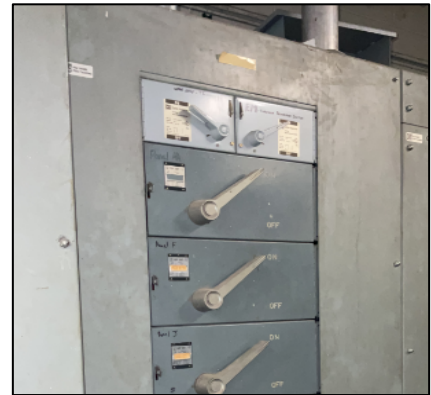
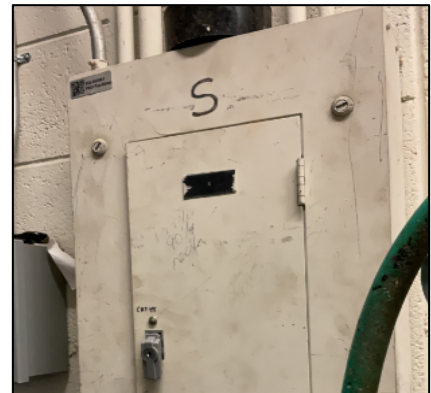
## 2. Replace Outdated Electrical Assets

While the majority of the building's electrical distribution assets have been replaced within the last 10-15 years, a handful of switchgear and panels appear to date back to the building's original 1967 construction. [REDACTED]

[REDACTED] plan to replace them within the next 4 years.

- Main Switchgear, Section 1 (FCAID-050223)
- Main Switchgear, Section 2 (FCAID-050224)
- Main Switchgear, Section 3 (FCAID-050225)
- Panel S (FCAID-050247)

**Priority Level:** 2  
**Estimated Cost:** \$140,080  
**Remaining Life:** 4 years

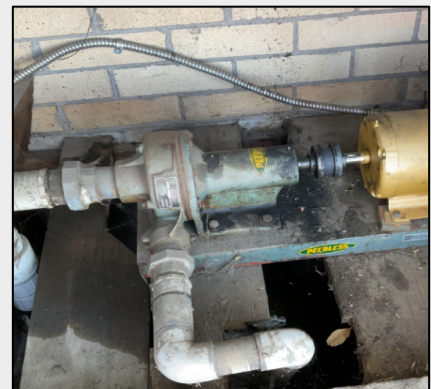
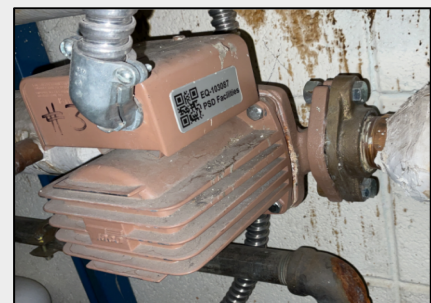
## 3. Replace Outdated Plumbing Assets

Several assets serving the domestic hot water supply system have reached the end of their lifespan, and will be due for replacement within the next 2-5 years. [REDACTED]

- DHW Pump P-3 (FCAID-050039)
- DHW Pump P-4 (FCAID-050040)
- Irrigation Pump (FCAID-050043)
- Backflow Preventer (FCAID-050037)
- Fire Suppression Backflow Preventer (FCAID-050042)
- Main Backflow Preventer (FCAID-050044)
- DHW Mixing Valve (FCAID-050038)

**Priority Level:** 3  
**Estimated Cost:** \$28,250  
**Remaining Life:** 2-5 years

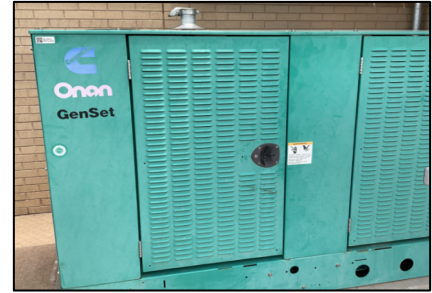
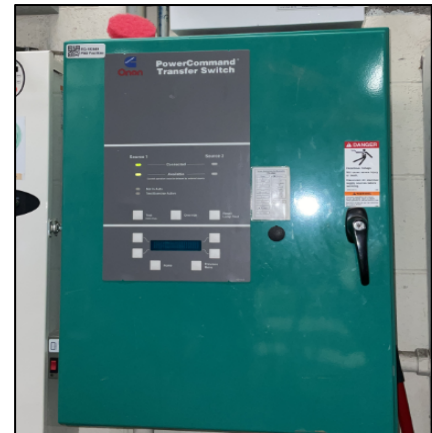
## 4. Replace the Generator

The building's backup generator was installed in 2001, and [REDACTED] it has reached the end of its industry recommended lifespan. [REDACTED]

- Backup Generator (FCAID-050216)
- ATS (FCAID-050215)

**Priority Level:** 3  
**Estimated Cost:** \$37,770  
**Remaining Life:** 5 years

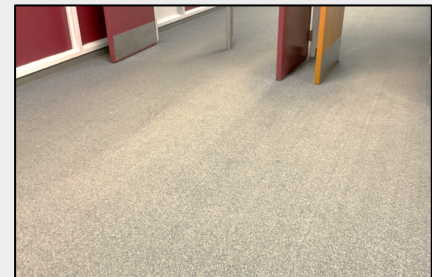
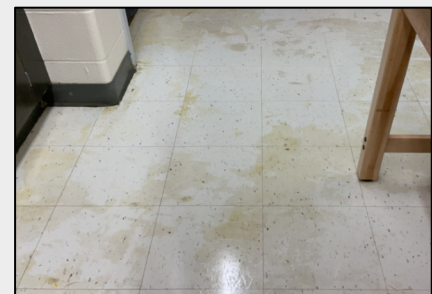
## 5. Update Interior Finishes

While the majority of the building's interior finishes are in good condition, areas of the building's carpeting and vinyl tiling are in poor condition. These areas are worn due to traffic, and can present tripping hazards especially for damaged vinyl tiles. Plan to replace heavily worn areas within 5 years. Note, the replacement cost shown below includes a full replacement of these systems which will likely not be necessary.

- Carpeting (FCAID-050024)
- VCT Flooring, Classrooms (FCAID-050031)

**Priority Level:** 3  
**Estimated Cost:** \$914,100  
**Remaining Life:** 5 years
