# POUDRE SCHOOL DISTRICT KINARD MIDDLE SCHOOL

## FACILITY CONDITION ASSESSMENT

FORT COLLINS, CO

OCTOBER 2023

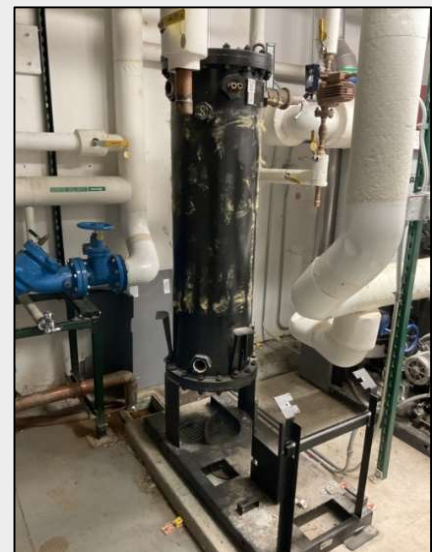
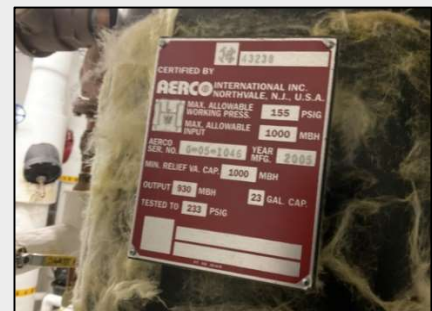
##### Replace Boiler-3

Boiler-3 was observed to be [REDACTED] in preparation for replacement. Recommend completion of boiler replacement prior to 2024-2025 heating season.

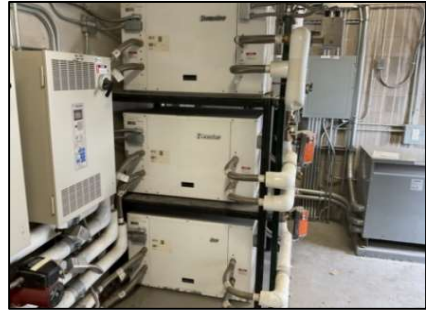
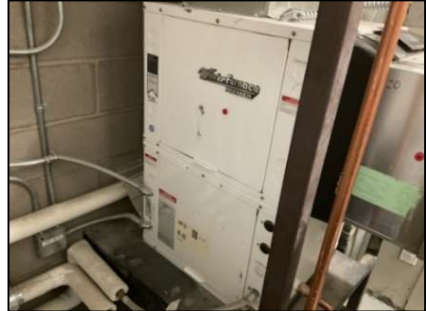
## Replace (73) Ground-Source Heat Pumps

The (73) original 2006-built ground source heat pumps are now two years past expected life and are estimated to require replacement within in three years. ■

■ This measure is a high priority as replacement of (73) heat pumps constitutes a significant Capital Expenditure.

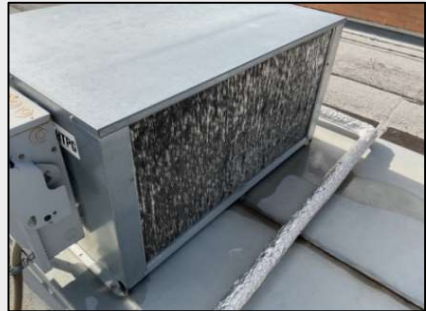
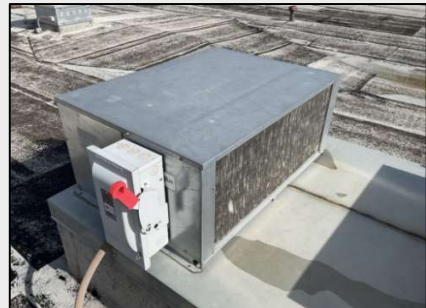
## Replace CU-1-Walk-In Cooler & CU-2-Walk-In Freezer & CU-3

CU-1-Walk-In Cooler, CU-2-Walk-In Freezer, and CU-3 ■  
■ are now two years past expected life. Replace condensing units within two years.

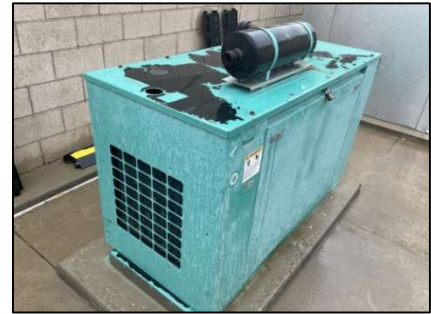
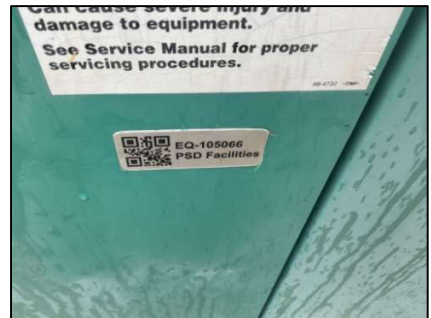
## Replace Back-Up Generator

[REDACTED]  
[REDACTED]  
[REDACTED] Recommend replacement within three years.

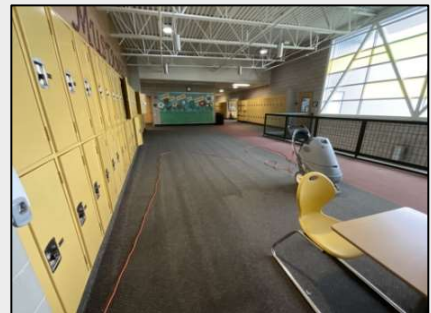
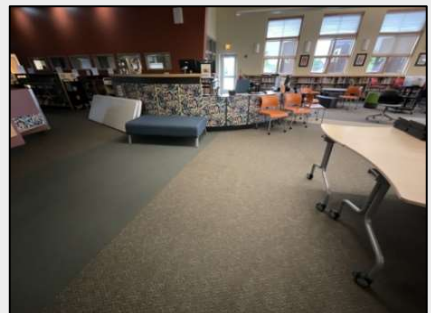
## Replace Carpeting

Though the carpeting has been maintained well by PSD Staff, it is now 7 years past expected life. Recommend replacement within two years.
