# POUDRE SCHOOL DISTRICT

## BOLTZ MIDDLE SCHOOL

### FACILITY CONDITION ASSESSMENT

OCTOBER 2023

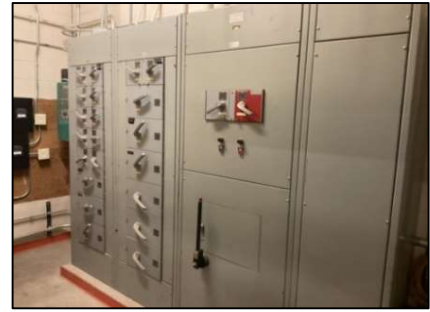
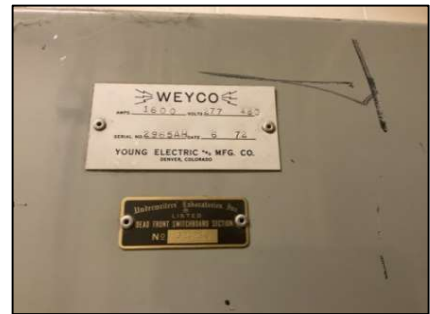
## 1972 Electrical Asset Replacement

[REDACTED]

The following assets are included within this measure:

FCAID-080241 through FCAID-080245, FCAID-080249, FCAID-080221, FCAID-080223, FCAID-080224, FCAID-080225, FCAID-080228, FCAID-080231, FCAID-080232

**Priority Level:** 1  
**Estimated Cost:** \$165,740  
**Remaining Life:** 1-2 Years

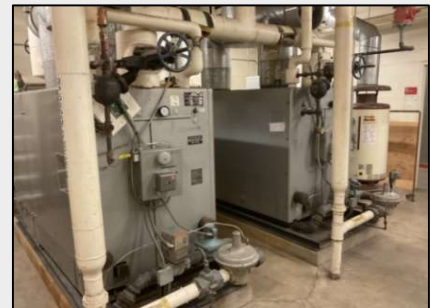
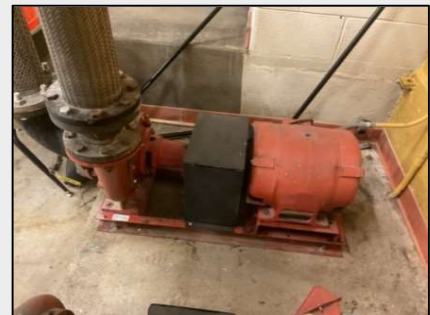
## Boiler & HWP Replacement

The heating water system features two 1972-built gas-fired boilers that are 16 past expected life, and two 1972-built circulation pumps that are 31 years past expected life. [REDACTED]

The following assets are included within this measure:

FCAID-080117, FCAID-080118, FCAID-080120, FCAID-080120

**Priority Level:** 1  
**Estimated Cost:** \$419,020  
**Remaining Life:** 1 Year

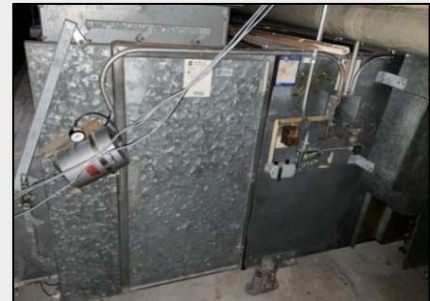
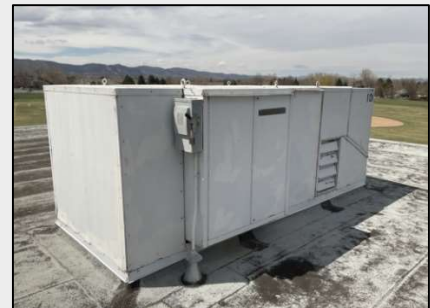
## AHU & RTU Replacement

The (5) 1972-built AHUs and (7) of the 1972-built RTUs were observed to be [REDACTED] requiring replacement within the year. AHUs are 26 year past due and RTUs are 16 years past expected life. Measure includes AHUs 16,5,6,7,8 and RTUs 2,10,11,12,13,14,15.

The following assets are included within this measure:

FCAID-080071 through FCAID-080075, FCAID-080123 through FCAID-080128

Priority Level: 2  
Estimated Cost: \$1,274,930  
Remaining Life: 1 Year
