# POUDRE SCHOOL DISTRICT PRESTON MIDDLE SCHOOL

## FACILITY CONDITION ASSESSMENT

FORT COLLINS, CO

OCTOBER 2023

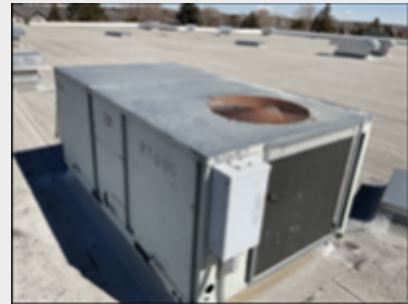
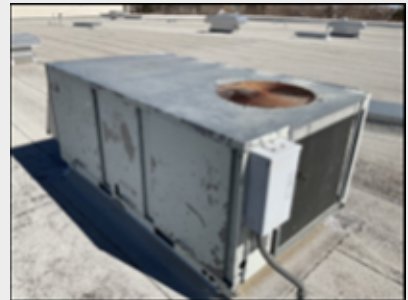
##### 1. Replace Rooftop Units

RTUs 01 through 08 are original to the 1994 construction. All eight are now 14 years past expected useful life. RTU-05 and RTU-07 are [REDACTED] requiring replacement within the year. RTUs 01,02,03,04,06, and 08 are [REDACTED] requiring replacement within two years.

| Priority Level: | 2 |
| Estimated Cost: | \$371,800 |

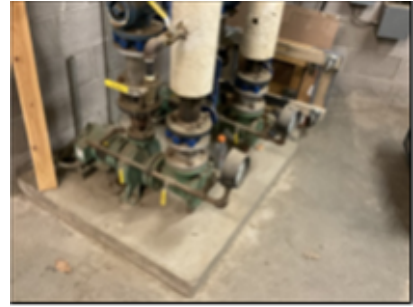
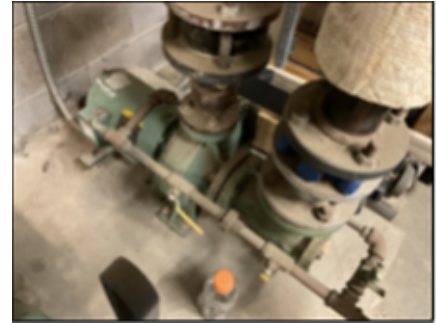
## 2. Heating Water Pumps Replacement

Heating Water System Pumps P-1, P-2, P-3, and P-4 are original to the 1994 construction. All four pumps are now 9 years past expected useful life. P-3 and P-4 are [REDACTED] requiring replacement within the year. P-1 and P-2 are [REDACTED] requiring replacement within two years.

**Priority Level:** 2  
**Estimated Cost:** \$42,980  
**Remaining Life:** 1-2 Years

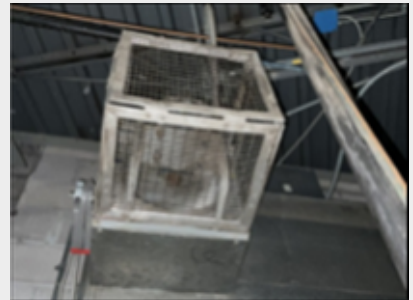
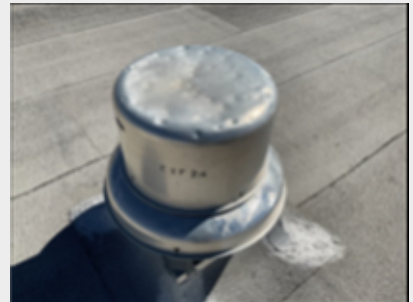
## 3. Exhaust Fan Replacements

EF-01 through EF-39 (28 EFs total) are original to the 1994 construction. These EFs are now 9 years past expected useful life. All 28 EFs have sustained substantial hail damage. EF-01 and EF-02 are [REDACTED] requiring replacement within the year. The remaining 26 EFs are [REDACTED] requiring replacement within two years.

**Priority Level:** 2  
**Estimated Cost:** \$208,790  
**Remaining Life:** 1-2 Years

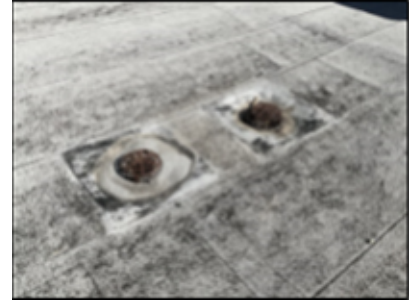
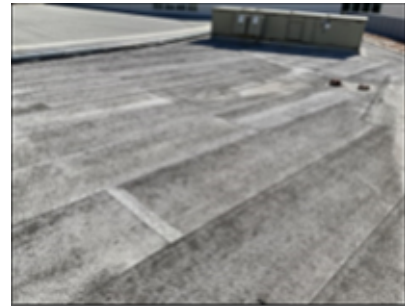
## 4. Replace Rolled Asphalt Roofing

The 1994 original rolled asphalt roof is now four years past expected useful life [REDACTED]. Roofing material is bubbled up and has visible cracks. Recommend replacement of the 1994 original rolled asphalt roof within two years.

**Priority Level:** 2  
**Estimated Cost:** \$710,580  
**Remaining Life:** 2 Years

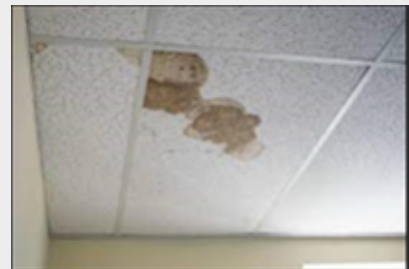
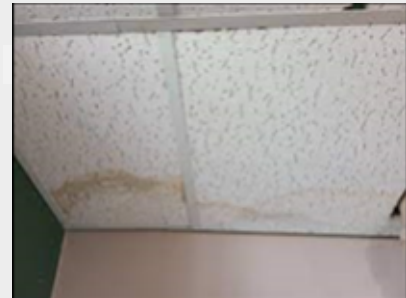
## 5. Replace Acoustical Tile Ceiling

The 1994 original acoustical ceiling panels are now 10 years past expected useful life [REDACTED]. Multiple water leaks were observed. Recommend replacement of the 1994 original acoustical ceiling panels within two years.

**Priority Level:** 2  
**Estimated Cost:** \$1,004,530  
**Remaining Life:** 2 Years
