# POUDRE SCHOOL DISTRICT WEBBER MIDDLE SCHOOL

## FACILITY CONDITION ASSESSMENT

FORT COLLINS, CO

OCTOBER 2023

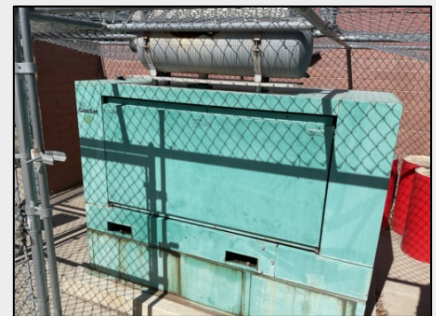
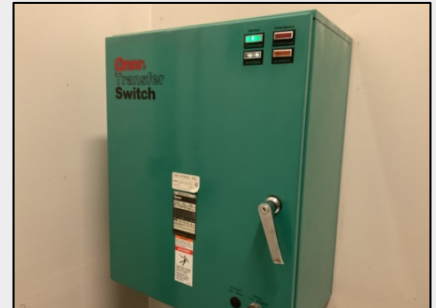
##### Replace Back-Up Generator & ATS-1

FCAID-600204, FCAID-600203

| Priority Level: | 2 |
| Estimated Cost: | \$32,490 |

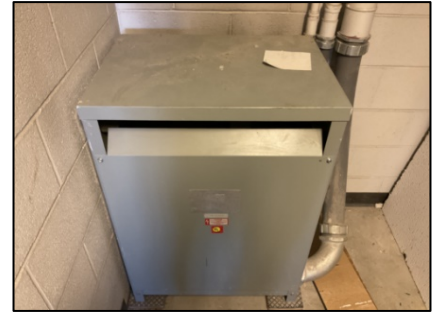
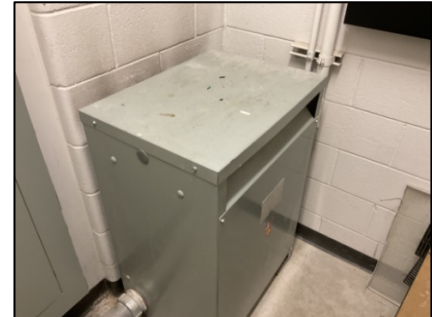
## Replace Transformers D23 & L3

Transformers D23 and L3 [REDACTED] Recommend replacement within the year.

FCAID-600233, FCAID-600235

**Priority Level:** 2  
**Estimated Cost:** \$16,380  
**Remaining Life:** 1 Year

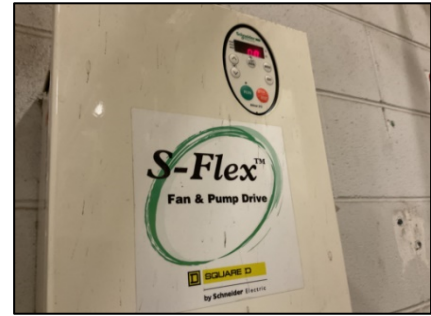
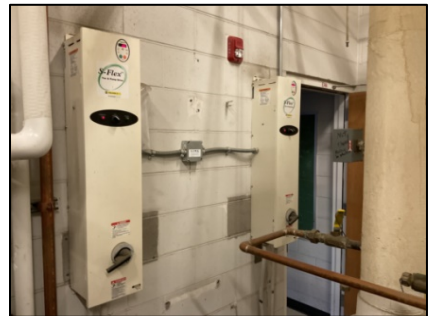
## Replace VFD-HWP-1, VFD-HWP-2, VFD-RTU-11

VFD-HWP-1, VFD-HWP-2, and VFD-RTU-11 are original 1990-built VFDs that are 14 years past expected life. [REDACTED]. Recommend replacement within two years.

FCAID-600238, FCAID-600239, FCAID-600240

| Priority Level: | 2 |
| Estimated Cost: | \$16,890 |

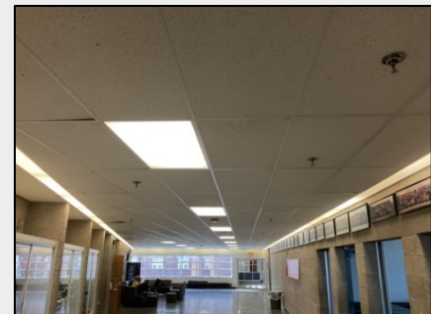
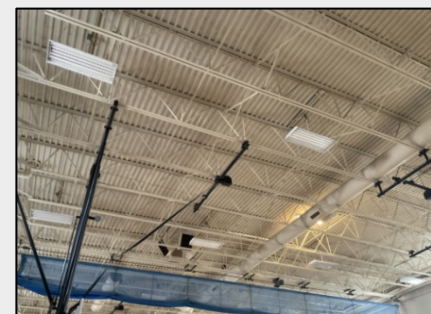
## Replace Interior Fluorescent Light Fixtures

The entirety of the interior consists of 1990 fluorescent lighting fixtures that are 13 years past expected life. Recommend replacement with LED fixtures throughout within two years

FCAID-600208

| Priority Level: | 2 |
| Estimated Cost: | \$1,879,870 |
