# POUDRE SCHOOL DISTRICT LINCOLN MIDDLE SCHOOL

## FACILITY CONDITION ASSESSMENT

FORT COLLINS, CO

OCTOBER 2023

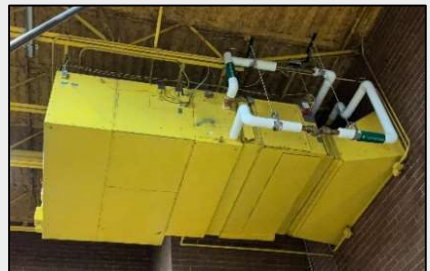
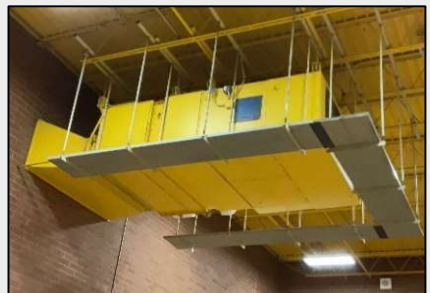
##### Replace Air Handling Units

The three air handling units serving the gym and mini gym areas [REDACTED] appear to have been installed during original construction in 1974. These units have surpassed their industry life expectancies and should be replaced within the next five years.

FCAID-330055, FCAID-330056, FCAID-330057

| Priority Level: | 2 |
| Estimated Cost: | \$255,960 |

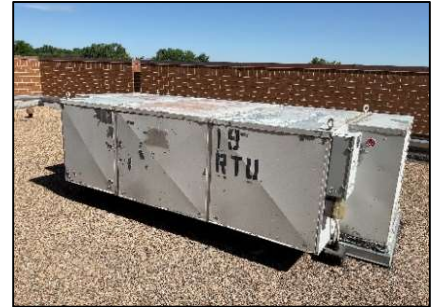
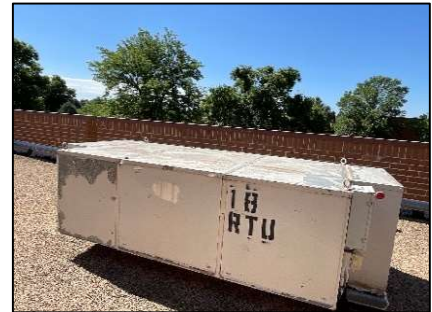
## Replace Rooftop Units

RTU-18 and RTU-19 serving the locker room areas [REDACTED] have surpassed their industry life expectancies and should be replaced within the next four years.

FCAID-330128, FCAID-330129

**Priority Level:** 2  
**Estimated Cost:** \$69,970  
**Remaining Life:** 4 years

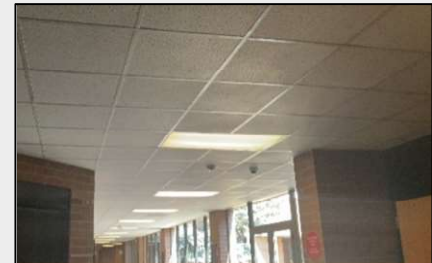
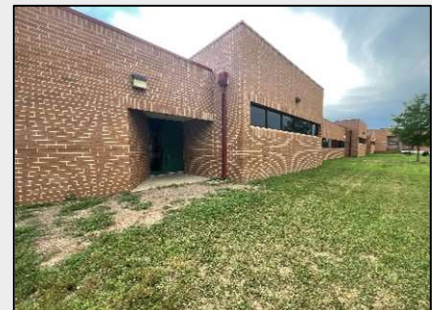
## Replace Lighting Fixtures

FCAID-330139, FCAID-330140, FCAID-330141, FCAID-330142, FCAID-330143, FCAID-330144, FCAID-330145, FCAID-330146, FCAID-330147, FCAID-330148, FCAID-330149, FCAID-330150, FCAID-330152, FCAID-330153

**Priority Level:** 2  
**Estimated Cost:** \$1,986,740  
**Remaining Life:** 2-4 years

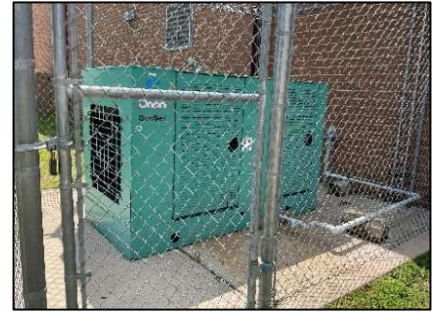
## Replace Emergency Generator

The emergency generator has surpassed its industry life expectancy and is anticipated to need replacement within the next six years

FCAID-330138

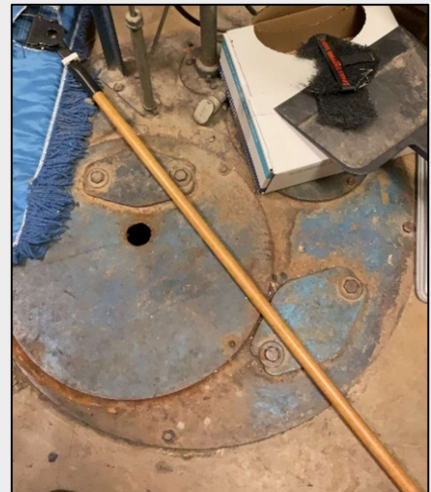
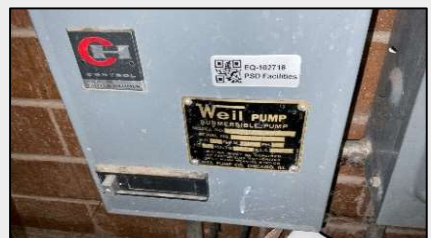
## Replace Sump Pump

The sump pump is estimated to have been installed in approximately 1974 and has surpassed its life expectancy and is anticipated to need replacement within the next two years.

FCAID-330050

| Priority Level: | 2 |
| Estimated Cost: | \$8,300 |
