# LESHER IB WORLD MIDDLE SCHOOL

POUDRE SCHOOL  
DISTRICT

FACILITY CONDITION ASSESSMENT

MARCH 2023

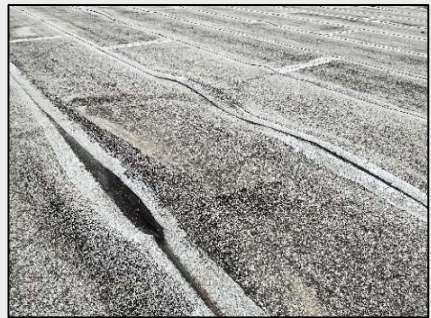
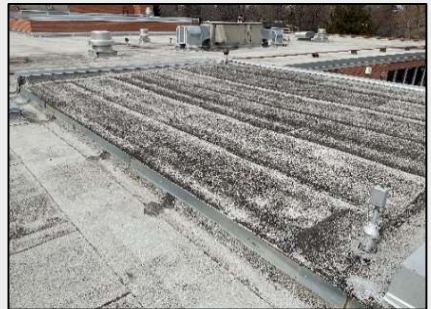
##### 1. Replace Rolled Asphalt Roofing

The 1993 and 1972 [REDACTED] Roofing material is bubbled up and has visible cracks. Recommend replacement of these sections within the year.

FCAID-320020, FCAID-320021

| Priority Level: | 2 |
| Estimated Cost: | \$42,630 |

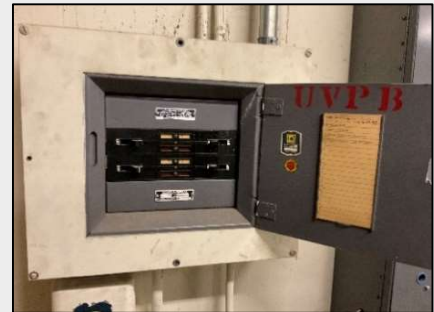
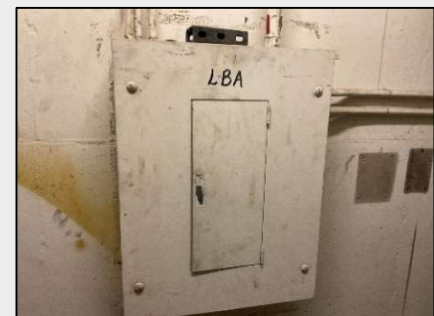
## 3. Replace Older Electrical Panelboards

Nine of the electrical panelboards date to 1980 [REDACTED]  
[REDACTED] Recommend replacement within the year.

FCAID-320210, FCAID-320214, FCAID-320214, FCAID-320215, FCAID-320216, FCAID-320217, FCAID-320218, FCAID-320219, FCAID-320225

**Priority Level:** 2  
**Estimated Cost:** \$28,620  
**Remaining Life:** ≤ 1 Year

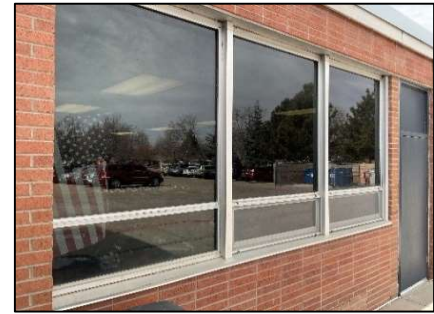
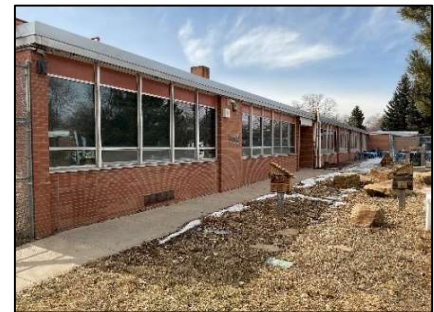
## 4. Replace Exterior Windows

FCAID-320012, FCAID-320013, FCAID-320014, FCAID-320015

**Priority Level:** 3  
**Estimated Cost:** \$367,840  
**Remaining Life:** ≤ 2 Years

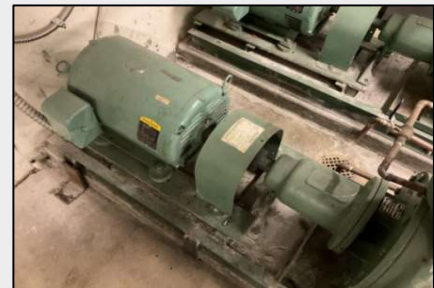
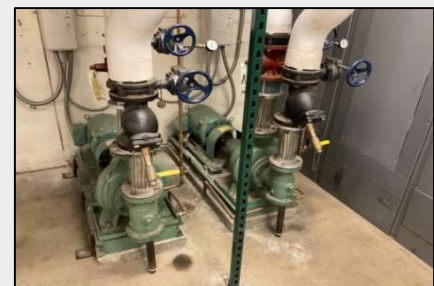
## 5. Replace Heating Water Pumps

HWP-1 and HWP-2 are 2006-built 20 Hp pumps that [REDACTED] require replacement within two years. HWP-3 and HWP-4 are 2006-built 2 Hp pumps that [REDACTED] [REDACTED] require replacement within two years.

FCAID-320143 through FCAID-320146

**Priority Level:** 2  
**Estimated Cost:** \$68,700  
**Remaining Life:** ≤ 2 Years
