# POUDRE SCHOOL DISTRICT

## WELLINGTON MIDDLE-HIGH SCHOOL

### FACILITY CONDITION ASSESSMENT

OCTOBER 2023

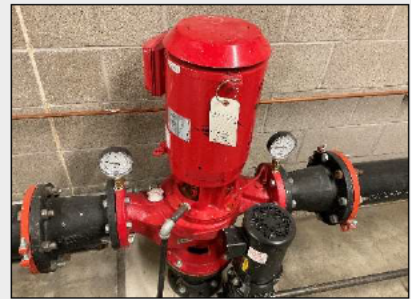
##### Replace Fire Pump 1

Although Wellington Middle/High School is a recently constructed building, fire pump 1 is [REDACTED]. It is recommended that this pump be replaced within two years.

| Priority Level: | 1 |
| Estimated Cost: | \$24,640 |

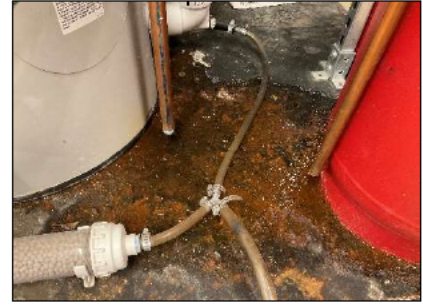
## Replace WH-4

Domestic hot water is provided by four (4) natural gas fired water heater installed in 2022. One of the water heaters (WH-4) was leaking. [REDACTED] Additional plumbing equipment includes backflow preventers, expansion tanks, and pumps. Overall, the plumbing system is in good condition.

Although Wellington Middle/High School is a recently constructed building, WH-4 was identified to have a leak [REDACTED]. It is recommended that this water heater be replaced within two years.

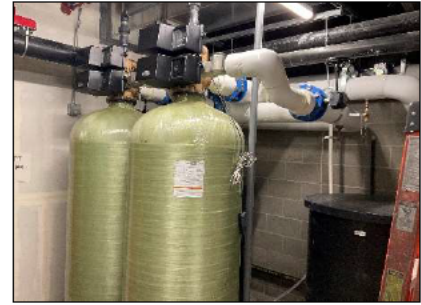
## Water Softeners

The water softeners have been taken offline due to [REDACTED] [REDACTED] Unsafe levels of copper have been detected in the DCWS. To ensure longevity of the school's domestic water systems, we recommend that an entirely new comprehensive water treatment system be installed that can treat domestic cold water for metals and other contaminants.
