# POUDRE SCHOOL DISTRICT POUDRE GLOBAL ACADEMY

## FACILITY CONDITION ASSESSMENT

FORT COLLINS, CO

OCTOBER 2023

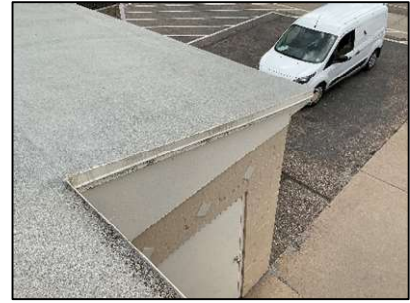
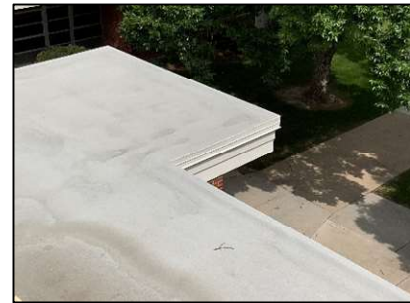
## Replace Gutters and Metal Flashing

Gutters and Metal Flashing installed in approximately 1975 have now surpassed their industry life expectancy [REDACTED]. These roofing components should be replaced within the next year.

FCAID-460017, FCAID-460018

**Priority Level:** 2  
**Estimated Cost:** \$16,310  
**Remaining Life:** 1 year

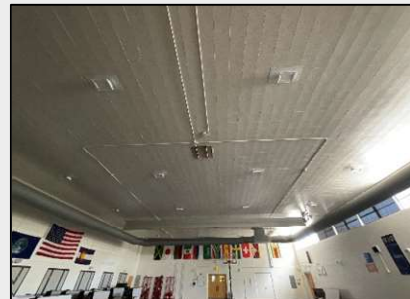
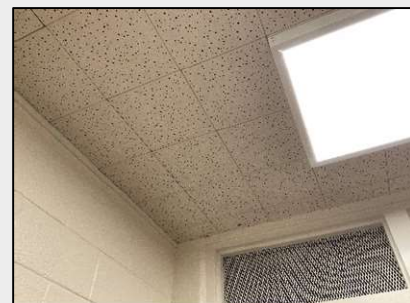
## Replace 1957 Acoustic Ceiling Tile

[REDACTED]  
[REDACTED]  
[REDACTED] This acoustic tile should be replaced within the next year.

FCAID-460049

**Priority Level:** 1  
**Estimated Cost:** \$44,360  
**Remaining Life:** 1 year

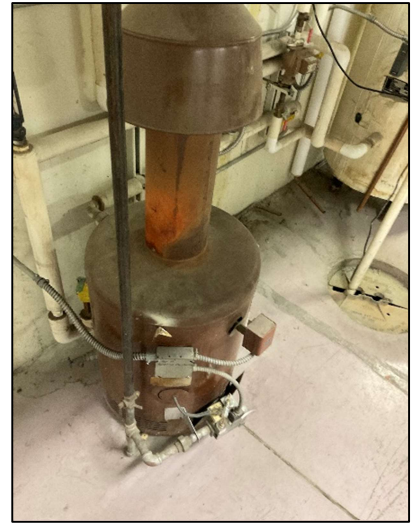
## Replace the Gas Water Heater

Domestic hot water is provided by a natural gas fired water heater installed in 1979, [REDACTED] and should be replaced within the next year.

FCAID-460060

| Priority Level: | 2 |

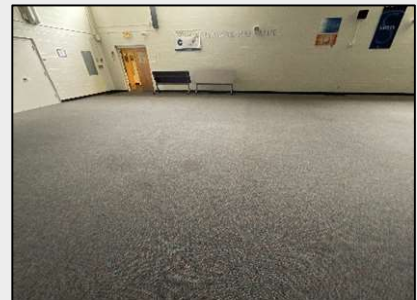
## Replace 1996 Carpet

The carpeting that was installed in 1996 has surpassed its life expectancy [REDACTED]. It is recommended that these areas of carpet be replaced within the next year.

FCAID-460045

| Priority Level: | 3 |
