# POUDRE SCHOOL DISTRICT POUDRE HIGH SCHOOL

## FACILITY CONDITION ASSESSMENT

FORT COLLINS, CO

OCTOBER 2023

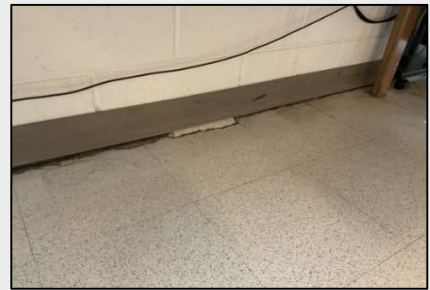
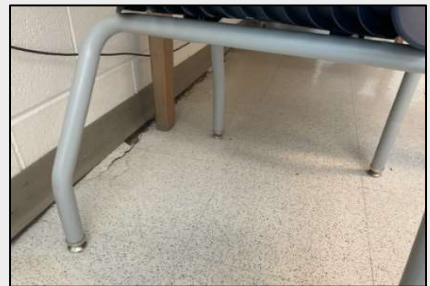
##### Foundation Subsidence - Wall & Floor Damage

Limited foundational Subsidence was observed in classrooms 312 and 314; the concrete floors are separating from the CMU wall. Gaps were also observed in the CMU walls. Interior finish assets have been damaged due to sub-flooring subsidence.

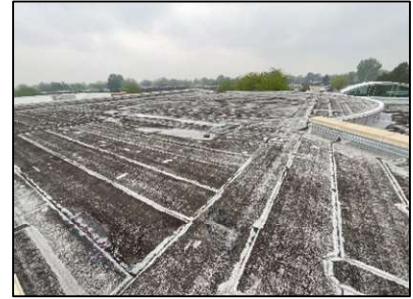
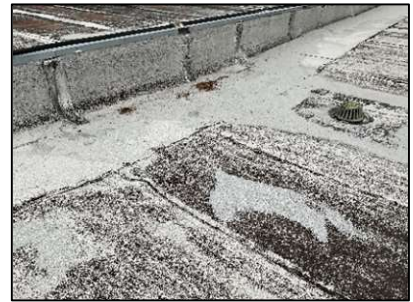
## Replace Rolled Asphalt Roofing

The rolled asphalt roofing installed in 1996 [REDACTED] has surpassed its industry life expectancy. Rolled asphalt roofing material is bubbled up and has lots of standing water and moss. These areas of roofing should be replaced within the next year.

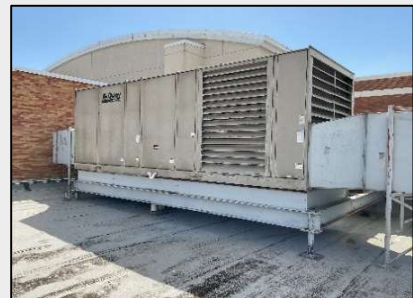
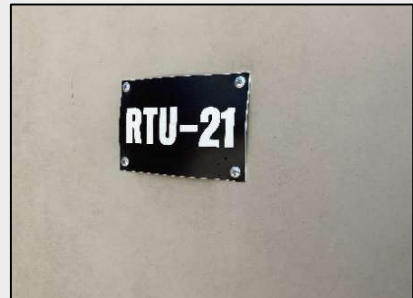
## Replace RTU-21

RTU-21 was installed in 1994 and has surpassed its industry life expectancy. This unit serves the main gym [REDACTED]. It is recommended that this unit be replaced within the next three years.

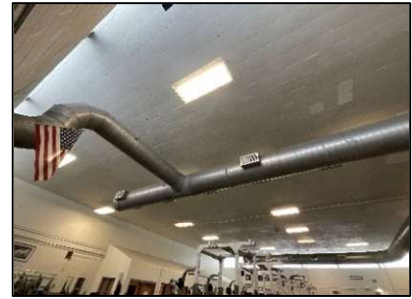
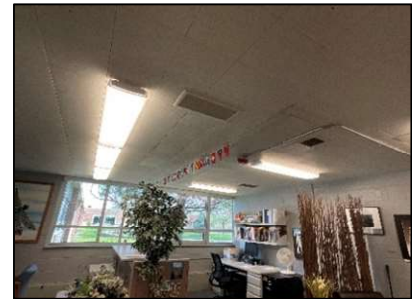
## Replace 1962 Acoustic Ceiling Tile

The acoustic ceiling tile installed during original construction in 1962 [REDACTED]  
[REDACTED]  
[REDACTED]. This acoustic tile should be replaced within the next year.
