# POUDRE SCHOOL DISTRICT CENTENNIAL HIGH SCHOOL

## FACILITY CONDITION ASSESSMENT

FORT COLLINS, CO

OCTOBER 2023

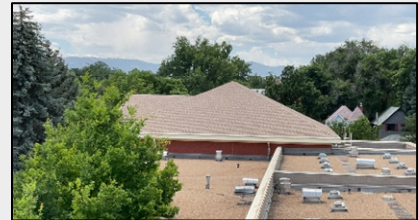
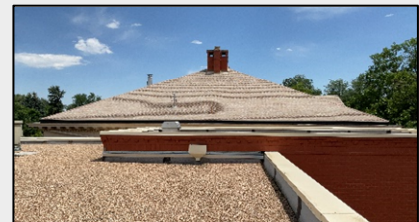
#### Asphalt Shingle Replacement

Both the East and West buildings have sloped roofs with Asphalt Shingles. These shingles are reaching the end of their designed lifespans and replacement should be considered in the near future.

| Priority Level: | 3 |

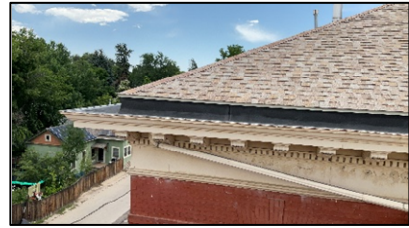
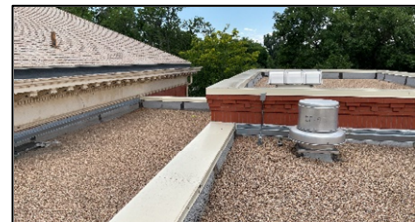
As part of the original roof design, an internal gutter was installed. It is presumed that as part of the latest re-roofing (with asphalt shingles) the flashing of this internal gutter was reviewed, repaired, and updated. As part of the re-roofing of the asphalt shingles (due to their lifespan) the internal gutter should once again be reviewed and repaired as needed. (similar to the adjacent Asphalt Shingles)

**Priority Level:** 3  
**Estimated Cost:** TBD  
**Remaining Life:** 1 Year

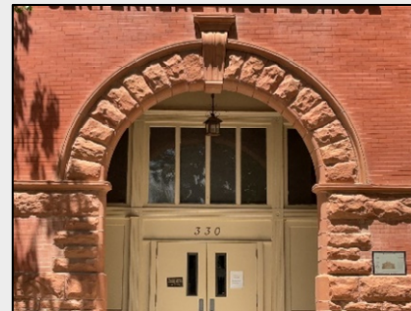
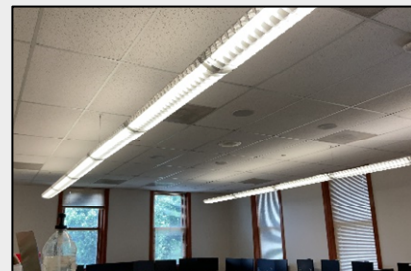
## Upgrade Interior and Exterior Lighting

**Priority Level:** 2  
**Estimated Cost:** \$393,630  
**Remaining Life:** 10 Years

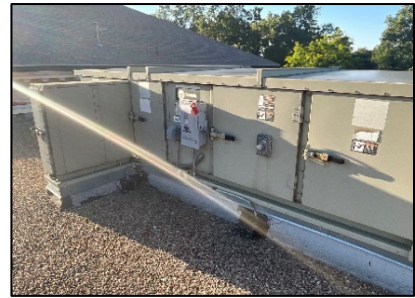
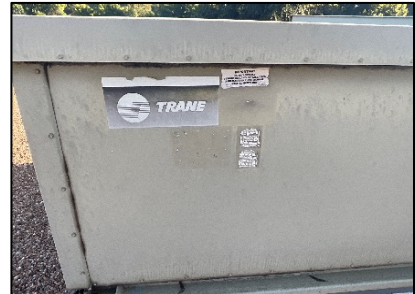
## Replace Rooftop Units

The five rooftop units were installed in 2003 [REDACTED] have surpassed their life expectancies, and should be replaced within the next five years.

| Priority Level: | 2 |

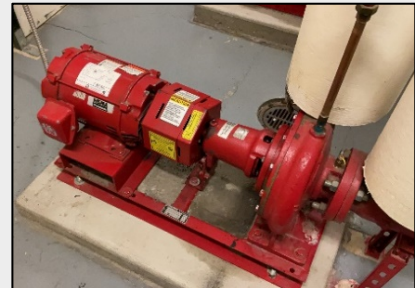
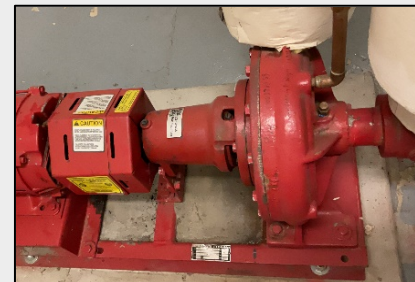
## Replace Hot Water Pumps

The hot water pumps have reached the end of their life expectancy and are anticipated to need to be replaced within the next four years.

| Priority Level: | 2 |
