POUDRE SCHOOL  
DISTRICT

POUDRE COMMUNITY  
ACADEMY HIGH  
SCHOOL

FACILITY CONDITION ASSESSMENT

OCTOBER 2023

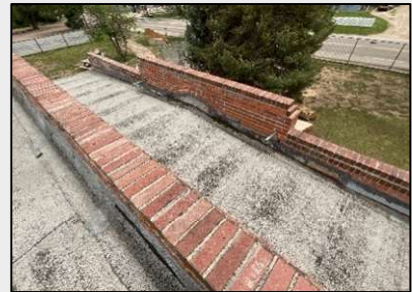
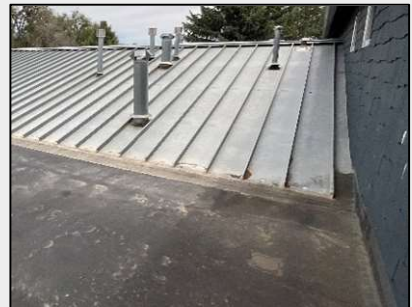
##### Replace Rolled Asphalt and Sheet Metal Roofing

Both the rolled asphalt and sheet metal roofing [REDACTED] have surpassed their industry life expectancies. Rolled asphalt roofing material is bubbled up and has visible cracks. The sheet metal roofing material is showing signs of deterioration. Roofing should be replaced within the next year.

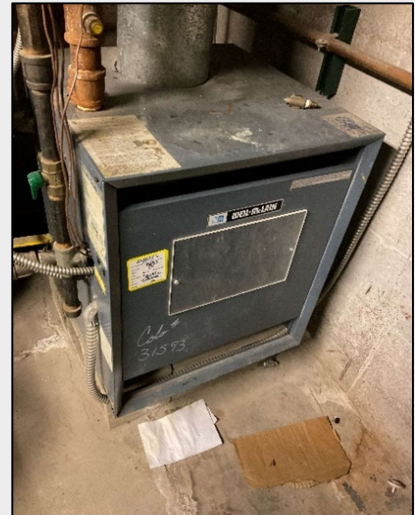
## Replace Boiler

The boiler was installed in 1991. [REDACTED] is nearing the end of its life expectancy and is anticipated to need replacement within the next three years.

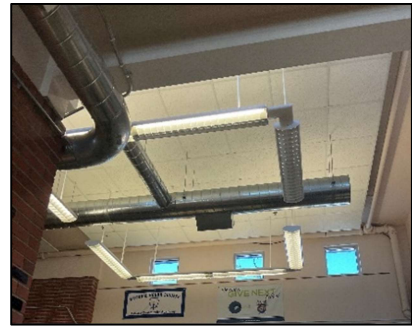
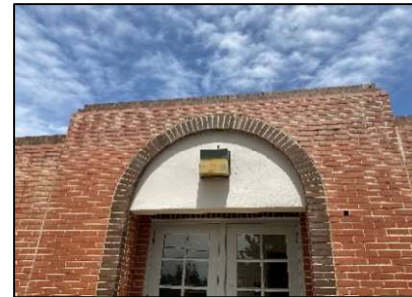
Interior lighting mostly consists of fluorescent lighting retrofitted in 2005. These fixtures will reach the end of their industry life expectancy within two years. Exterior lighting is made up, in part, of incandescent and fluorescent fixtures that [REDACTED] should be replaced [REDACTED]. Consider upgrading the interior and exterior lighting to LED fixtures to reduce energy costs and maintenance needs.

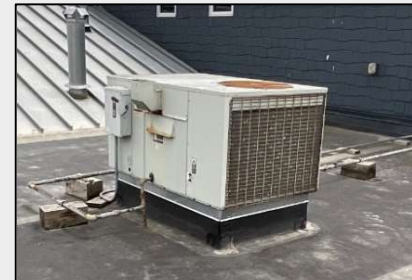
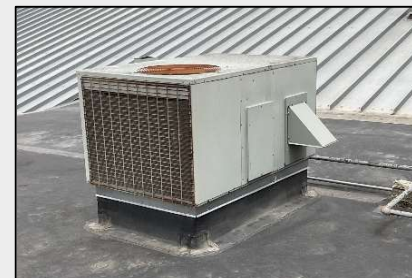
## Replace RTU-1

RTU-1 [REDACTED], is estimated to have surpassed its life expectancy, and is anticipated to need replacement within the next two years.
