POUDRE SCHOOL  
DISTRICT

POLARIS  
EXPEDITIONARY  
LEARNING K-12

FACILITY CONDITION ASSESSMENT

MARCH 2023

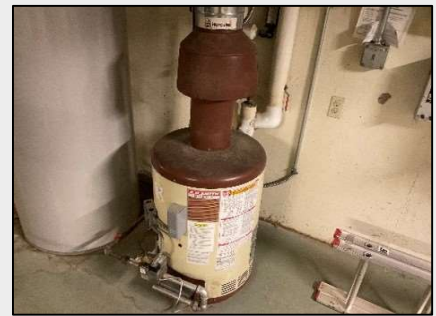
##### 1. Replace GWH-1

Serving the DHW needs of the building, GWH-1 was built in 1996 and is now 17 years past expected useful life. The water heater is [REDACTED] recommended that it be replaced within the year.

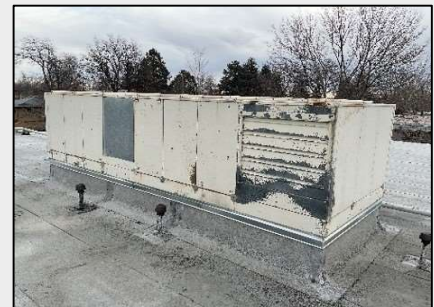
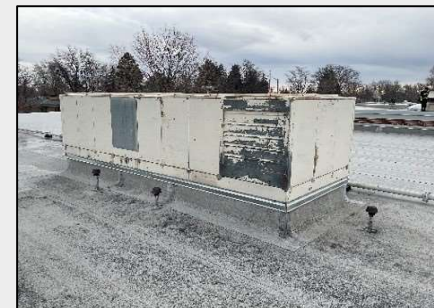
### 3. Replace MZU-1 and MZU-2

These multi-zone air units were built in 1994 and are now 14 years past expected useful life. The MZUs were [REDACTED] recommended that they be replaced within the year prior to failure.

**Priority Level:** 2  
**Estimated Cost:** \$145,820  
**Remaining Life:** ≤ 1 Year

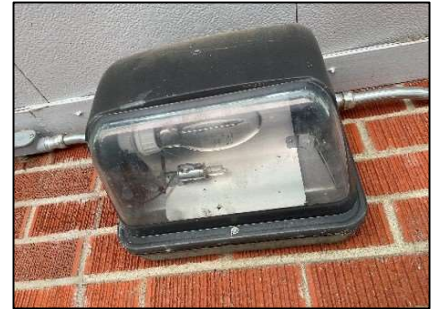
## 4. Replace Exterior Wall Pack Lighting

The 25 exterior incandescent wall pack light fixtures were installed in 1996. These assets are [REDACTED] seven years past expected life. The plastic covers are opaque and discolored. Recommend replacement with LED fixtures within two years.

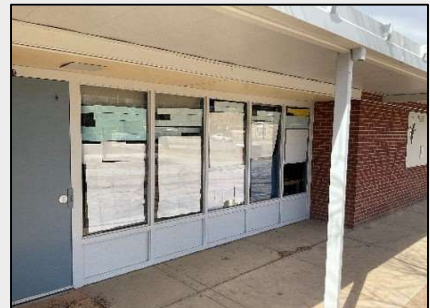
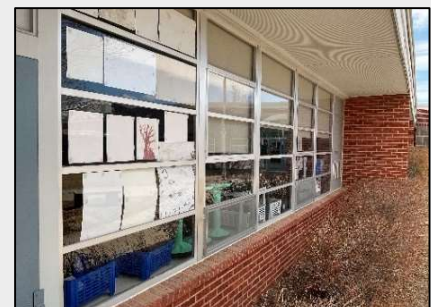
## 5. Replace Exterior Windows

The original 1958 exterior wood windows are 35 years past expected life. Steel casement windows dating to 1956 and 1966 are now 27-37 years past life. Recommend that these original windows be replaced within 1-2 years.

**Priority Level:** 3  
**Estimated Cost:** \$226,760  
**Remaining Life:** ≤ 1-2 Years
