# FACILITY CONDITION ASSESSMENT

Noyes Elementary School  
1919 Pinecrest Drive  
Altadena, California 91001

154554.22R000-027.354

September 11, 2022

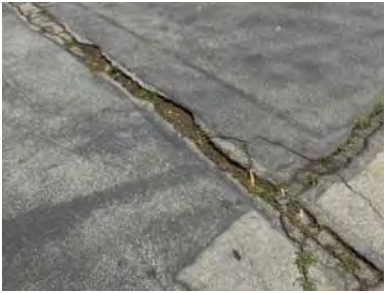
### Play Surfaces in Poor condition.

Asphalt Pavement  
Site Noyes Elementary School Site

Huge cracks in asphalt. Potential for trip hazards. - AssetCALC ID: 3987007

Uniformat Code: G2050  
Recommendation: **Mill and Overlay in 2022**

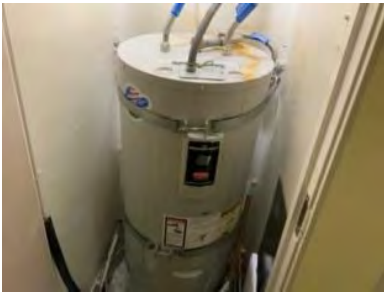
### Water Heater in Poor condition.

Electric, Residential  
Admin (A Building) Noyes Elementary  
School Fire sprinkler control valve closet

Past estimated useful life. - AssetCALC ID: 3986913

Uniformat Code: D2010  
Recommendation: **Replace in 2024**

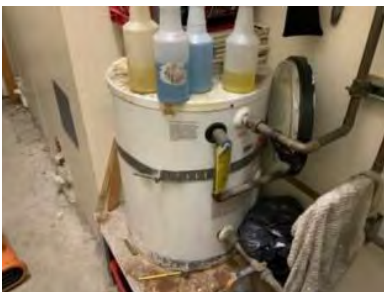
### Water Heater in Poor condition.

Electric, Residential  
C/M Building Noyes Elementary School  
Utility closet

Past estimated useful life. - AssetCALC ID: 3987110

Uniformat Code: D2010  
Recommendation: **Replace in 2024**

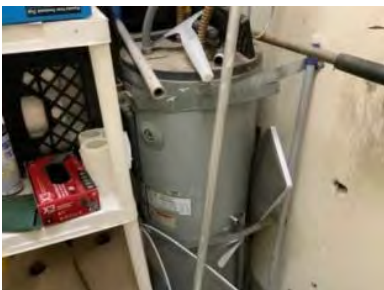
### Water Heater in Poor condition.

Electric, Residential  
D/F Building Noyes Elementary School  
Utility closet

Past estimated useful life. - AssetCALC ID: 3987169

Uniformat Code: D2010  
Recommendation: **Replace in 2024**

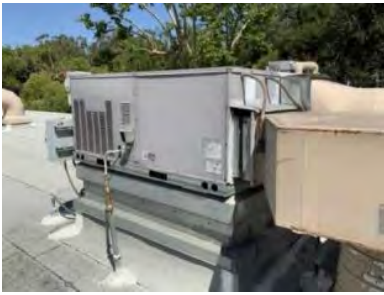
**Packaged Unit in Poor condition.**

RTU, Pad or Roof-Mounted  
C/M Building Noyes Elementary School  
Roof

Well past estimated useful life. - AssetCALC ID: 3987079

Uniformat Code: D3050  
Recommendation: **Replace in 2023**

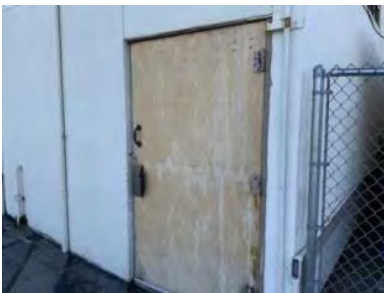
**Exterior Door in Poor condition.**

Wood, Solid-Core  
Auditorium/Cafeteria (G Building) Noyes  
Elementary School Building Exterior

Doors are old and coming apart. - AssetCALC ID: 3986978

| <b>Key Issues and Findings</b> | Exterior wood doors are decaying and need to be replaced. | |

Uniformat Code: B2050  
Recommendation: **Replace in 2024**

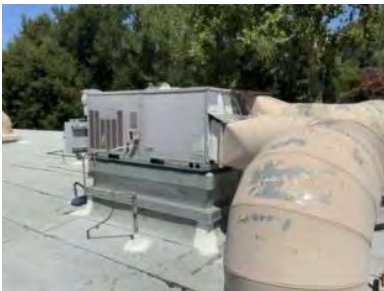
**Packaged Unit in Poor condition.**

RTU, Pad or Roof-Mounted  
D/F Building Noyes Elementary School  
Roof

At estimated useful life. - AssetCALC ID: 3987118

Uniformat Code: D3050  
Recommendation: **Replace in 2024**

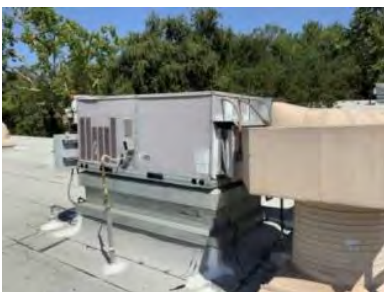
**Packaged Unit in Poor condition.**

RTU, Pad or Roof-Mounted  
C/M Building Noyes Elementary School  
Roof

At estimated useful life. - AssetCALC ID: 3987102

Uniformat Code: D3050  
Recommendation: **Replace in 2024**

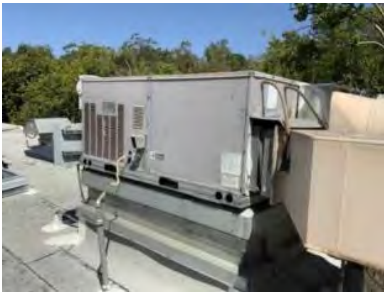
### Packaged Unit in Poor condition.

RTU, Pad or Roof-Mounted  
C/M Building Noyes Elementary School  
Roof

At its estimated useful life. - AssetCALC ID: 3987107

Uniformat Code: D3050  
Recommendation: **Replace in 2024**

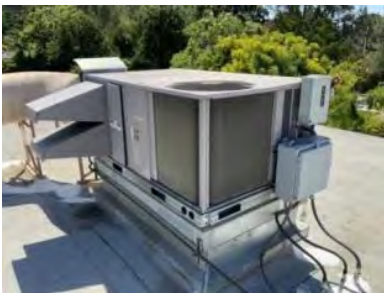
### Packaged Unit in Poor condition.

RTU, Pad or Roof-Mounted  
B Building Noyes Elementary School Roof

At its estimated useful life. - AssetCALC ID: 3987031

Uniformat Code: D3050  
Recommendation: **Replace in 2024**

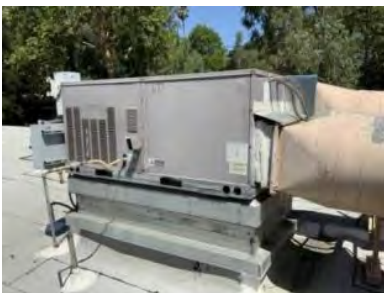
### Packaged Unit in Poor condition.

RTU, Pad or Roof-Mounted  
D/F Building Noyes Elementary School  
Roof

At its estimated useful life. - AssetCALC ID: 3987124

Uniformat Code: D3050  
Recommendation: **Replace in 2024**

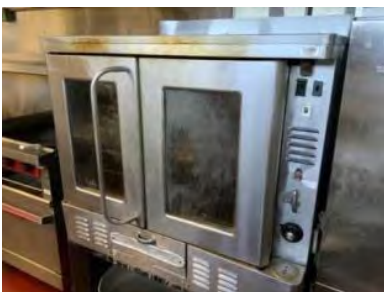
### Foodservice Equipment in Poor condition.

Convection Oven, Single  
Auditorium/Cafeteria (G Building) Noyes  
Elementary School Kitchen

Uniformat Code: E1030  
Recommendation: **Replace in 2024**

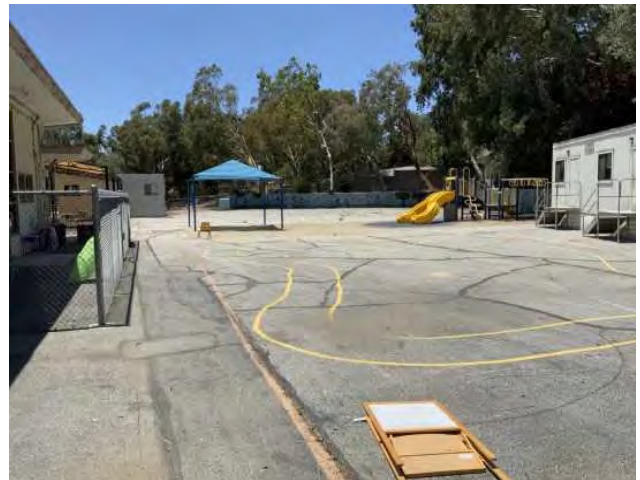
16 - ASPHALT PLAY AREA

| Site Information | | |
|---|---|---|
| <b>Key Issues and Findings</b> | South asphalt play structure has many large cracks. | |
