# FACILITY CONDITION ASSESSMENT

Longfellow Elementary  
1065 East Washington Boulevard  
Pasadena, California 91104

154554.22R000-006.354

September 7, 2022

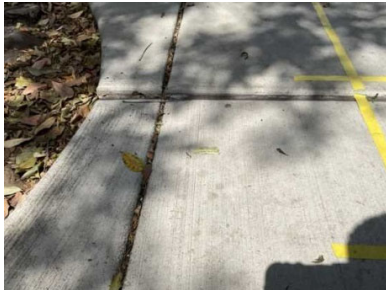
### Sidewalk in Poor condition.

Concrete, Small Areas/Sections  
Children's Center DNU Longfellow Elementary  
Children center

Roots pulling up sidewalk, trip hazards - AssetCALC ID: 3858011

Unifomat Code: G2030  
Recommendation: **Replace in 2023**

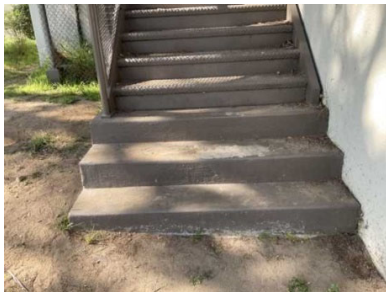
### Stairs in Failed condition.

Concrete, Exterior  
Site Longfellow Elementary East of entrance

Landing Not Even. Dirt and mud - AssetCALC ID: 3854864

Unifomat Code: B1080  
Recommendation: **Replace in 2022**

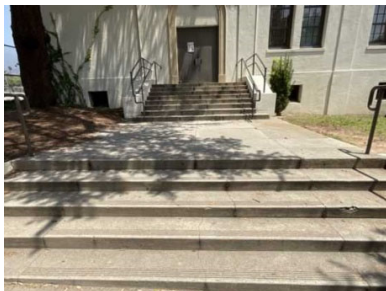
### Stairs in Poor condition.

Concrete, Exterior  
Site Longfellow Elementary Site West side  
north corner

Cement cracked and uneven causing a potential trip hazard - AssetCALC ID: 3854842

Unifomat Code: B1080  
Recommendation: **Replace in 2023**

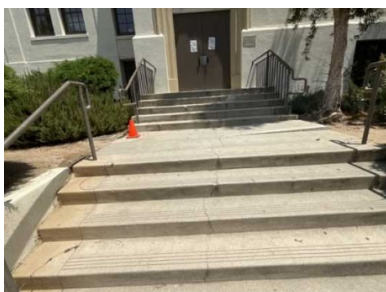
### Stairs in Poor condition.

Concrete, Exterior  
Site Longfellow Elementary West entrance 1

Cement cracked and uneven causing a potential trip hazard - AssetCALC ID: 3854839

Unifomat Code: B1080  
Recommendation: **Replace in 2023**

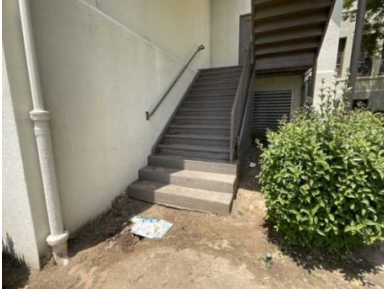
### Stairs in Poor condition.

Concrete, Exterior  
Site Longfellow Elementary Site north side  
west of entrance

Landing Not Even. Dirt and mud - AssetCALC ID: 3854900

Uniformat Code: B1080  
Recommendation: **Replace in 2023**

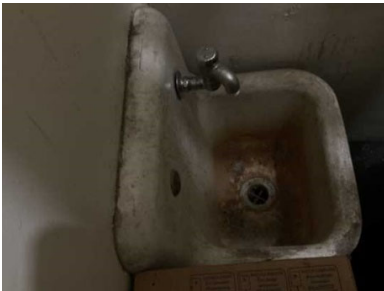
### Sink/Lavatory in Poor condition.

Wall-Hung, Vitreous China  
Administration Longfellow Elementary Utility  
closet first floor

Sink is extremely corroded - AssetCALC ID: 3854903

Uniformat Code: D2010  
Recommendation: **Replace in 2023**

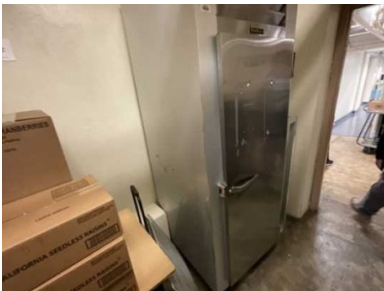
### Foodservice Equipment in Failed condition.

Refrigerator, 1-Door Reach-In  
Administration Longfellow Elementary Kitchen

Not working - AssetCALC ID: 3854833

Uniformat Code: E1030  
Recommendation: **Replace in 2022**

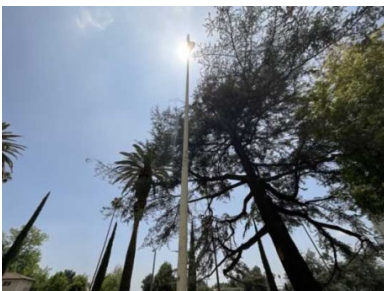
### Flagpole in Poor condition.

Metal  
Site Longfellow Elementary Building exterior

Concrete is cracked and separating - AssetCALC ID: 3854893

Uniformat Code: G2060  
Recommendation: **Replace in 2023**
