# FACILITY CONDITION ASSESSMENT

## **DLR Group**

Washington STEAM Multilingual Academy  
1505 Marengo Avenue  
Pasadena, California 91103

154554.22R000-017.354

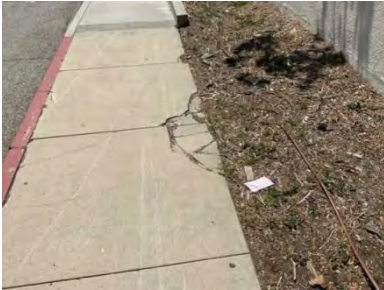
### Sidewalk in Failed condition.

Multiple areas of damaged sidewalk across south side of building A - AssetCALC ID: 3864438

Uniformat Code: G2030  
Recommendation: **Repair in 2022**

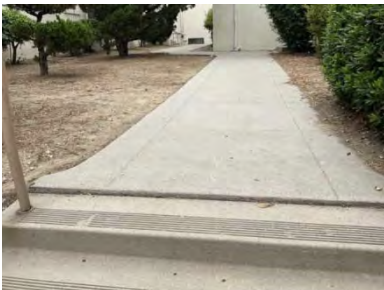
### Sidewalk in Failed condition.

Trip hazard, east side, between A and C building - AssetCALC ID: 3864435

Uniformat Code: G2030  
Recommendation: **Repair in 2022**

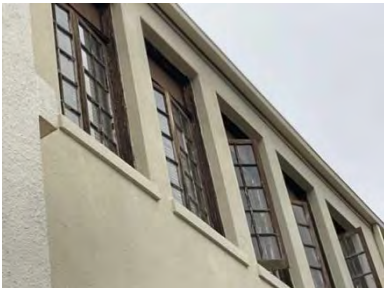
### Window in Poor condition.

Wooden windows in poor condition throughout - AssetCALC ID: 3864503

Uniformat Code: B2020  
Recommendation: **Replace in 2023**

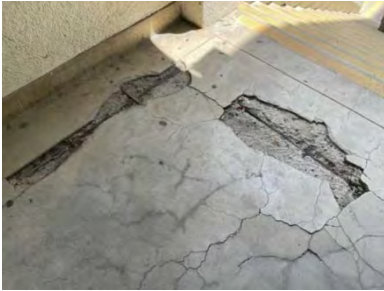
### Sidewalk in Failed condition.

A building east side stairs - AssetCALC ID: 3864471

Uniformat Code: G2030  
Recommendation: **Repair in 2022**

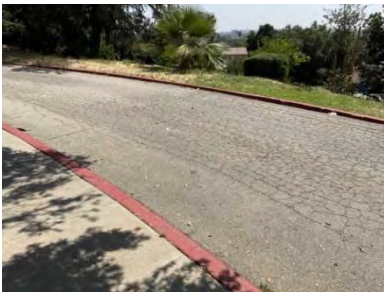
### Parking Lots in Poor condition.

Multiple areas of deteriorated asphalt noted in parking lots and drive lanes - AssetCALC ID: 3864460

Uniformat Code: G2020  
Recommendation: **Cut and Patch in 2022**

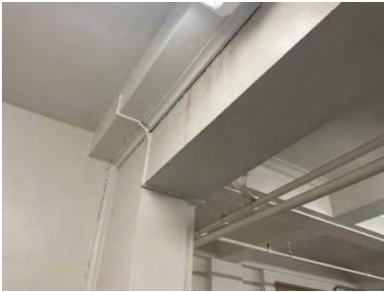
## Recommended Follow-up Study: Structural, Superstructure

Crack observed on 2nd floor near bridge to B building. According to building staff, crack grows and shrinks over the year, has been there several years. - AssetCALC ID: 3864476

Uniformat Code: P2030  
Recommendation: **Evaluate/Report in  
2022**

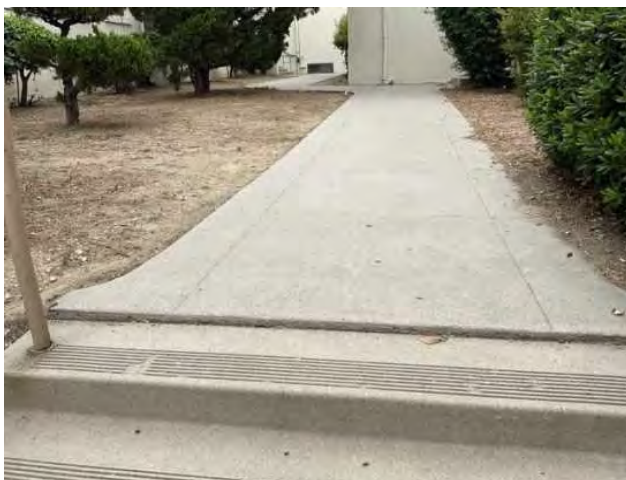
53 - TRIP HAZARD, EAST SIDE BETWEEN A AND C BUILDINGS

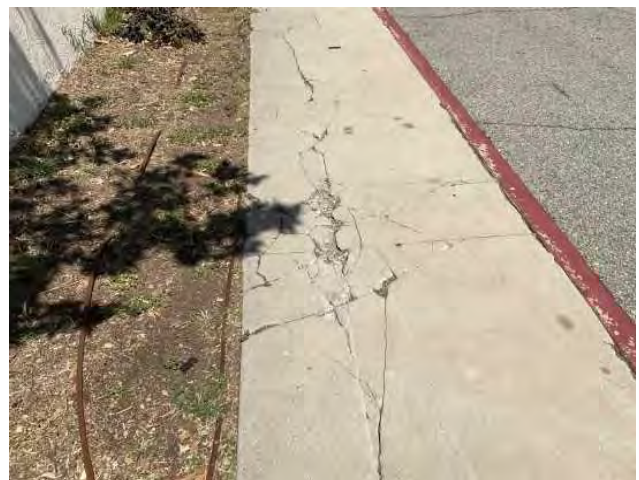
54 - DETERIORATED SIDEWALK, SOUTH SIDE OF A BUILDINGS

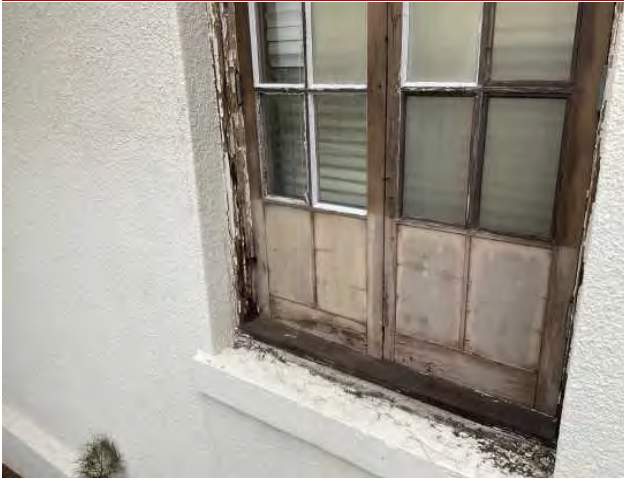
55 - DETERIORATED WOOD WINDOWS, A BUILDING T

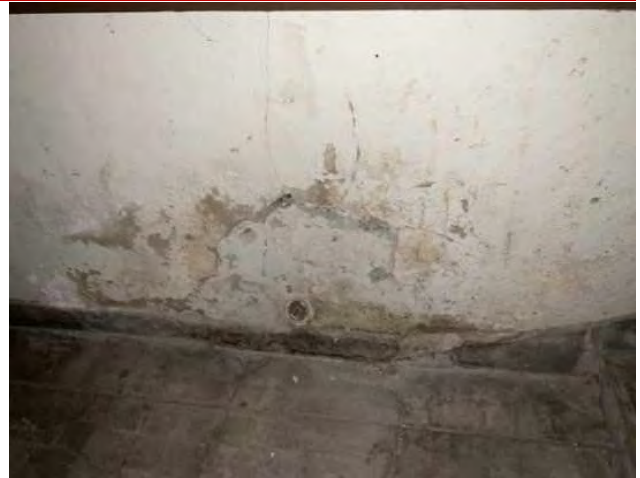
56 - MOISTURE INDUCED DETERIORATION, LOWER LEVEL

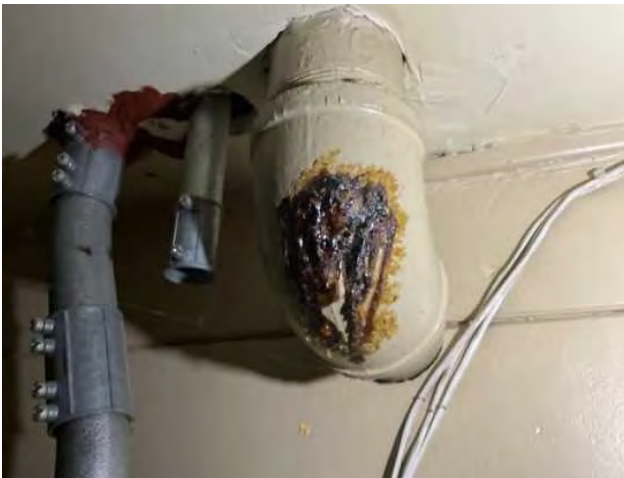
57 - DETERIORATED SANITARY PLUMBING, C BUILDING

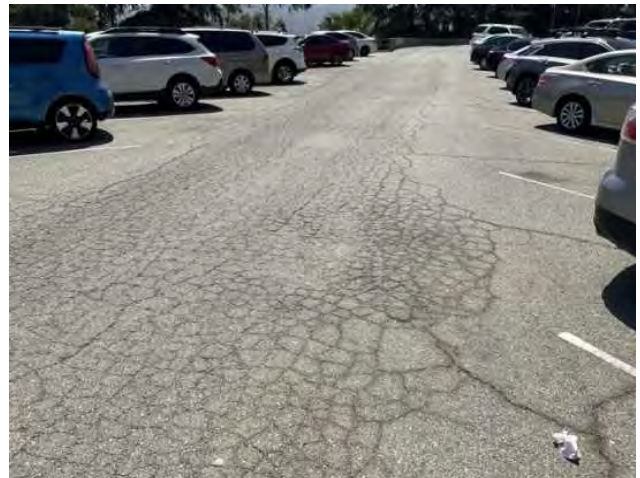
58 - DETERIORATED ASPHALT PAVING

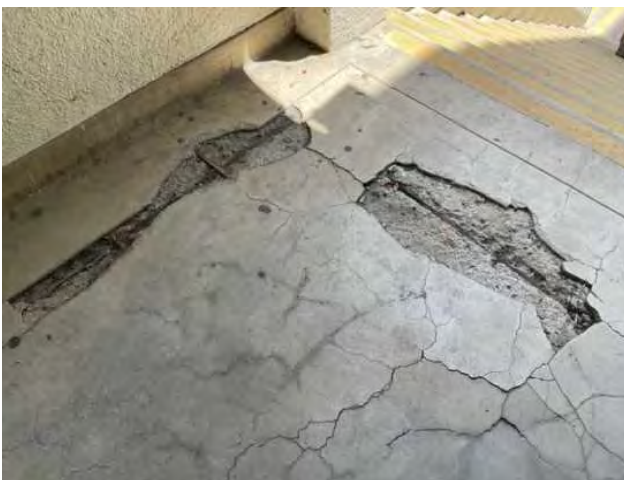
59 - DETERIORATED STEPS EAST SIDE OF A BUILDING

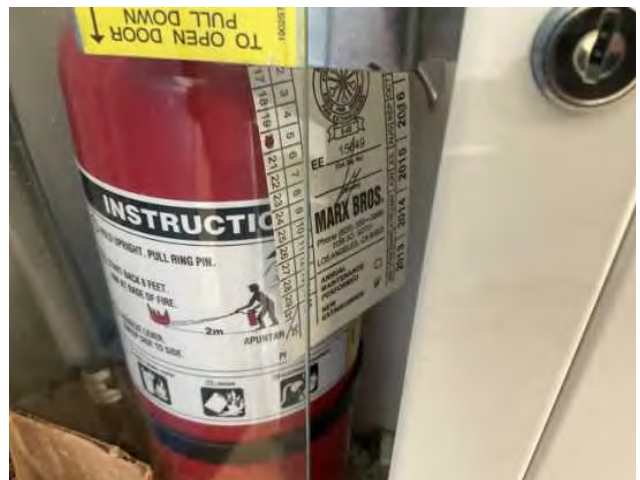
60 - EXPIRED FIRE EXTINGUISHER IN GYMNASIUM
