# FACILITY CONDITION ASSESSMENT

## **DLR Group**

Webster Elementary  
2101 East Washington Boulevard  
Pasadena, California 91104

September 8, 2022

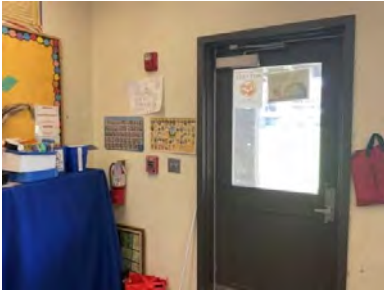
### Emergency and Exit Lighting

Exit Sign/Emergency Combo, LED  
C Webster Elementary Throughout building

Emergency lighting and exit signs were not found in Building C. Recommend installing exit signs and emergency lighting.  
- AssetCALC ID: 3788569

Recommendation: **Replace in 2022**

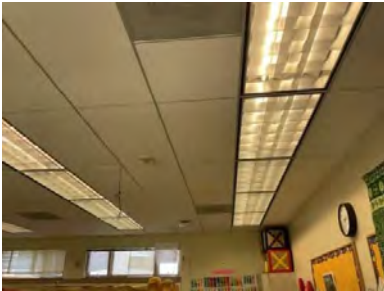
### Fire Suppression System

Full System Install, Medium  
Density/Complexity  
C Webster Elementary Throughout building

No sprinkler system found in building C. Recommend installing new fire sprinkler system. - AssetCALC ID: 3788610

Recommendation: **Install in 2022**
