# FACILITY CONDITION ASSESSMENT

Edison Elementary School  
119 West Palm Street  
Pasadena, California 91117

154554.22R000-025.354

September 12, 2022

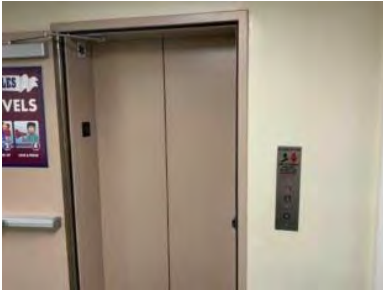
**Elevator Cab Finishes in Failed condition.**

Standard  
Alma Fuerte Edison Elementary School Lobby

Doors do not open. - AssetCALC ID: 3966050

Uniformat Code: D1010  
Recommendation: **Replace in 2022**

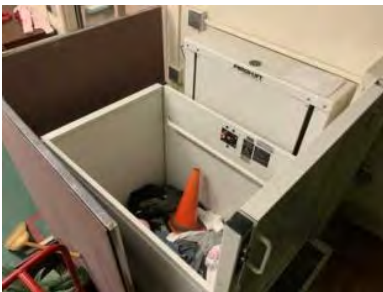
**ADA Elevators in Failed condition.**

Wheelchair Lift, Up to One Floor  
Alma Fuerte Edison Elementary School  
Multipurpose Room

Uniformat Code: Y1040  
Recommendation: **Install in 2022**

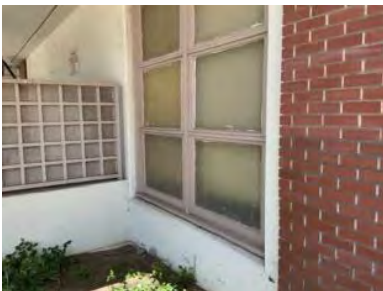
**Window in Poor condition.**

Wood, 28-40 SF  
Alma Fuerte Edison Elementary School  
Building Exterior

Very old and worn. - AssetCALC ID: 3966109

Uniformat Code: B2020  
Recommendation: **Replace in 2024**

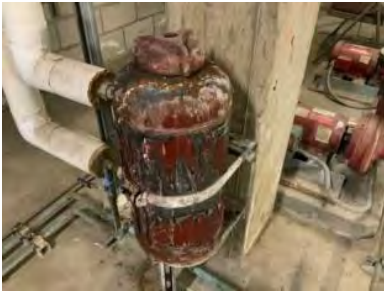
### Boiler Supplemental Components in Poor condition.

Expansion Tank  
Alma Fuerte Edison Elementary School Boiler room

Old and rusting. - AssetCALC ID: 3966100

Unimat Code: D3020  
Recommendation: **Replace in 2024**

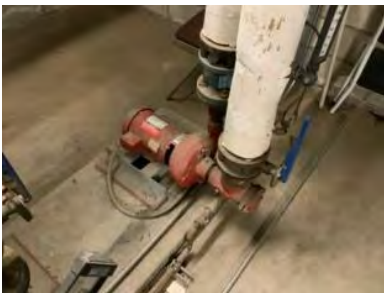
### Pump in Poor condition.

Distribution, HVAC Heating Water  
Alma Fuerte Edison Elementary School Boiler room

Well past its remaining useful life. - AssetCALC ID: 3966103

Unimat Code: D3050  
Recommendation: **Replace in 2024**

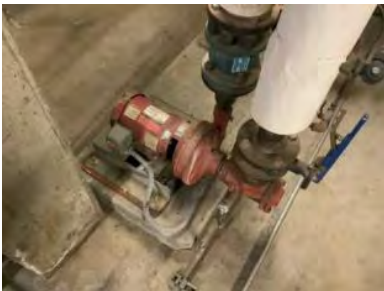
### Pump in Poor condition.

Distribution, HVAC Heating Water  
Alma Fuerte Edison Elementary School Boiler room

Well past its remaining useful life. - AssetCALC ID: 3966083

Unimat Code: D3050  
Recommendation: **Replace in 2024**

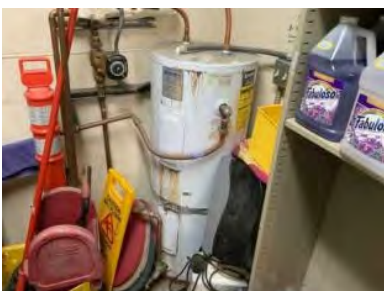
### Water Heater in Poor condition.

Electric, Residential  
Alma Fuerte Edison Elementary School Janitor

Older than expected useful life and rusting. - AssetCALC ID: 3966062

Unimat Code: D2010  
Recommendation: **Replace in 2024**

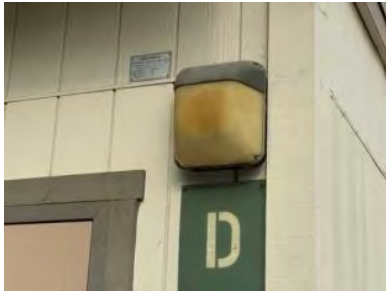
**Standard Fixture w/ Lamp in Failed condition.**

any type, w/ LED Replacement  
South Portable Classroom Portables (3)  
Building exterior

Out of service - AssetCALC ID: 4103153

Uniformat Code: D5040  
Recommendation: **Replace in 2022**

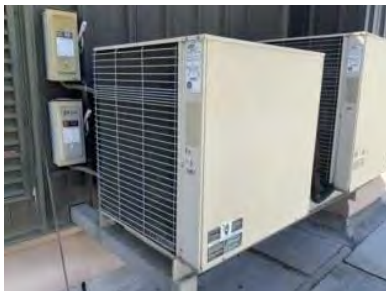
**Split System in Poor condition.**

Condensing Unit/Heat Pump  
Focus Point Edison Elementary School Roof

Well past its estimated useful life. - AssetCALC ID: 3963900

Uniformat Code: D3030  
Recommendation: **Replace in 2024**

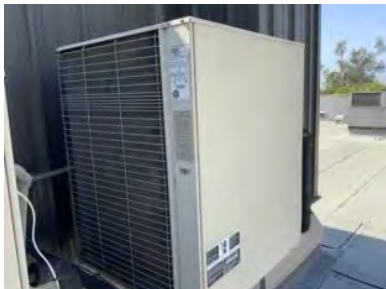
**Split System in Poor condition.**

Condensing Unit/Heat Pump  
Focus Point Edison Elementary School Roof

Uniformat Code: D3030  
Recommendation: **Replace in 2024**

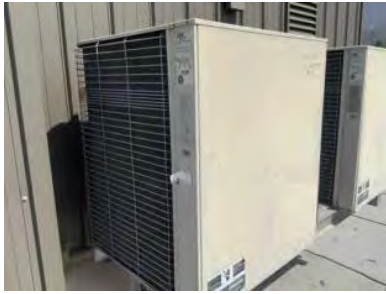
**Split System in Poor condition.**

Condensing Unit/Heat Pump  
Focus Point Edison Elementary School Roof

Well past its estimated useful life. - AssetCALC ID: 3963862

Uniformat Code: D3030  
Recommendation: **Replace in 2024**

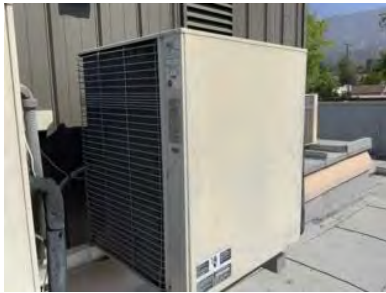
**Split System in Poor condition.**

Condensing Unit/Heat Pump  
Focus Point Edison Elementary School Roof

Uniformat Code: D3030  
Recommendation: **Replace in 2024**
