# FACILITY CONDITION ASSESSMENT

## **DLR Group**

Loma Alta Elementary School  
3544 North Canon Boulevard  
Altadena, California 91001

September 12, 2022

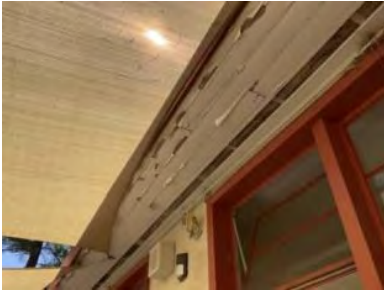
### Exterior Walls in Poor condition.

Any painted surface  
H Loma Alta Elementary School Building  
Exterior

Paint is peeling. - AssetCALC ID: 4008383

Uniformat Code: B2010  
Recommendation: **Prep and Paint in 2023**

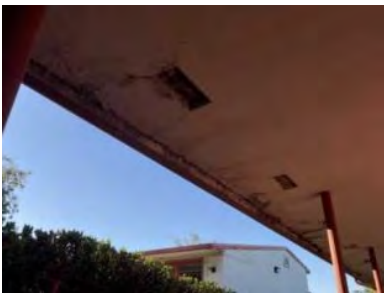
### Exterior Walls in Poor condition.

Any painted surface  
A Loma Alta Elementary School Building  
Exterior

Paint is peeling. - AssetCALC ID: 4008421

Uniformat Code: B2010  
Recommendation: **Prep and Paint in 2023**

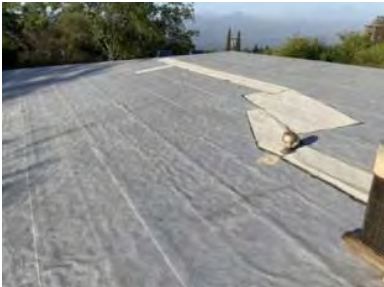
### Roofing in Poor condition.

Modified Bitumen  
A Loma Alta Elementary School Roof

Roof has cracking throughout. - AssetCALC ID: 4008314

| <b>Key Issues and Findings</b> | Building A's roof was found cracking in multiple locations. Possible roof leaks. | |

Uniformat Code: B3010  
Recommendation: **Replace in 2023**

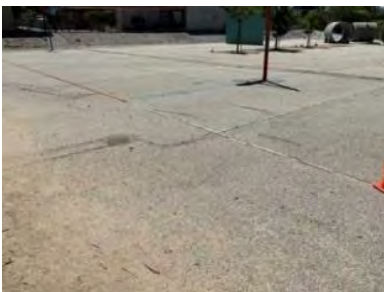
### Parking Lots in Poor condition.

Pavement, Asphalt  
Site Loma Alta Elementary School Site

Severe cracking throughout playground. - AssetCALC ID: 4008516

Uniformat Code: G2020  
Recommendation: **Mill and Overlay in 2023**

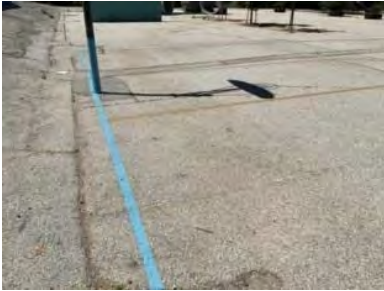
**Parking Lots in Poor condition.**

Pavement, Asphalt  
Site Loma Alta Elementary School Site

Severe cracking throughout playground. - AssetCALC ID: 4008468

Unimat Code: G2020  
Recommendation: **Seal and Stripe in 2023**

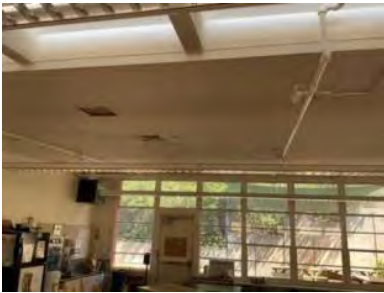
**Suspended Ceilings in Poor condition.**

Hard Tile, Replacement w/ ACT  
H Loma Alta Elementary School Throughout building

Ceiling tiles are loose and falling. - AssetCALC ID: 4008289

Unimat Code: C1070  
Recommendation: **Replace in 2023**

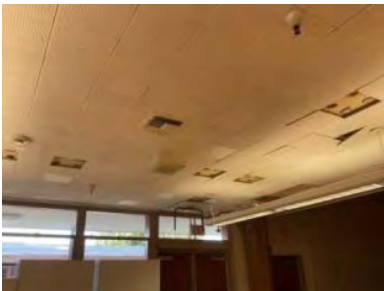
**Suspended Ceilings in Poor condition.**

Hard Tile, Replacement w/ ACT  
C Loma Alta Elementary School Throughout building

Ceiling tiles are falling or missing. - AssetCALC ID: 4008348

| <b>Key Issues and Findings</b> | Interior ACT ceiling tiles are missing or loose throughout building C. | |

Unimat Code: C1070  
Recommendation: **Replace in 2023**

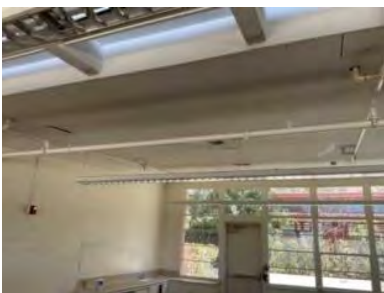
**Suspended Ceilings in Poor condition.**

Hard Tile, Replacement w/ ACT  
G Loma Alta Elementary School Throughout building

Ceiling tiles are loose and falling. - AssetCALC ID: 4008265

Unimat Code: C1070  
Recommendation: **Replace in 2023**

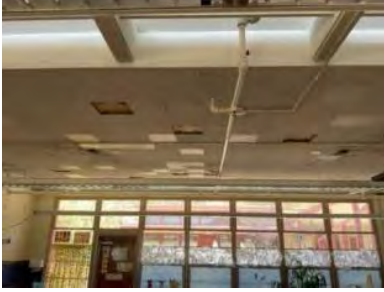
### Suspended Ceilings in Poor condition.

Hard Tile, Replacement w/ ACT  
F Loma Alta Elementary School Throughout building

Ceiling tiles are loose and falling. - AssetCALC ID: 4008495

Uniformat Code: C1070  
Recommendation: **Replace in 2023**

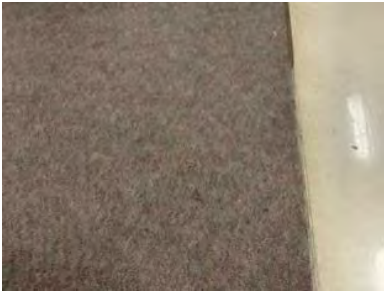
### Flooring in Poor condition.

Carpet, Commercial Standard  
A Loma Alta Elementary School Throughout building

Carpet is detaching from floor and stained. - AssetCALC ID: 4008300

Uniformat Code: C2030  
Recommendation: **Replace in 2023**

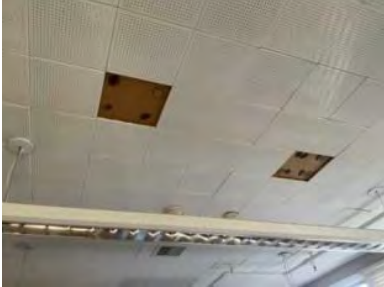
### Suspended Ceilings in Poor condition.

Hard Tile, Replacement w/ ACT  
B Loma Alta Elementary School Throughout building

Tiles are loose or have fallen. - AssetCALC ID: 4008417

Uniformat Code: C1070  
Recommendation: **Replace in 2023**
