# FACILITY CONDITION ASSESSMENT

Don Benito Fundamental  
3700 Denair Street  
Pasadena, California 91107

154554.22R000-002.354

September 6, 2022

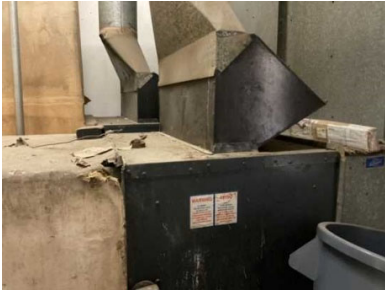
**Furnace in Failed condition.**

Gas  
C Don Benito Fundamental Mechanical room

Staff stated furnaces stopped working 6 years ago. - AssetCALC ID: 3862661

Uniformat Code: D3020  
Recommendation: **Replace in 2022**

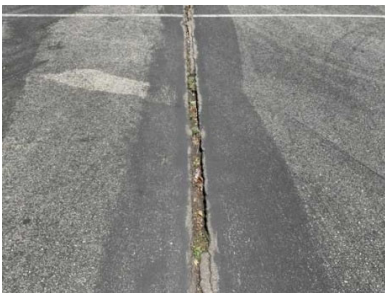
**Parking Lots in Poor condition.**

Pavement, Asphalt  
Don Benito Fundamental Site

Expansion joint needs to be patched and sealed. - AssetCALC ID: 3862682

Uniformat Code: G2020  
Recommendation: **Cut and Patch in 2022**

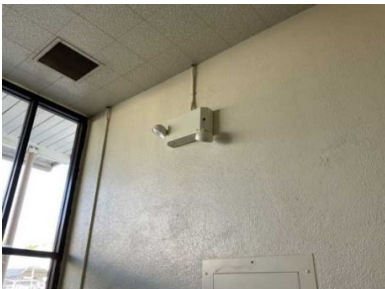
**Emergency and Exit Lighting in Poor condition.**

Emergency Light Pack, 2 Light w/ Battery  
D Don Benito Fundamental Hallway

Light is falling off. - AssetCALC ID: 3862611

Uniformat Code: D5040  
Recommendation: **Replace in 2022**

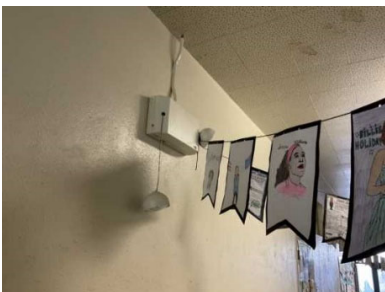
**Emergency and Exit Lighting in Poor condition.**

Exit Sign, LED  
B Don Benito Fundamental Hallway

Light has fallen off. - AssetCALC ID: 3862719

Uniformat Code: D5040  
Recommendation: **Replace in 2022**

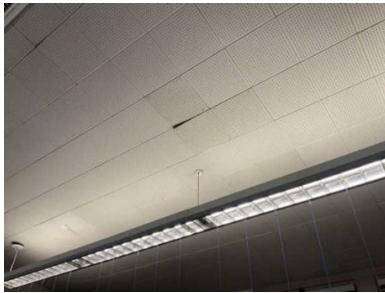
**Suspended Ceilings in Poor condition.**

Hard Tile, Replacement w/ ACT  
A Don Benito Fundamental Throughout building

Ceiling tiles are separating. - AssetCALC ID: 3862626

Uniformat Code: C1070  
Recommendation: **Replace in 2023**

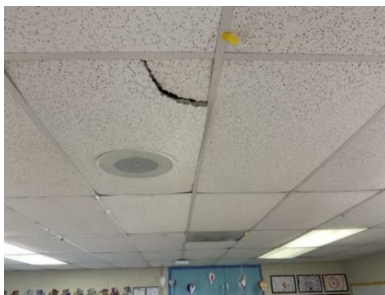
**Suspended Ceilings in Poor condition.**

Acoustical Tile (ACT)  
Portables Don Benito Fundamental Throughout building

Ceiling tiles are cracked and bowing. - AssetCALC ID: 3862544

Uniformat Code: C1070  
Recommendation: **Replace in 2023**
