# FACILITY CONDITION ASSESSMENT

San Rafael Elementary  
1090 Nithsdale Road  
Pasadena, California 91105

154554.22R000-009.354

September 8, 2022

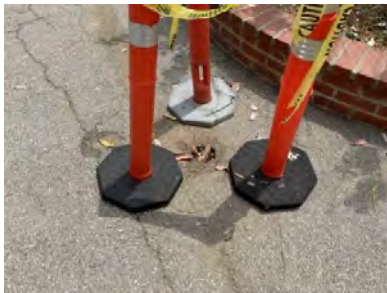
### Piping and Valves in Failed condition.

Piping Steel, HVAC Steam  
Building B San Rafael Elementary B

Steam escapes from leak in steam line; injury hazard in area where students walk - AssetCALC ID: 3857073

Uniformat Code: D3050  
Recommendation: **Replace in 2022**

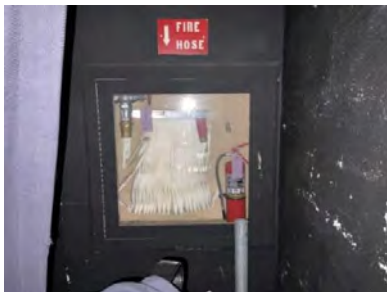
### Fire Extinguisher

Wet Chemical/CO2  
Building C San Rafael Elementary  
Classrooms

Fire hose cabinet and extinguisher blocked by stage equipment; inaccessible - AssetCALC ID: 3857108

Uniformat Code: D4030  
Recommendation: **Replace in 2022**

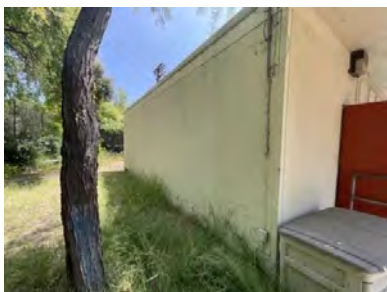
### Exterior Walls in Failed condition.

Plywood/OSB  
Building G San Rafael Elementary Building  
Exterior

Multiple areas of wood deterioration - AssetCALC ID: 3857166

Uniformat Code: B2010  
Recommendation: **Replace in 2022**

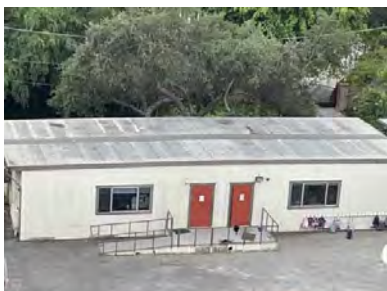
### Roofing in Failed condition.

Modified Bitumen  
Building F San Rafael Elementary Roof

Sheathing deteriorated at soffits all around - AssetCALC ID: 3857214

Uniformat Code: B3010  
Recommendation: **Replace in 2022**

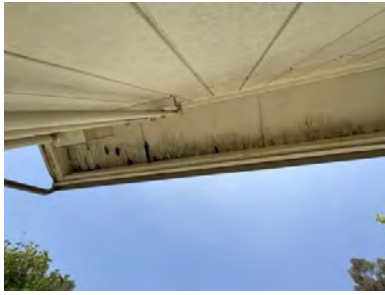
### Roofing in Failed condition.

Built-Up  
Building F San Rafael Elementary F

Leaking caused wood deterioration in sheathing - AssetCALC ID: 3857193

Uniformat Code: B3010  
Recommendation: **Replace in 2022**

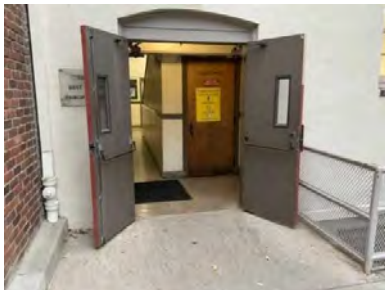
### Exterior Door in Poor condition.

Wood, Solid-Core  
Building A San Rafael Elementary Building exterior

Signs of delamination at top corners - AssetCALC ID: 3857083

Uniformat Code: B2050  
Recommendation: **Replace in 2023**

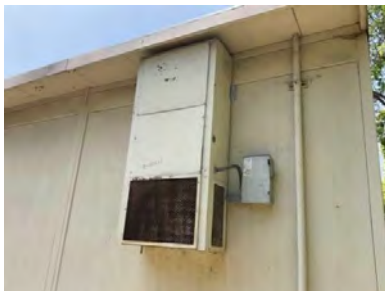
### Heat Pump in Poor condition.

Packaged and Wall-Mounted  
Building G San Rafael Elementary Building exterior

Unit slated for replacement this quarter - AssetCALC ID: 3857172

Uniformat Code: D3030  
Recommendation: **Replace in 2023**

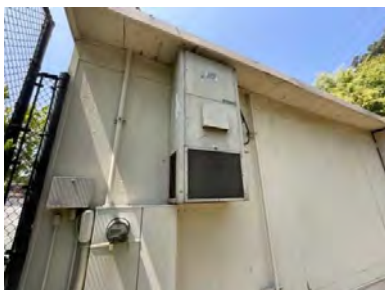
### Heat Pump in Poor condition.

Packaged and Wall-Mounted  
Building G San Rafael Elementary Building exterior

Unit slated for replacement this quarter - AssetCALC ID: 3857200

Uniformat Code: D3030  
Recommendation: **Replace in 2023**

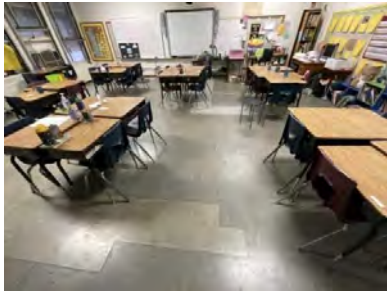
## Flooring

Vinyl Tile (VCT), w/ Asbestos Abatement  
Building D San Rafael Elementary  
Classrooms

Type of floor is likely to contain asbestos. - AssetCALC ID: 3857160

Uniformat Code: C2030  
Recommendation: **Replace in 2022**

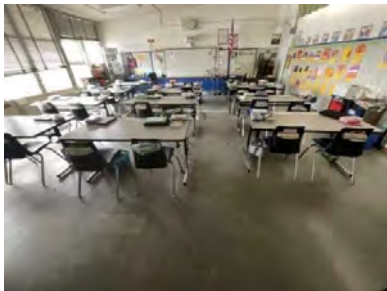
## Flooring in Poor condition.

Vinyl Tile (VCT), w/ Asbestos Abatement  
Building E San Rafael Elementary  
Classrooms

Type of flooring likely to contain asbestos - AssetCALC ID: 3857116

Uniformat Code: C2030  
Recommendation: **Replace in 2022**

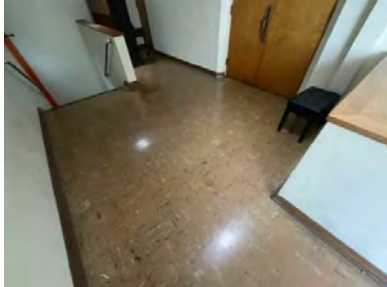
## Flooring in Poor condition.

Vinyl Tile (VCT), w/ Asbestos Abatement  
Building C San Rafael Elementary  
Gymnasium

Type of flooring likely to contain asbestos - AssetCALC ID: 3857153

Uniformat Code: C2030  
Recommendation: **Replace in 2022**

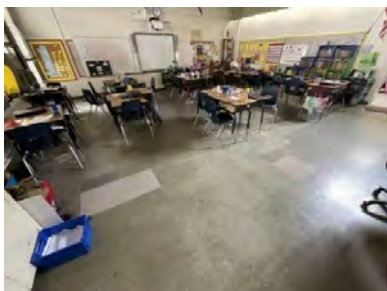
## Flooring in Poor condition.

Vinyl Tile (VCT), w/ Asbestos Abatement  
Building E San Rafael Elementary  
Classrooms

Uniformat Code: C2030  
Recommendation: **Replace in 2022**

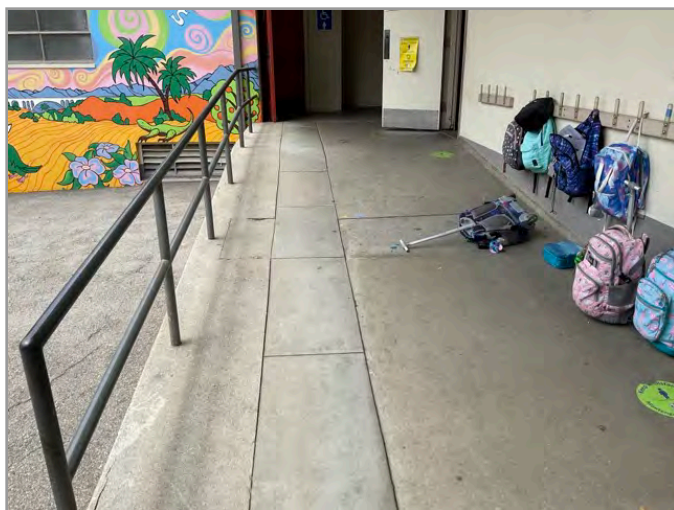
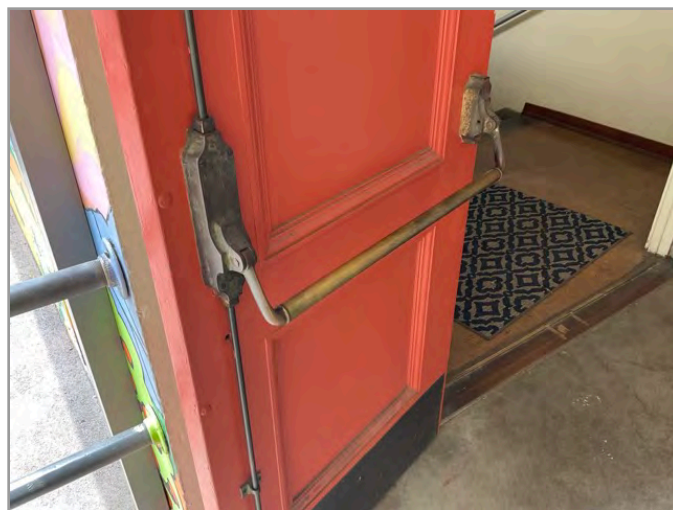
### Interior Accessible Route

| Question | | Yes | No | NA | Comments |
|---|---|---|---|---|---|
| 1 | Does an accessible route appear to connect all public areas inside the building ? | | ✗ | | No upper floor access. Stairs only |
