# FACILITY CONDITION ASSESSMENT

## **DLR Group**

Sierra Madre Elementary  
141 West Highland Avenue  
Sierra Madre, California 91024

September 8, 2022

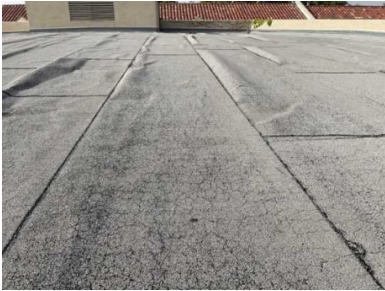
### Roofing in Poor condition.

Modified Bitumen  
A Sierra Madre Elementary Roof

Roof is lifting in many locations. - AssetCALC ID: 3851393

Uniformat Code: B3010  
Recommendation: **Replace in 2024**

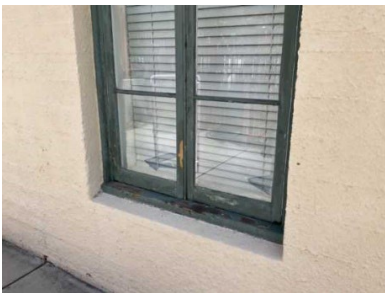
### Window in Poor condition.

Wood, up to 15 SF  
A Sierra Madre Elementary Building Exterior

Window frames are weathered with paint peeling. - AssetCALC ID: 3851346

Uniformat Code: B2020  
Recommendation: **Replace in 2023**

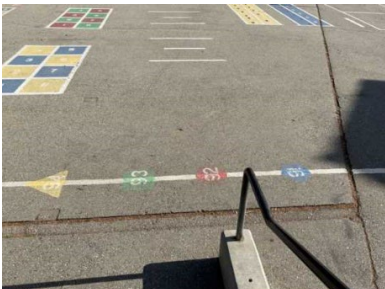
### Parking Lots in Poor condition.

Pavement, Asphalt  
Site Sierra Madre Elementary Site

Expansion joint needs to be filled and sealed throughout play area. - AssetCALC ID: 3851516

| System | Description | Condition |
|---|---|---|
| <b>Key Issues and Findings</b> | Significant trip hazard on asphalt play area. Asphalt expansion joint needs to be filled and sealed. | |

| ID | Location | Location Description | UF Code | Description | Condition | Plan Type | Cost |
|---|---|---|---|---|---|---|---|
| 3851516 | Sierra Madre Elementary / Site | Site | G2020 | Parking Lots, Pavement, Asphalt, Repair | Poor | Performance/Integrity | \$6,400 |

Uniformat Code: G2020  
Recommendation: **Repair in 2022**

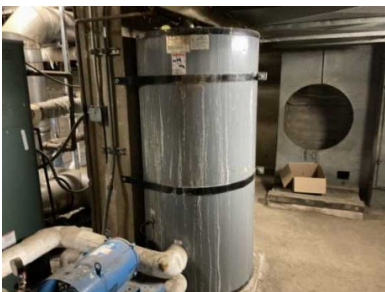
### Storage Tank in Poor condition.

Domestic Water  
A Sierra Madre Elementary Boiler room

Mineral buildup and corrosion from water leaking. - AssetCALC ID: 3851474

Uniformat Code: D2010  
Recommendation: **Replace in 2023**

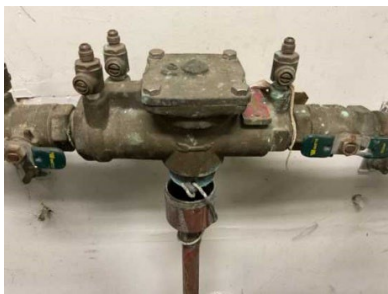
**Backflow Preventer in Poor condition.**

Domestic Water  
A Sierra Madre Elementary Mechanical room

Leaking outside of drain catch. - AssetCALC ID: 3851351

Uniformat Code: D2010  
Recommendation: **Replace in 2023**
