# FACILITY CONDITION ASSESSMENT

Washington Elementary Stem Magnet  
1520 North Raymond Avenue  
Pasadena, California 91103

154554.22R000-011.354

September 8, 2022

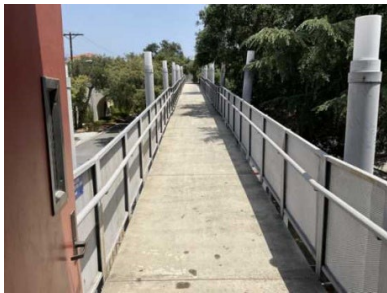
### Recommended Follow-up Study: Structural, Seismic

Structural, Seismic  
Washington Elementary STEM Magnet  
Pedestrian Bridge

Reported structural/seismic issues. Recommend study. - AssetCALC ID: 3890100

Uniformat Code: P2030  
Recommendation: **Evaluate/Report in 2022**

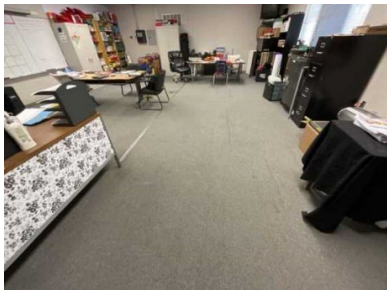
### Flooring in Poor condition.

Carpet, Commercial Standard  
B Portable Washington Elementary STEM  
Magnet Throughout building

Bubbling carpeting presents significant trip hazards - AssetCALC ID: 3890272

Uniformat Code: C2030  
Recommendation: **Replace in 2022**

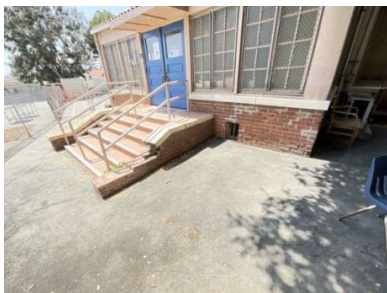
### Exterior Walls in Poor condition.

Brick  
B Washington Elementary STEM Magnet  
Building exterior

Allowance for 20% repoint/repair work. - AssetCALC ID: 3890153

Uniformat Code: B2010  
Recommendation: **Repair/Repoint in 2022**

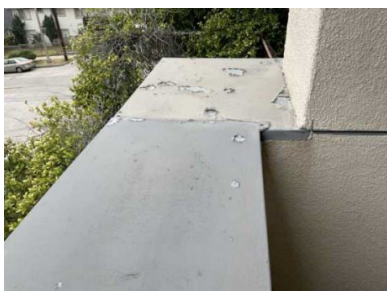
### Exterior Walls in Poor condition.

any painted surface  
E Washington Elementary STEM Magnet  
Balconies

Paint is peeling on balcony parapets in E Building - AssetCALC ID: 3890331

Uniformat Code: B2010  
Recommendation: **Prep & Paint in 2022**

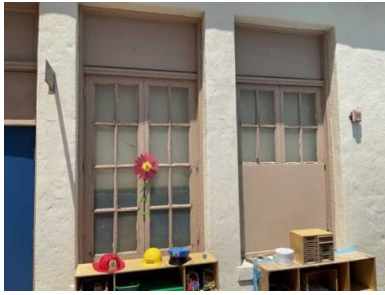
### Window in Poor condition.

Wood Historical, 28-40 SF  
B Washington Elementary STEM Magnet  
Building Exterior

Wooden window framing is damaged, panes are broken/boarded up. - AssetCALC ID: 3890337

Recommendation: **Restore in 2022**

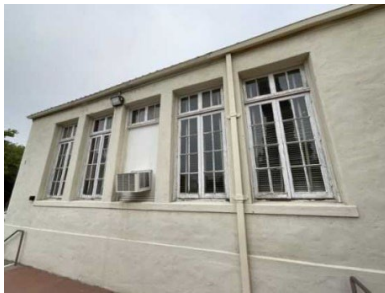
### Window in Poor condition.

Wood Historical, 28-40 SF  
A Washington Elementary STEM Magnet  
Building Exterior

Original window framing is heavily rotted, potential LBP and ACM - AssetCALC ID: 3890241

Recommendation: **Restore in 2022**

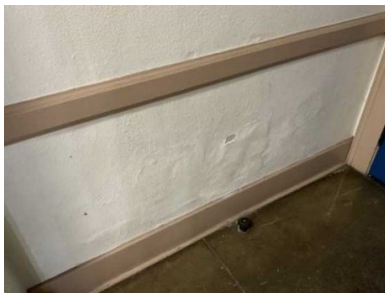
### Interior Wall in Poor condition.

Gypsum Board/Plaster  
B Washington Elementary STEM Magnet 100

Minor plaster repair needed outside computer lab - AssetCALC ID: 3890266

Recommendation: **Repair in 2022**

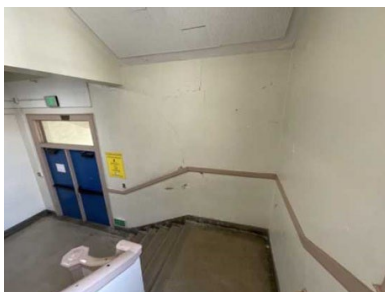
### Interior Wall in Poor condition.

Gypsum Board/Plaster  
A Washington Elementary STEM Magnet Stairs

Plaster repairs needed in A Building staircases - AssetCALC ID: 3890411

Recommendation: **Repair in 2022**

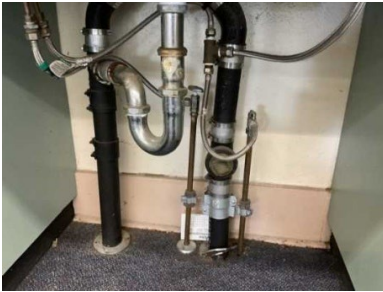
### Plumbing System in Poor condition.

Supply & Sanitary, Medium Density (excludes fixtures)  
A Washington Elementary STEM Magnet  
Throughout building

Galvanized piping was observed, replacement strongly recommended. - AssetCALC ID: 3890098

Uniformat Code: D2010  
Recommendation: **Replace in 2024**

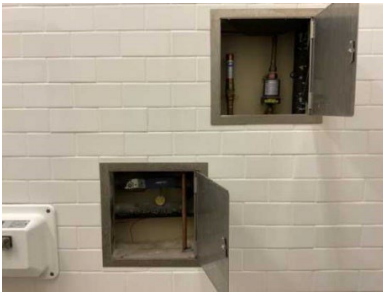
### Plumbing System in Poor condition.

Supply & Sanitary, Medium Density (excludes fixtures)  
B Washington Elementary STEM Magnet  
Throughout building

Galvanized pipe was observed in system, replacement is recommended. - AssetCALC ID: 3890261

Uniformat Code: D2010  
Recommendation: **Replace in 2024**

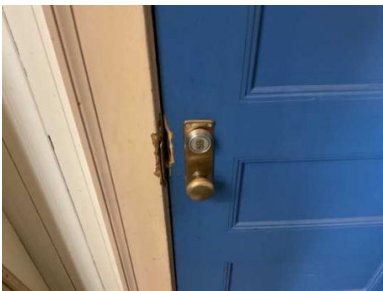
### Interior Door in Poor condition.

Wood, Solid-Core  
A Washington Elementary STEM Magnet Front  
Office

Damaged door in front office - AssetCALC ID: 3890415

Uniformat Code: C1030  
Recommendation: **Replace in 2022**

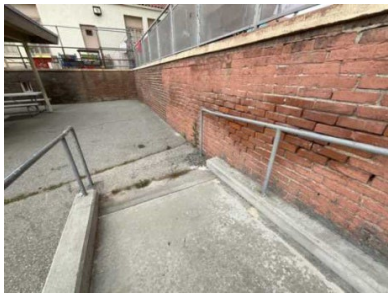
Retaining Wall in Poor condition.

Brick/Stone  
Site Washington Elementary STEM Magnet  
Site

Uniformat Code: G2060  
Recommendation: **Repair in 2022**
