# FACILITY CONDITION ASSESSMENT

Madison Elementary  
515 Ashtabula Street  
Pasadena, California 91105

154554.22R000-007.354

September 8, 2022

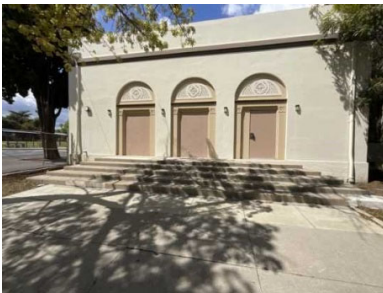
### Sidewalk in Poor condition.

Concrete Pad in Front of Auditorium  
Site Madison Elementary Site

Small trip hazards present on concrete pad near front entrance. - AssetCALC ID: 3806355

Recommendation: **Replace in 2023**

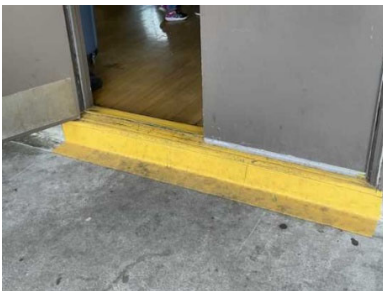
### Exterior Door in Poor condition.

Steel, Standard  
Bldg B Madison Elementary Building exterior

Door from lunchroom has unseen curb directly leading to the outside area, several people have already tripped over it hence why it is painted. Step should be brought a few feet from doors. - AssetCALC ID: 3806351

Recommendation: **Replace in 2023**

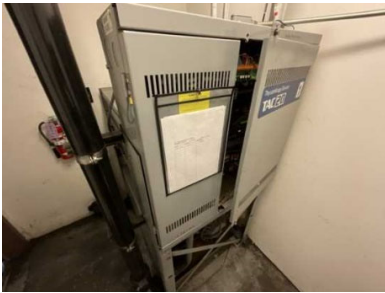
### Elevator Controls in Poor condition.

Automatic, 1 Car  
Bldg A Madison Elementary Elevator

Elevator hydraulic controls is leaking an excessive amount of oil, point of contact has stated oil has been replenished numerous times over the past couple years. Elevator will shake while in use, and is showing signs of extreme wear. - AssetCALC ID: 3806231

Uniformat Code: D1010  
Recommendation: **Replace in 2023**

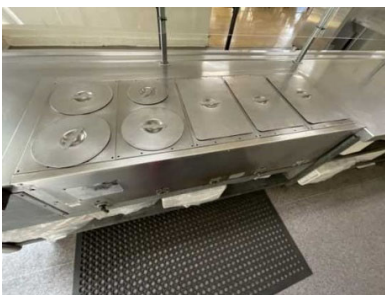
### Foodservice Equipment in Failed condition.

Food Warmer, Proofing Cabinet on Wheels  
Bldg B Madison Elementary Kitchen

Point of contact says food warmers not operational - AssetCALC ID: 3806243

Uniformat Code: E1030  
Recommendation: **Replace in 2022**

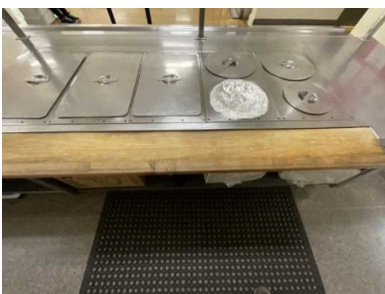
### Foodservice Equipment in Failed condition.

Food Warmer, Proofing Cabinet on Wheels  
Bldg B Madison Elementary Kitchen

Point of contact says food warmers not operational - AssetCALC ID: 3806297

Uniformat Code: E1030  
Recommendation: **Replace in 2022**

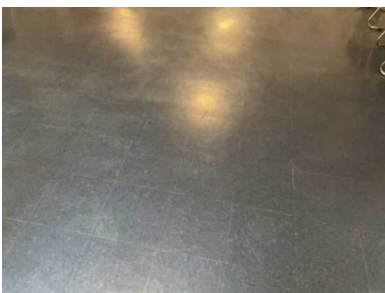
### Flooring in Poor condition.

Vinyl Tile (VCT)  
Bldg A Madison Elementary Throughout building

Uniformat Code: C2030  
Recommendation: **Replace in 2023**

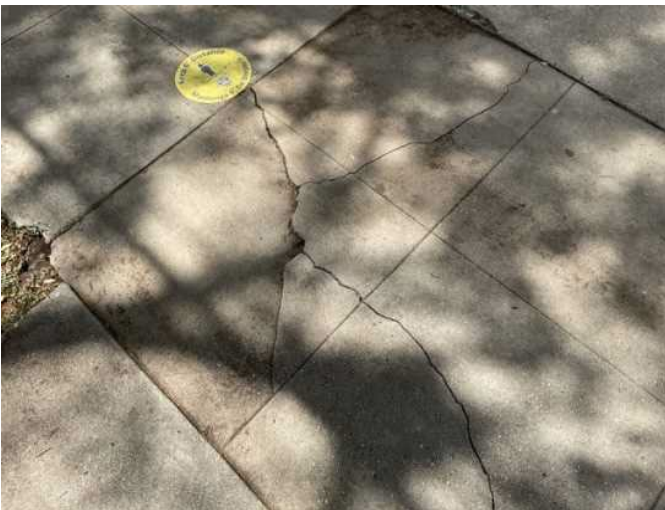
9 - CRACKED CONCRETE PAD ON SOUTH ENTRANCE

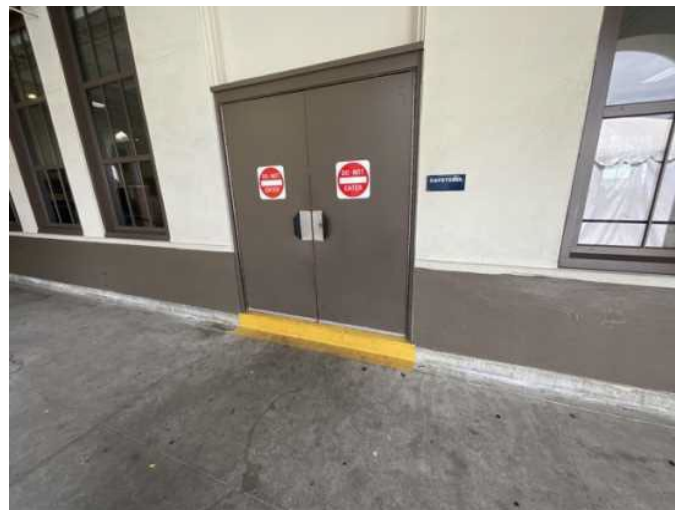
12 - TRIP HAZARD BUILDING B

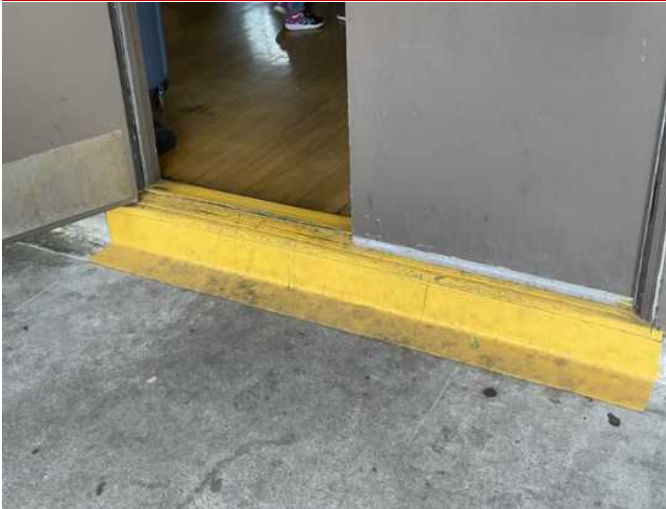
13 - CLOSE-UP TRIP HAZARD BUILDING B

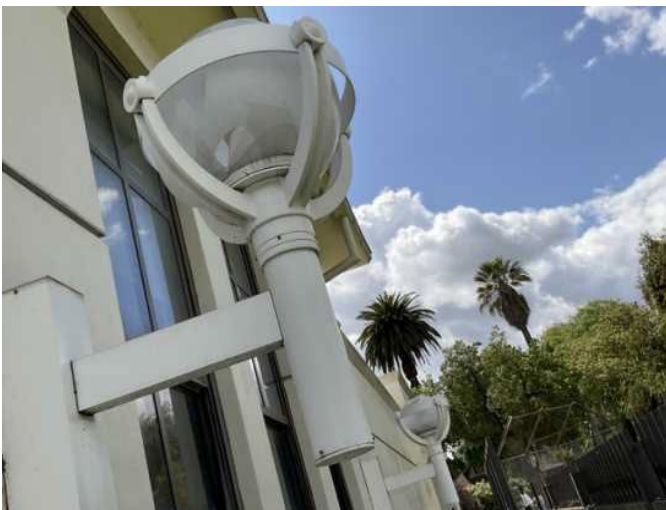
17 - CRACKED EXTERIOR LIGHTS BUILDING C

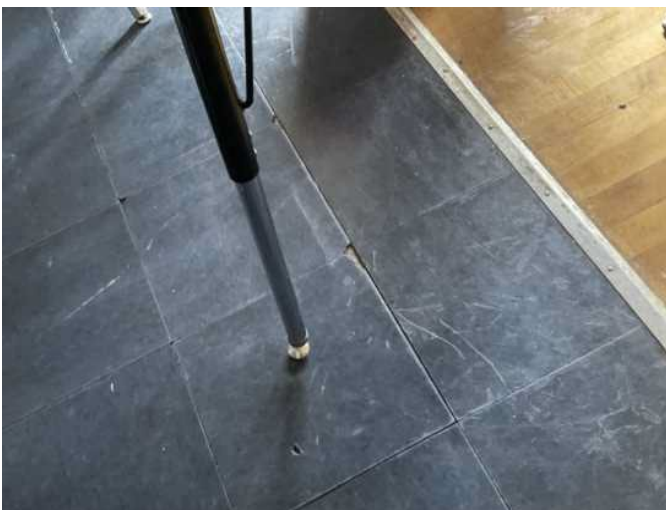
35 - BROKEN/WARPED VCT FLOORING BUILDING A
