# FACILITY CONDITION ASSESSMENT

Field Elementary  
3600 East Sierra Madre Boulevard  
Pasadena, California 91107

September 7, 2022

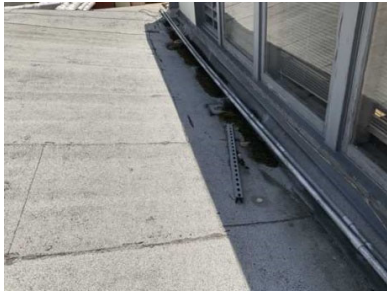
### Roofing in Failed condition.

Modified Bitumen  
B Field Elementary Roof

Moss buildup along roof edge drainage area. Roof is cracking in this area. - AssetCALC ID: 3811076

Uniformat Code: B3010  
Recommendation: **Replace in 2022**

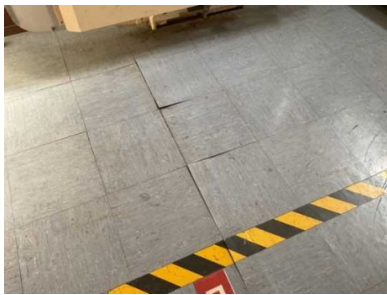
### Flooring in Poor condition.

Vinyl Tile (VCT)  
E Field Elementary Hallway

| Building E: Systems Summary | | |
|---|---|---|
| <b>Key Issues and Findings</b> | VCT flooring was found lifting near wheelchair lift. | |

Uniformat Code: C2030  
Recommendation: **Replace in 2023**

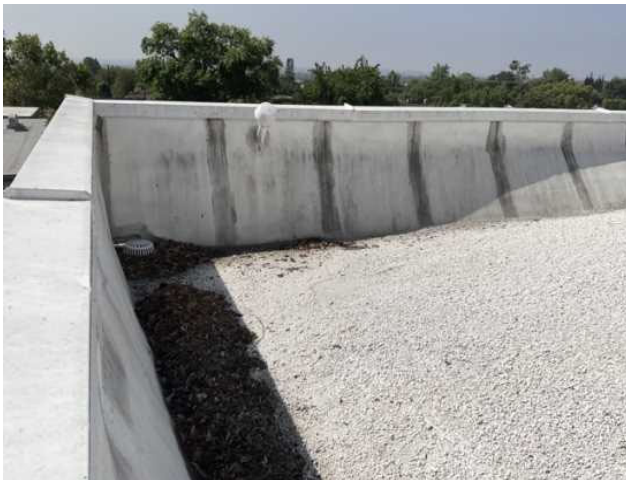
9 - PARAPET WALL EDGE AND FLASHING
