# FACILITY CONDITION ASSESSMENT

Norma Coombs Elementary  
2600 Paloma Street  
Pasadena, California 91107

154554.22R000-008.354

September 8, 2022

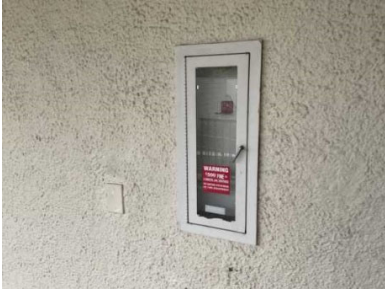
### Fire Extinguisher in Failed condition.

Wet Chemical/CO2  
D Norma Coombs Elementary Building exterior

Missing fire extinguisher. Outside of classroom 9. - [AssetCALC ID: 3834052](#)

Uniformat Code: D4030  
Recommendation: **Replace in 2022**

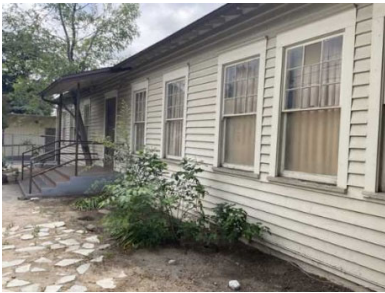
### Roofing in Poor condition.

Asphalt Shingle, 20-Year Standard  
J Norma Coombs Elementary Roof

Roof appears to be leaking in multiple spots. - [AssetCALC ID: 3835778](#)

Uniformat Code: B3010  
Recommendation: **Replace in 2022**

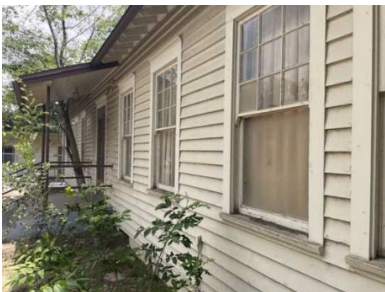
### Exterior Walls in Poor condition.

any painted surface  
J Norma Coombs Elementary Building Exterior

Paint is peeling. - [AssetCALC ID: 3834090](#)

Uniformat Code: B2010  
Recommendation: **Prep and Paint in 2023**

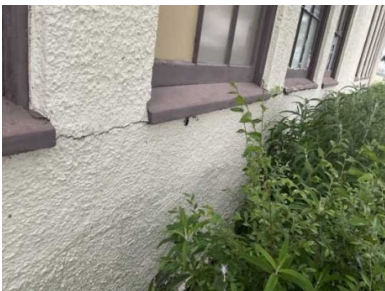
### Exterior Walls in Poor condition.

Stucco  
D Norma Coombs Elementary Building Exterior

Wall cracking along lower window area. - [AssetCALC ID: 3834120](#)

| <b>Key Issues and Findings</b> | Stucco is cracking along the length of the south exterior wall.<br>Galvanized piping was observed on the service for the plumbing system. Replacement is recommended. | |

Uniformat Code: B2010  
Recommendation: **Replace in 2024**

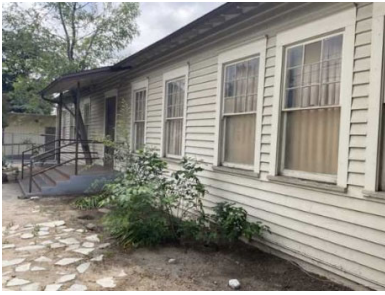
**Window in Poor condition.**

Wood, up to 15 SF  
J Norma Coombs Elementary Building Exterior

Windows frames are weathered with paint peeling. - AssetCALC ID: 3834159

Uniformat Code: B2020  
Recommendation: **Replace in 2023**

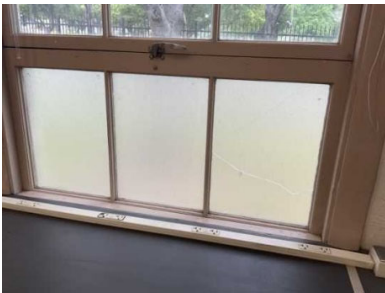
**Window in Poor condition.**

Wood, up to 15 SF  
A Norma Coombs Elementary Building Exterior

Broken window in Room 2. - AssetCALC ID: 3834002

| Building A: Systems Summary | | |
|---|---|---|
| <b>Key Issues and Findings</b> | Broken exterior window found in building A.<br>Galvanized piping was observed on the service for the plumbing system. Replacement is recommended. | |

Uniformat Code: B2020  
Recommendation: **Replace in 2023**

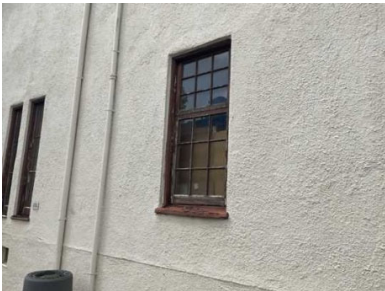
**Window in Poor condition.**

Wood, up to 15 SF  
E Norma Coombs Elementary Building Exterior

Window frames are aged and weathered. - AssetCALC ID: 3834086

Uniformat Code: B2020  
Recommendation: **Replace in 2023**

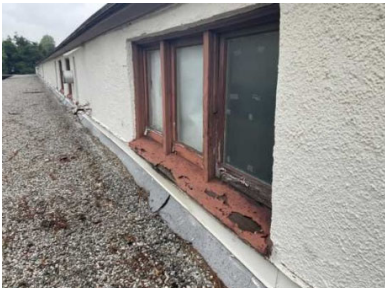
**Window in Poor condition.**

Wood, up to 15 SF  
A Norma Coombs Elementary Building Exterior

Windows are weathered and paint is peeling. - AssetCALC ID: 3833969

Uniformat Code: B2020  
Recommendation: **Replace in 2023**

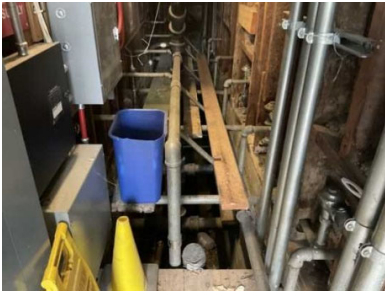
### Plumbing System in Poor condition.

Supply and Sanitary, Medium Density  
(excludes fixtures)  
B Norma Coombs Elementary Throughout  
building

Galvanized piping was observed, replacement is recommended. - AssetCALC ID: 3834076

| Building B: Systems Summary | | |
|---|---|---|
| <b>Key Issues and Findings</b> | Galvanized piping was observed on the service for the plumbing system. Replacement is recommended. | |

Uniformat Code: D2010  
Recommendation: **Replace in 2024**

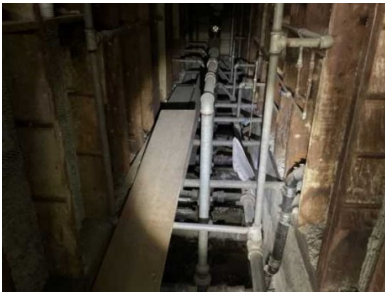
### Plumbing System in Poor condition.

Supply and Sanitary, Medium Density  
(excludes fixtures)  
A Norma Coombs Elementary Throughout  
building

Galvanized supply piping was identified, replacement is recommended. - AssetCALC ID: 3834221

Uniformat Code: D2010  
Recommendation: **Replace in 2024**
