# FACILITY CONDITION ASSESSMENT

Hamilton Elementary  
2089 Rose Villa Street  
Pasadena, California 91107

154554.22R000-004.354

September 7, 2022

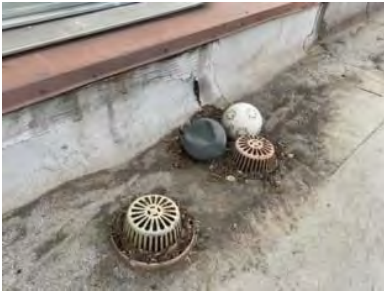
### Roofing in Failed condition.

Modified Bitumen  
C Hamilton Elementary Roof

Patches are cracked and lifting. Possible leak issues. - AssetCALC ID: 4051520

Uniformat Code: B3010  
Recommendation: **Replace in 2022**

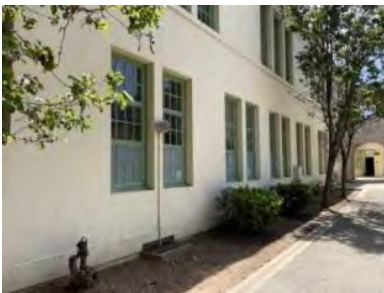
### Window in Poor condition.

Wood, 28-40 SF  
B Hamilton Elementary Building Exterior

Windows are weathered with paint peeling. - AssetCALC ID: 4051481

Uniformat Code: B2020  
Recommendation: **Replace in 2024**

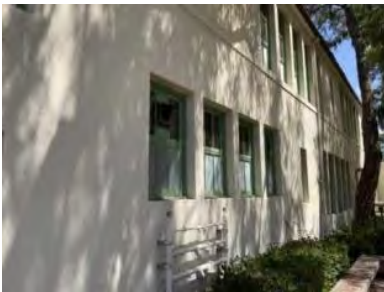
### Window in Poor condition.

Wood, 28-40 SF  
A Hamilton Elementary Building Exterior

Windows are weathered with paint peeling. - AssetCALC ID: 4051434

Uniformat Code: B2020  
Recommendation: **Replace in 2024**

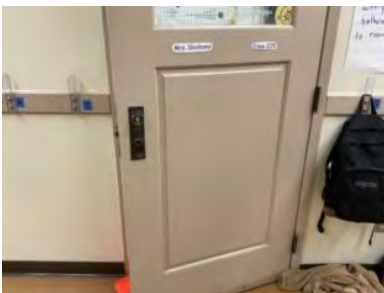
### Door Hardware in Poor condition.

School, per Door  
D Hamilton Elementary D229

Missing door handle - AssetCALC ID: 4051416

Uniformat Code: C1030  
Recommendation: **Replace in 2022**

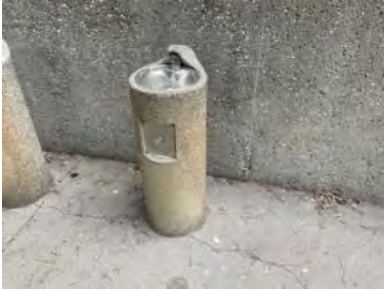
### Drinking Fountain in Failed condition.

Exterior/Site, Precast Pedestal  
Site Hamilton Elementary Site

Not working. - AssetCALC ID: 4051428

Uniformat Code: D2010  
Recommendation: **Replace in 2022**

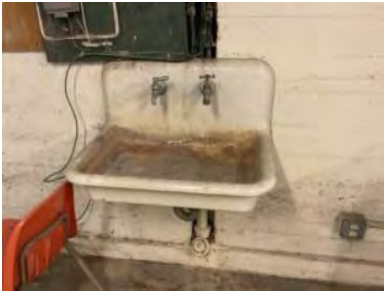
### Sink/Lavatory in Poor condition.

Service Sink, Wall-Hung  
A Hamilton Elementary Mechanical room  
A001

Sink is rusted and calcified. - AssetCALC ID: 4051437

Uniformat Code: D2010  
Recommendation: **Replace in 2023**

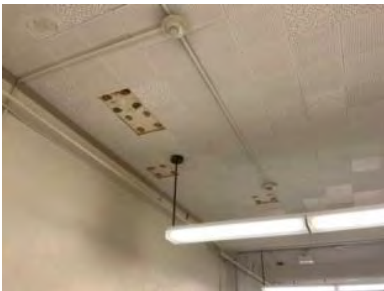
### Suspended Ceilings in Failed condition.

Hard Tile, Replacement with ACT  
B Hamilton Elementary Resource room  
A206

Loose or fallen tiles. - AssetCALC ID: 4051460

Uniformat Code: C1070  
Recommendation: **Replace in 2022**

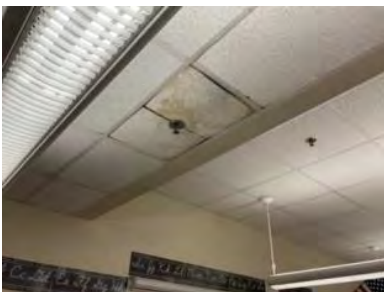
### Suspended Ceilings in Poor condition.

Acoustical Tile (ACT)  
D Hamilton Elementary D114

Water stained tiles found in room D114. - AssetCALC ID: 4051508

Uniformat Code: C1070  
Recommendation: **Replace in 2022**
