# FACILITY CONDITION ASSESSMENT

Sierra Madre Middle  
160 North Cañon Avenue  
Sierra Madre, California 91024

*September 10, 2022*

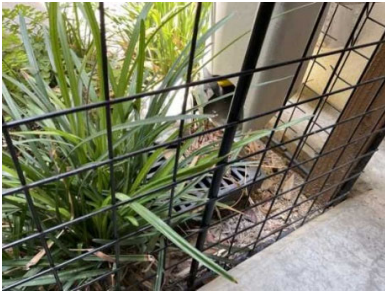
### Electrical System in Failed condition.

Wiring & Switches, Average or Low  
Density/Complexity  
Sierra Madre Middle Site

Fountain is not hardwired. An extension cord is traveling through a rain gutter to a roof outlet. Potential fire hazard. Recommend running new electrical to fountain in compliance with code. - AssetCALC ID: 3890929

Uniformat Code: D5030  
Recommendation: **Replace in 2022**

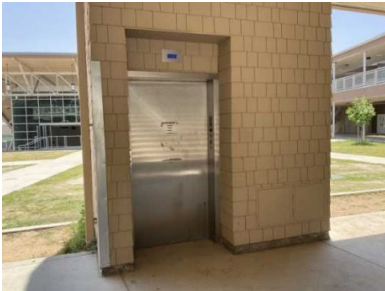
### Passenger Elevator in Failed condition.

Overhead Traction, 2-5 Floors  
F Sierra Madre Middle Site

Staff stated elevator has not been in operation since the beginning of the school year. - AssetCALC ID: 3890793

Uniformat Code: D1010  
Recommendation: **Renovate in 2022**

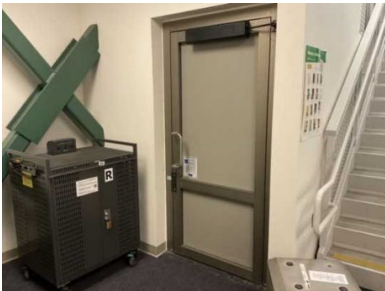
### Vertical Lift in Failed condition.

Wheelchair, 5' Rise  
Sierra Madre Middle Library

Lift was found locked out tagged out. Currently not in operation. - AssetCALC ID: 3890907

Uniformat Code: D1010  
Recommendation: **Renovate in 2022**

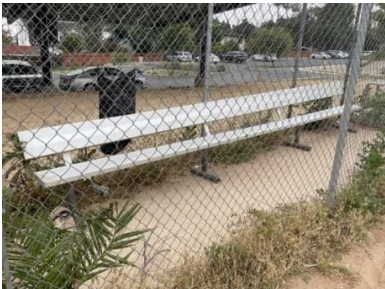
### Sports Apparatus in Poor condition.

Player/Dugout Benches, 12' Length  
Site Sierra Madre Middle Site

Backrest is bent. - AssetCALC ID: 3890773

Uniformat Code: G2050  
Recommendation: **Replace in 2023**

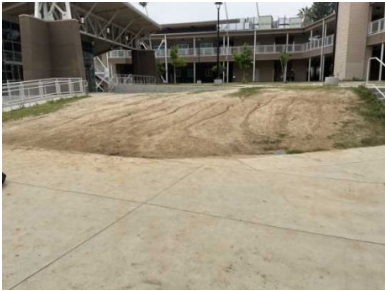
### Landscaping in Poor condition.

Sod at Eroded Areas  
Site Sierra Madre Middle Site

Rill erosion with dirt washing onto walkway was found in the center campus area. Recommend adding sod and evaluate drainage. - AssetCALC ID: 3890835

Uniformat Code: G2080  
Recommendation: **Repair in 2022**

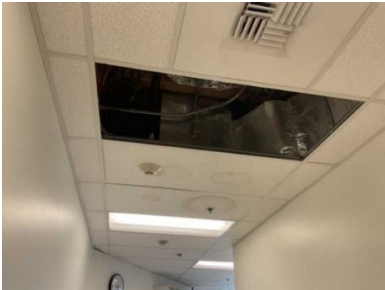
### Suspended Ceilings in Poor condition.

Acoustical Tile (ACT)  
C Sierra Madre Middle Hallway

Water stains and missing ceiling tile below non-insulated ducting. Possible condition dripping from ducting. Recommend insulating ducting and replace ceiling tiles. - AssetCALC ID: 3890967

Uniformat Code: C1070  
Recommendation: **Replace in 2023**

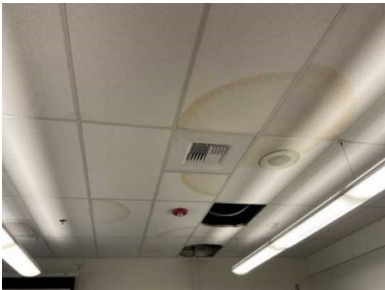
### Suspended Ceilings in Poor condition.

Acoustical Tile (ACT)  
F Sierra Madre Middle F123

Water stains and falling ceiling tiles. - AssetCALC ID: 3890863

Uniformat Code: C1070  
Recommendation: **Replace in 2023**
