# FACILITY CONDITION ASSESSMENT

Willard Elementary  
301 Madre Street  
Pasadena, California 91107

154554.22R000-013.354

September 8, 2022

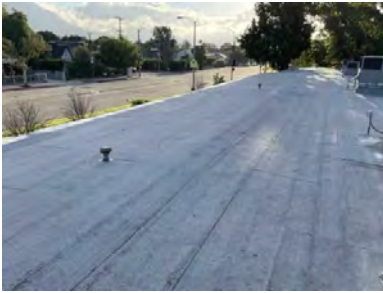
### Roofing in Poor condition.

Modified Bitumen  
Building B Willard Elementary Roof

Several regular occupants reported minor leaks when raining. - AssetCALC ID: 3797395

Uniformat Code: B3010  
Recommendation: **Replace in 2024**

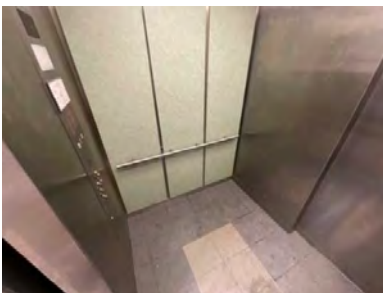
### Elevator Cab Finishes in Poor condition.

Economy  
Building A Willard Elementary Elevator

Damaged interior elevator finishes - AssetCALC ID: 3797288

Uniformat Code: D1010  
Recommendation: **Replace in 2023**

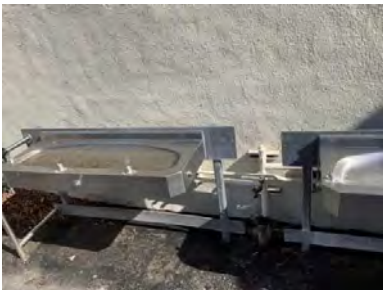
### Drinking Fountain in Poor condition.

Exterior/Site, Metal Pedestal  
Building A Willard Elementary Building exterior

Clogged drains - AssetCALC ID: 3797316

Uniformat Code: D2010  
Recommendation: **Replace in 2023**

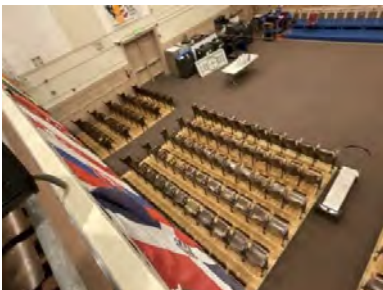
### Fixed Seating in Poor condition.

Courtroom/Church, Wood Benches/Pews  
Building A Willard Elementary Auditorium

A small percentage of seats are broken/heavily worn - AssetCALC ID: 3797377

Uniformat Code: E2010  
Recommendation: **Replace in 2023**

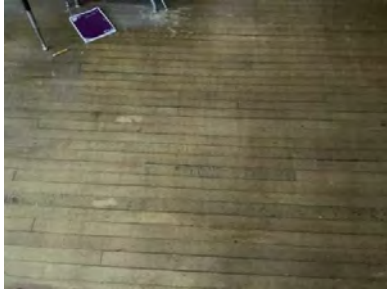
**Flooring in Poor condition.**

Wood, Strip  
Building A Willard Elementary Throughout  
building

Wood strip flooring is damaged and should be refinished. - AssetCALC ID: 3797211

Uniformat Code: C2030  
Recommendation: **Replace in 2023**

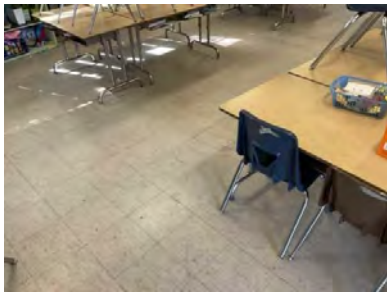
**Flooring in Poor condition.**

Vinyl Tile (VCT)  
Building B Willard Elementary Throughout  
building

heavily worn flooring - AssetCALC ID: 3797359

Uniformat Code: C2030  
Recommendation: **Replace in 2024**
