# FACILITY CONDITION ASSESSMENT

## **DLR Group**

Eliot Arts Magnet Academy  
2184 North Lake Avenue  
Altadena, California 91001

September 8, 2022

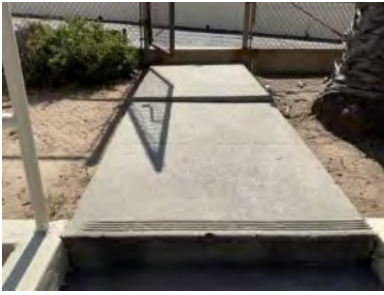
### Parking Lots in Poor condition.

Pavement, Concrete  
Site Eliot Arts Magnet Academy Site

Sidewalk is lifting causing a trip hazard outside of D building. - AssetCALC ID: 3964360

Uniformat Code: G2020  
Recommendation: **Replace in 2022**

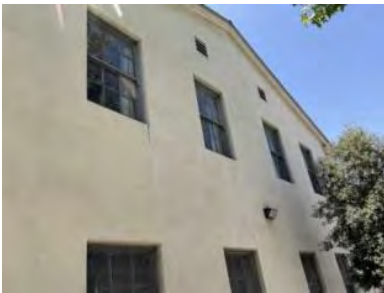
### Window in Poor condition.

Wood, 16-25 SF  
A Eliot Arts Magnet Academy Building Exterior

Paint is peeling off window frames. Staff advised debris blows in during windy days. - AssetCALC ID: 3964438

Uniformat Code: B2020  
Recommendation: **Replace in 2024**

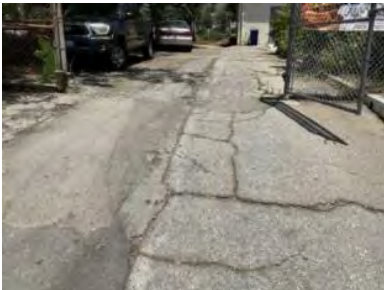
### Parking Lots in Poor condition.

Pavement, Asphalt  
Site Eliot Arts Magnet Academy Site

Asphalt is not level and cracking throughout the south side of the campus. - AssetCALC ID: 3964680

Uniformat Code: G2020  
Recommendation: **Mill & Overlay in 2023**

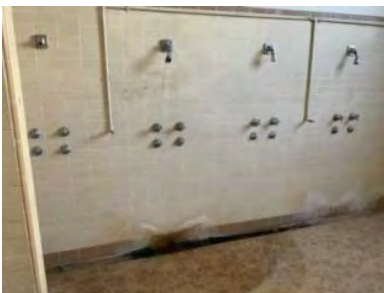
### Shower in Poor condition.

Ceramic Tile  
B Eliot Arts Magnet Academy Locker Room boys

Showers are leaking. Cracked tile throughout shower area. - AssetCALC ID: 3964451

Uniformat Code: D2010  
Recommendation: **Replace in 2023**

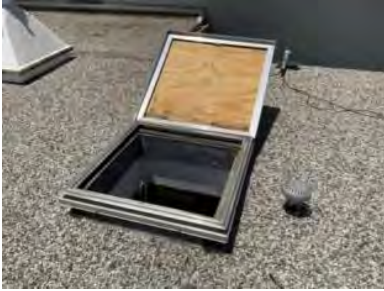
### Roof Hatch in Poor condition.

Metal  
E Eliot Arts Magnet Academy Roof

Roof hatch is missing hardware. Difficult to open or close. - AssetCALC ID: 3964523

Uniformat Code: B3060  
Recommendation: **Replace in 2023**

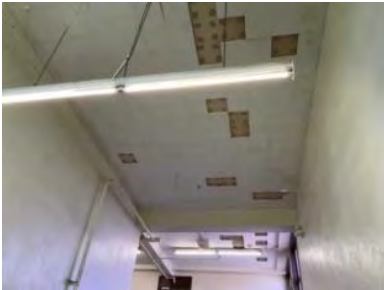
### Suspended Ceilings in Poor condition.

Hard Tile, Replacement w/ ACT  
A Eliot Arts Magnet Academy Throughout building

Ceiling tiles have fallen throughout the building. - AssetCALC ID: 3964541

Uniformat Code: C1070  
Recommendation: **Replace in 2023**

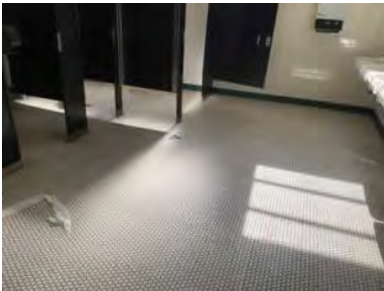
### Flooring in Poor condition.

Ceramic Tile  
A Eliot Arts Magnet Academy Restrooms

Floor tiles missing. - AssetCALC ID: 3964658

Uniformat Code: C2030  
Recommendation: **Replace in 2023**

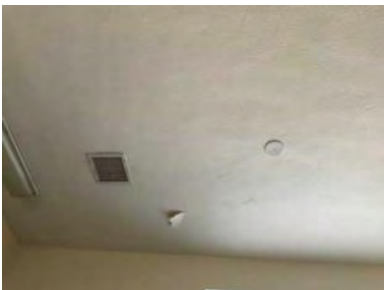
### Ceiling Finishes in Poor condition.

any flat surface  
B Eliot Arts Magnet Academy Restrooms

Uniformat Code: C2050  
Recommendation: **Prep & Paint in 2023**
