# FACILITY CONDITION ASSESSMENT

Center for Independent Study (CIS)  
2925 East Sierra Madre Boulevard  
Pasadena, California 91107

September 11, 2022

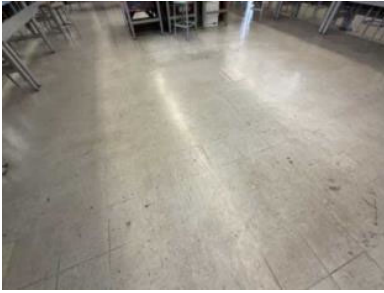
### Flooring in Poor condition.

Vinyl Tile (VCT)  
Building N Center for Independent Study (CIS)  
Throughout building

VCT exhibits extensive wear and is poorly maintained, loose tiles present trip hazards - AssetCALC ID: 3934321

Uniformat Code: C2030  
Recommendation: **Replace in 2022**

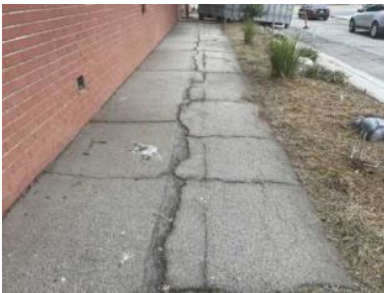
### Sidewalk in Poor condition.

Asphalt  
Site Center for Independent Study (CIS) Site

Wide cracks were observed throughout the sidewalk. - AssetCALC ID: 3946016

Uniformat Code: G2030  
Recommendation: **Replace in 2023**

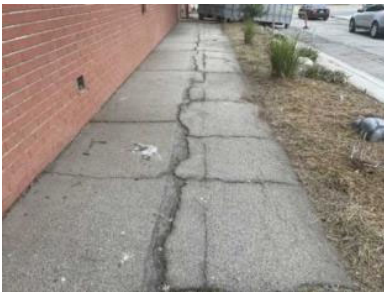
### Sidewalk in Poor condition.

Asphalt  
Site Center for Independent Study (CIS) Site

The sidewalk will need to be sealed after it is replaced. - AssetCALC ID: 3998660

Uniformat Code: G2030  
Recommendation: **Seal in 2023**

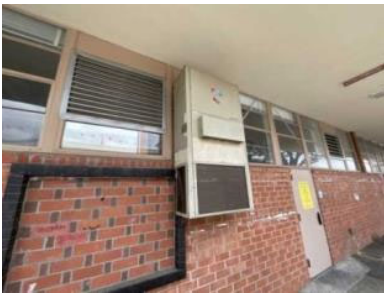
### Heat Pump

Packaged & Wall-Mounted  
Building N Center for Independent Study (CIS)  
Building exterior

Uniformat Code: D3030  
Recommendation: **Replace in 2023**

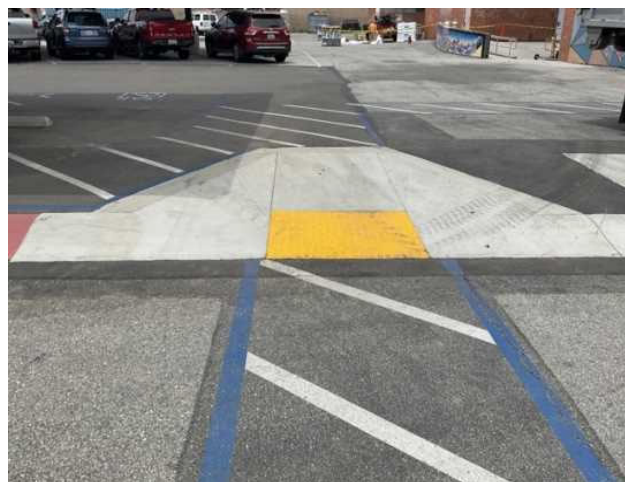
28 - WALKWAY

The site is limited to the area immediately surrounding the three buildings, and consists of asphalt and concrete areas, walkways, and ramps. The asphalt walkway at the front of building N is most in need of repair due to cracking and lifting.
