# FACILITY CONDITION ASSESSMENT

Rose City High (Continuation HS)  
351 South Hudson Avenue  
Pasadena, California 91101

154554.22R000-022.354

September 11, 2022

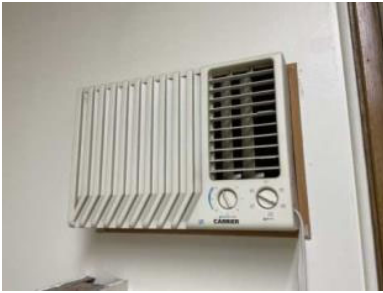
### Air Conditioner in Failed condition.

Window/Thru-Wall  
Administration Building Rose City High  
(Continuation HS) 130 Clinic

Does not function - AssetCALC ID: 3898872

Uniformat Code: D3030  
Recommendation: **Replace in 2022**

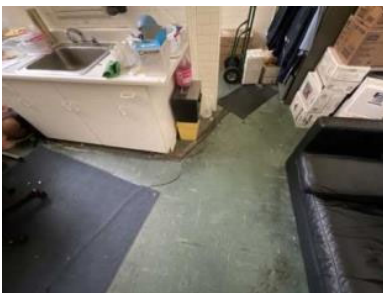
### Flooring in Poor condition.

Vinyl Tile (VCT), w/ Asbestos Abatement  
Administration Building Rose City High  
(Continuation HS) 136 Custodian Office

Broken and missing tiles in 136. VCT is indicative of ACM. - AssetCALC ID: 3898894

Uniformat Code: C2030  
Recommendation: **Replace in 2022**

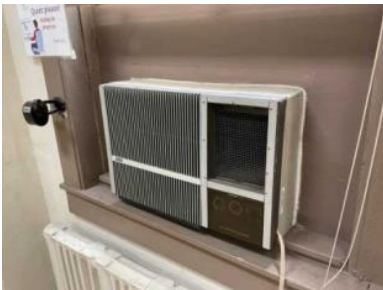
### Air Conditioner in Poor condition.

Window/Thru-Wall  
Administration Building Rose City High  
(Continuation HS) 129 A

Exceedingly aged, several settings DNF - AssetCALC ID: 3898916

Uniformat Code: D3030  
Recommendation: **Replace in 2022**

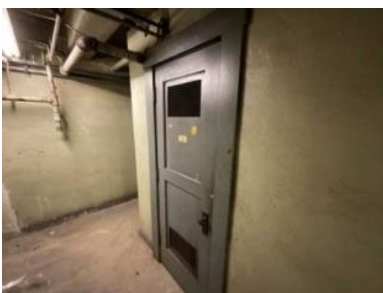
### Recommended Follow-up Study: Environmental, Asbestos (ACM) & Lead Base Paint (LBP)

Environmental, Asbestos (ACM) & Lead Base  
Paint (LBP)  
Administration Building Rose City High

Uniformat Code: P2030  
Recommendation: **Evaluate/Report in 2022**
