October 15, 2026

This report summarizes the results of our October 7, 2026 1<sup>st</sup> Quarter mercury air monitoring of the Somerset Intermediate School gym for mercury vapors. Evaluation criteria and methods are identical to those previously reported and will not be repeated herein.

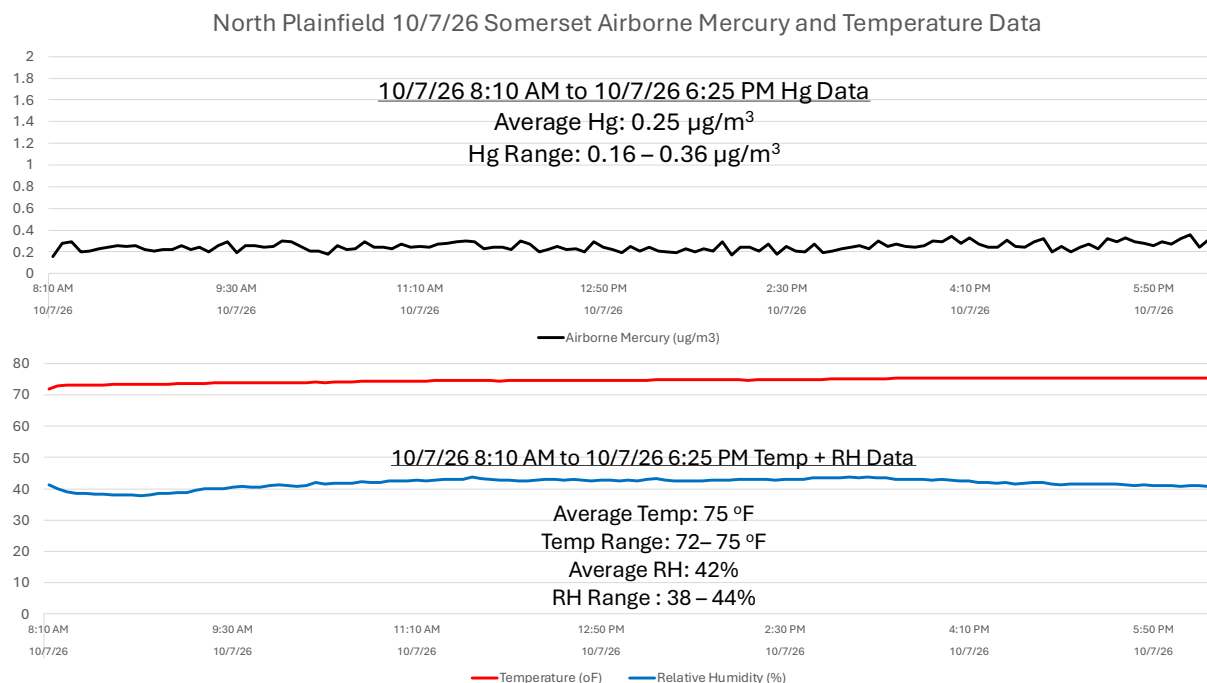
- Outdoor airborne mercury was measured at approximately 0.01 micrograms per cubic meter ( $\mu\text{g}/\text{m}^3$ ). The outdoor temperature ranged between 45-69 °F during the inspection period.
- Airborne mercury levels measured in the gym **averaged  $0.25 \mu\text{g}/\text{m}^3$  (range 0.16 to  $0.36 \mu\text{g}/\text{m}^3$ ); well below the NJDOH Guideline of  $0.8 \mu\text{g}/\text{m}^3$ .**
- Gym temperature averaged approximately 75°F (range 72-75°F).

Figure #1 below shows details of continuous monitoring results.

The 1<sup>st</sup> Quarter October 7, 2026 routine mercury monitoring of the Somerset Intermediate School gym revealed that **airborne mercury averaged  $0.25 \mu\text{g}/\text{m}^3$** . Despite air conditioner chillers functioning optimally and gym temperatures higher than normal, airborne mercury levels **were lower than the NJ Department of Health guideline of  $0.8 \mu\text{g}/\text{m}^3$** .

1. Continue efforts to repair the gym's HVAC cooling system. To the extent possible, lower gym thermostat settings to approximately  $70^{\circ}\text{F}$  to reduce airborne mercury levels.
2. Until the cooling system is repaired open fresh air dampers to increase outdoor air introduction rates, cool outdoor weather conditions permitting.
3. Continue routine non-abrasive floor cleaning to remove accumulated dusts.
