# Carnevale Elementary School and DelSesto PK-8 School

October 21, 2026

# Existing School Conditions Report

# **Structural Existing Conditions Report**

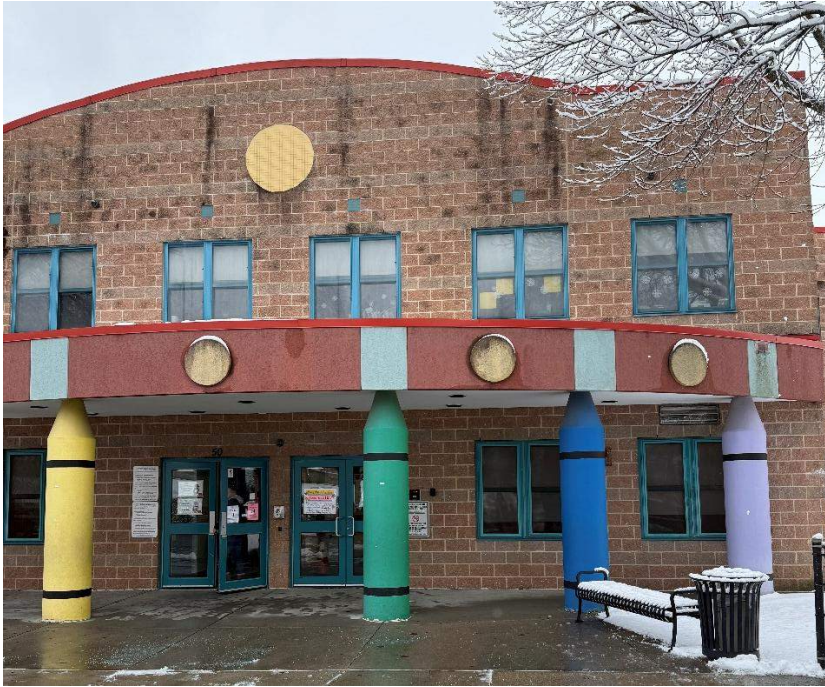
Front entrance access exhibits visible staining on masonry surfaces.

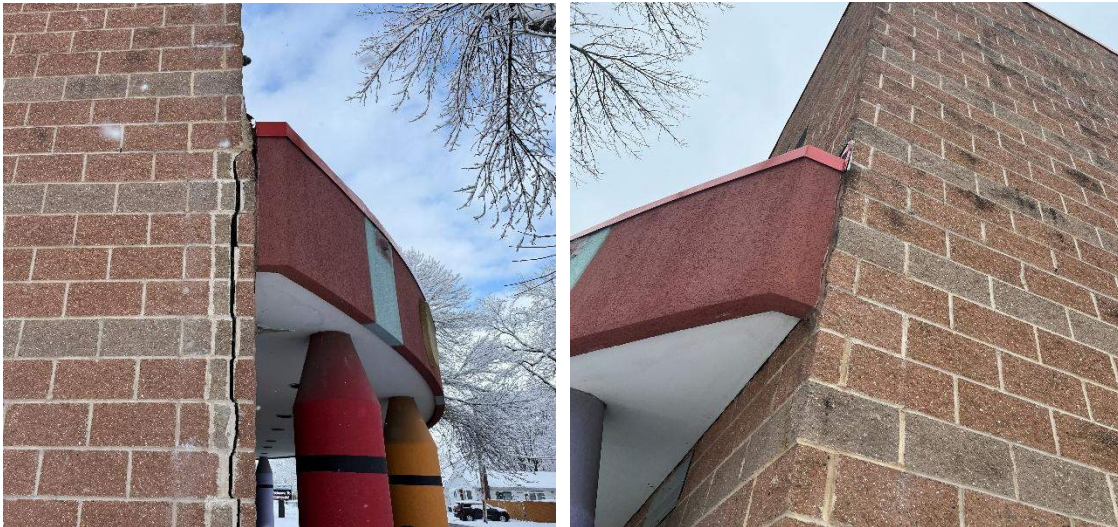
Front entrance canopy exhibits structural movement, resulting in separation of the veneer masonry from the CMU backup wall.

As a precautionary measure, foundation stabilization is recommended to mitigate further settlement. Engagement of a qualified specialty contractor or geotechnical engineer is advised to evaluate subsurface conditions and develop appropriate stabilization strategies. In addition, localized reconstruction of veneer masonry at the southern corner of the main entrance is recommended where deterioration is most pronounced.

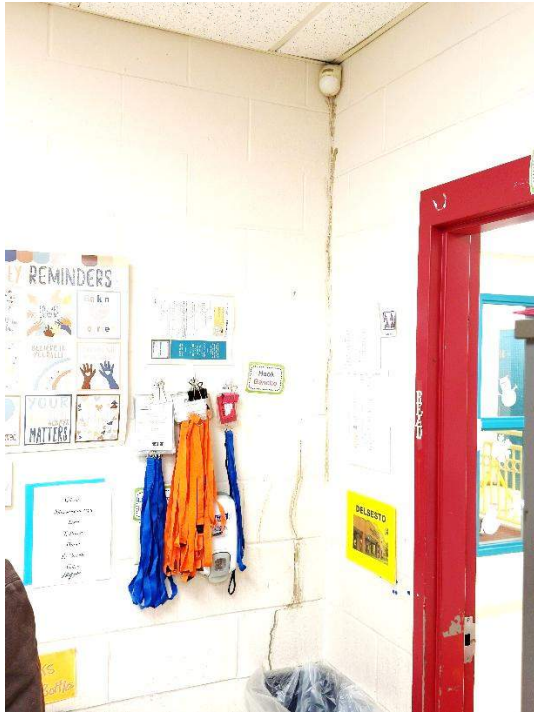
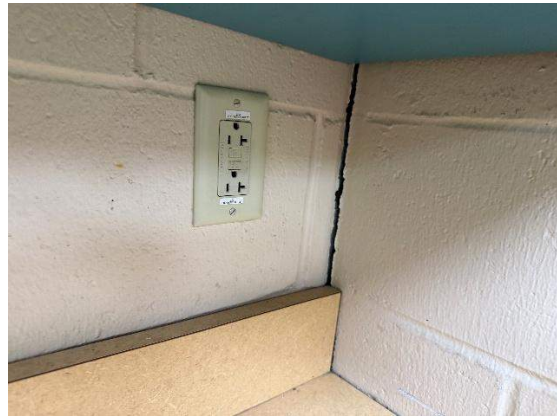
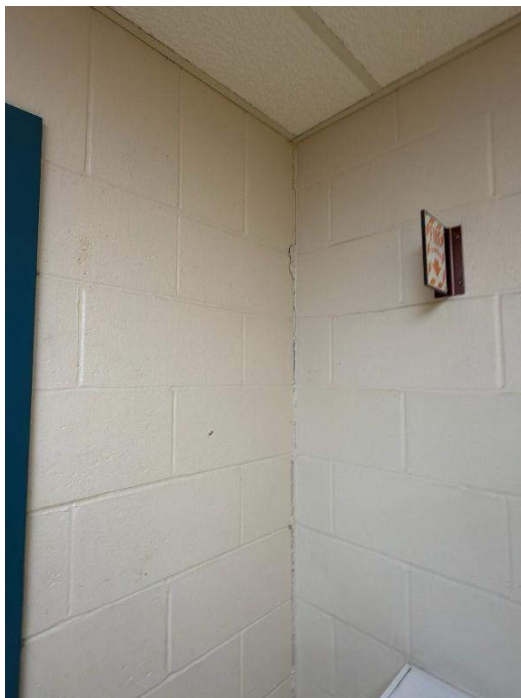
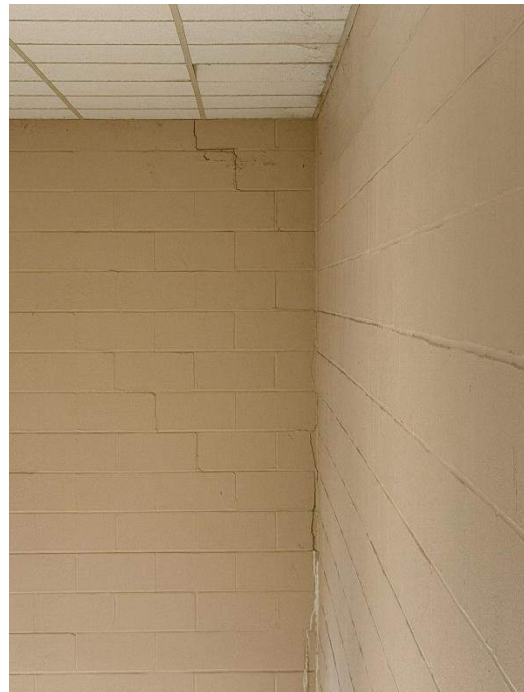
Interior CMU wall assemblies exhibit visible separation and cracking at select locations. These conditions may be indicative of building movement, material shrinkage, or stress at connections and should be monitored and further evaluated.

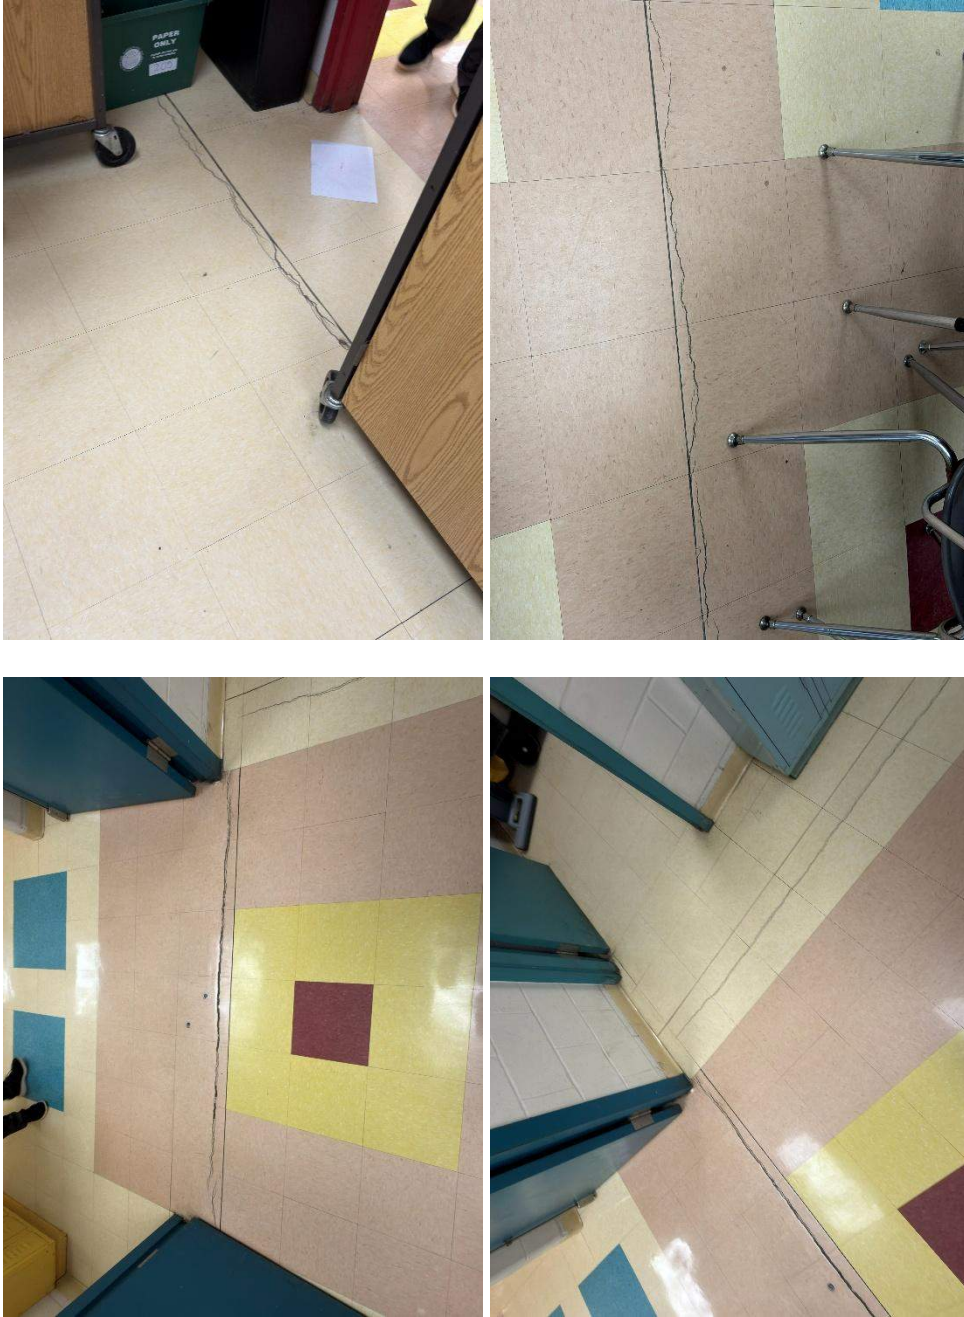
Interior floors exhibit visible cracking at select locations.

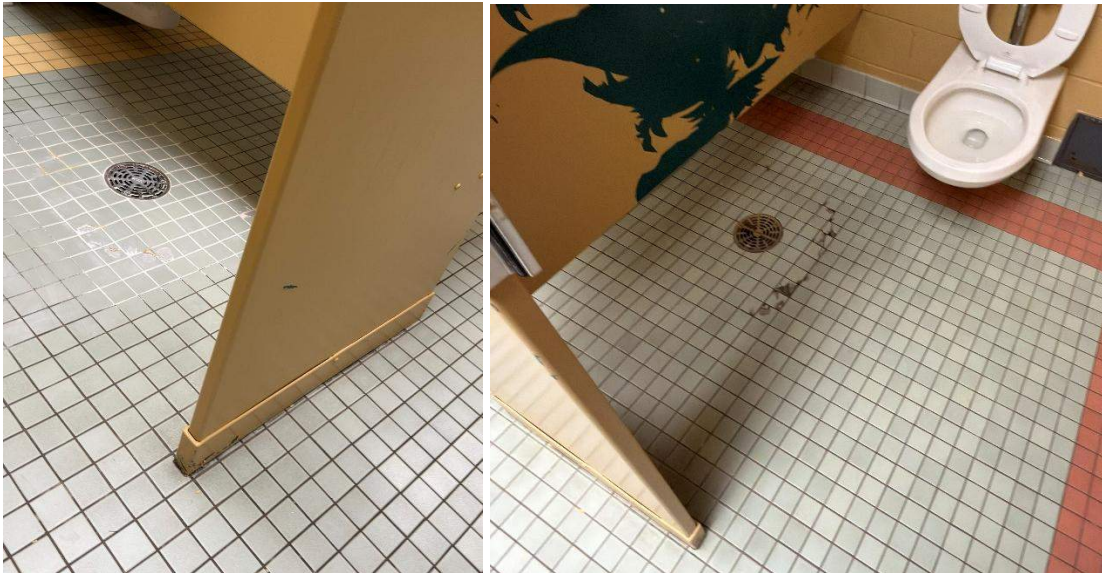
Floor drain areas were observed to be improperly sloped toward the drains, resulting in standing water. This condition may contribute to maintenance concerns, potential slip hazards, bacterial growth, and long-term material deterioration.

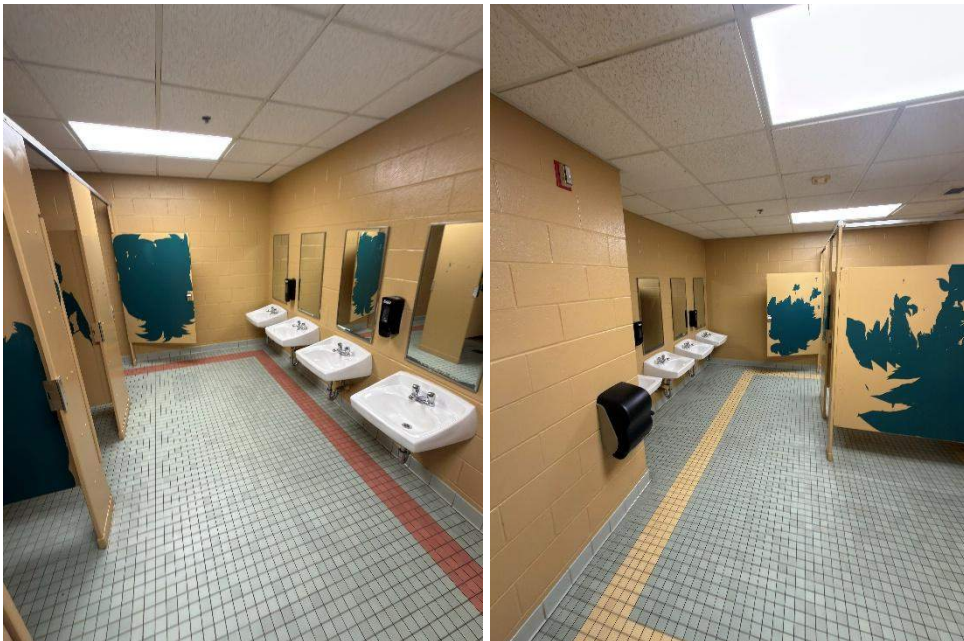
Typical bathrooms are non-compliant with current ADA standards for mounting heights and fixtures.

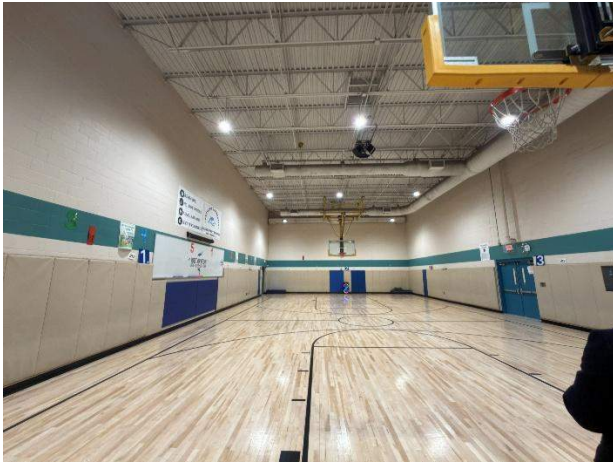
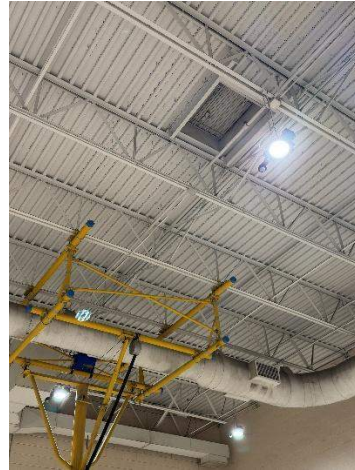
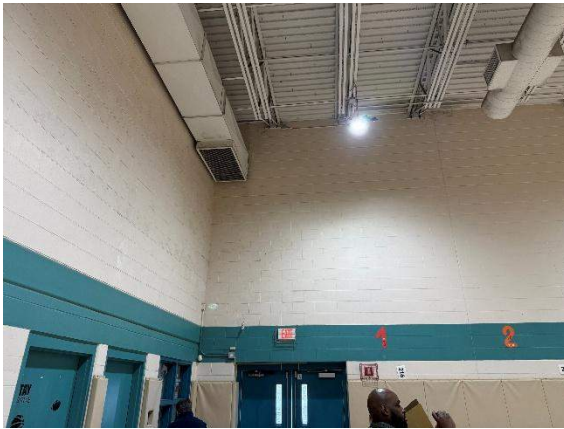
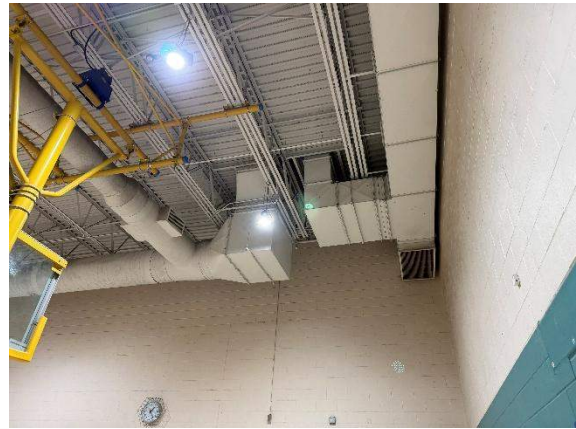
Gymnasium is in overall good condition; however it was observed that the doors have improper or damaged panic hardware.

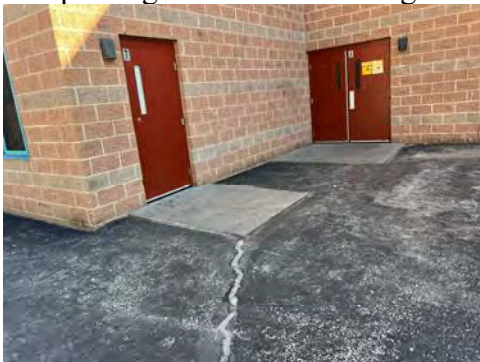
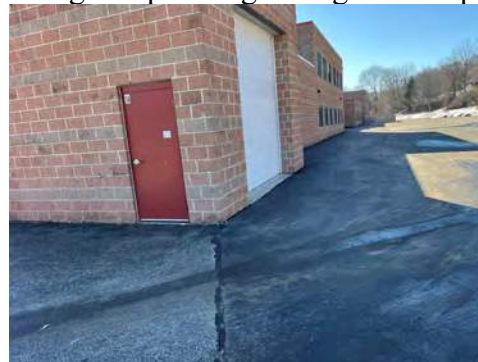
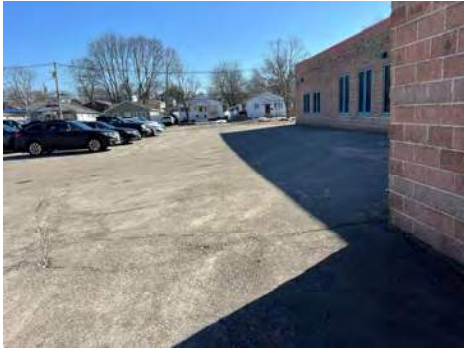
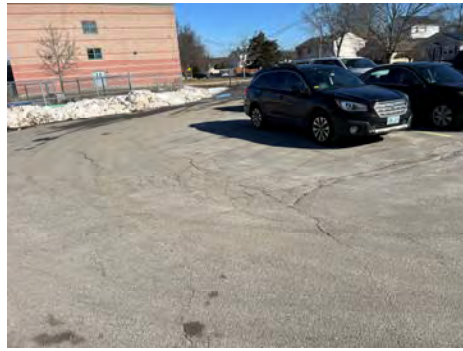
- The parking area has linear/alligator cracking and patching throughout the parking area.

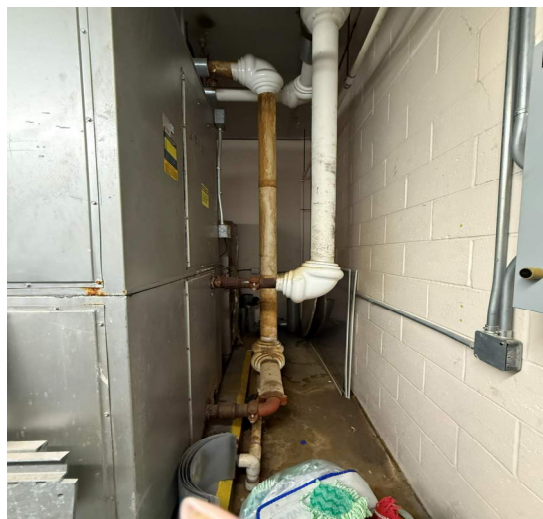
MAU-1 (1st floor Boiler Rm): Ductwork insulation is intact but **the water pipe insulation should be replaced.**

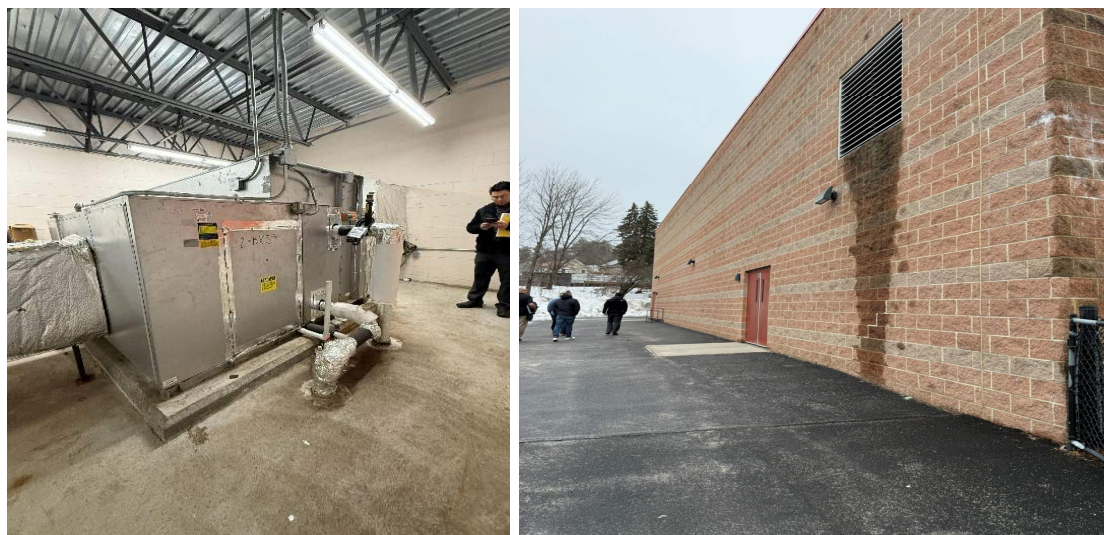
MAU-2 (2nd floor Mech Rm at the south end of the building):

Ductwork insulation is intact but the water pipe insulation should be replaced.

There is a Belimo actuator on the outdoor air damper and one on the face&bypass damper for temperature control in lieu of a dual temperature water control valve. Operation of these dampers should be checked; it is reported that during an unoccupied time this past winter, there was frost covering the outdoor air intake damper connected to this unit. This would likely be due to the outdoor air damper, not closing fully during unoccupied and positive building pressure flowing back through the ductwork and exhausting out through that louver. Evidence of this problem and the resulting moisture problem created on the exterior wall below the water is shown in the photo above.

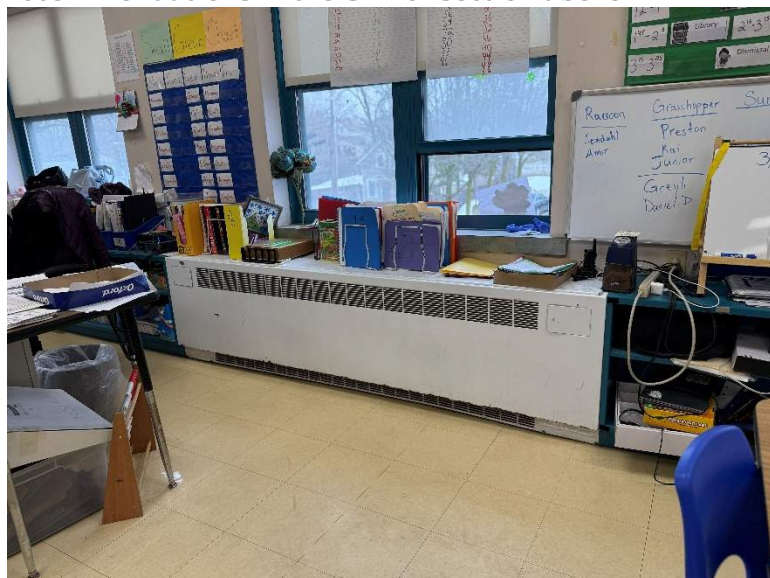
Classroom unit ventilators are very loud and do not provide consistent cooling. **Refer to recommendations in the Chiller section above.**

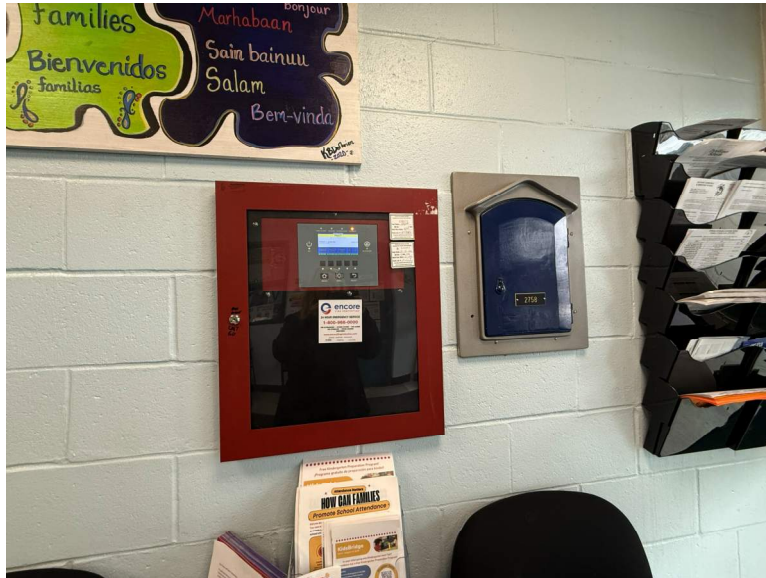
A fire alarm panel is located in the main entrance lobby along with Fireman's box #2758. No specific areas of deficiency were noted in this site visit.

**This is not an annunciator type panel which is now required in K-12 Educational buildings.**
