**SOLICITATION ADDENDUM NO. 1**  
**ITB 19-0002**  
**Cedar Mill HVAC, Roof, and Electrical Upgrades**

# **ASBESTOS ABATEMENT CONTRACTOR BID DOCUMENT AND SPECIFICATIONS**

## **Cedar Mill Elementary School HVAC and Roofing Project**

## Appendix A – LIMITED SUPPLEMENTAL ASBESTOS AND LEAD PAINT SURVEY REPORT

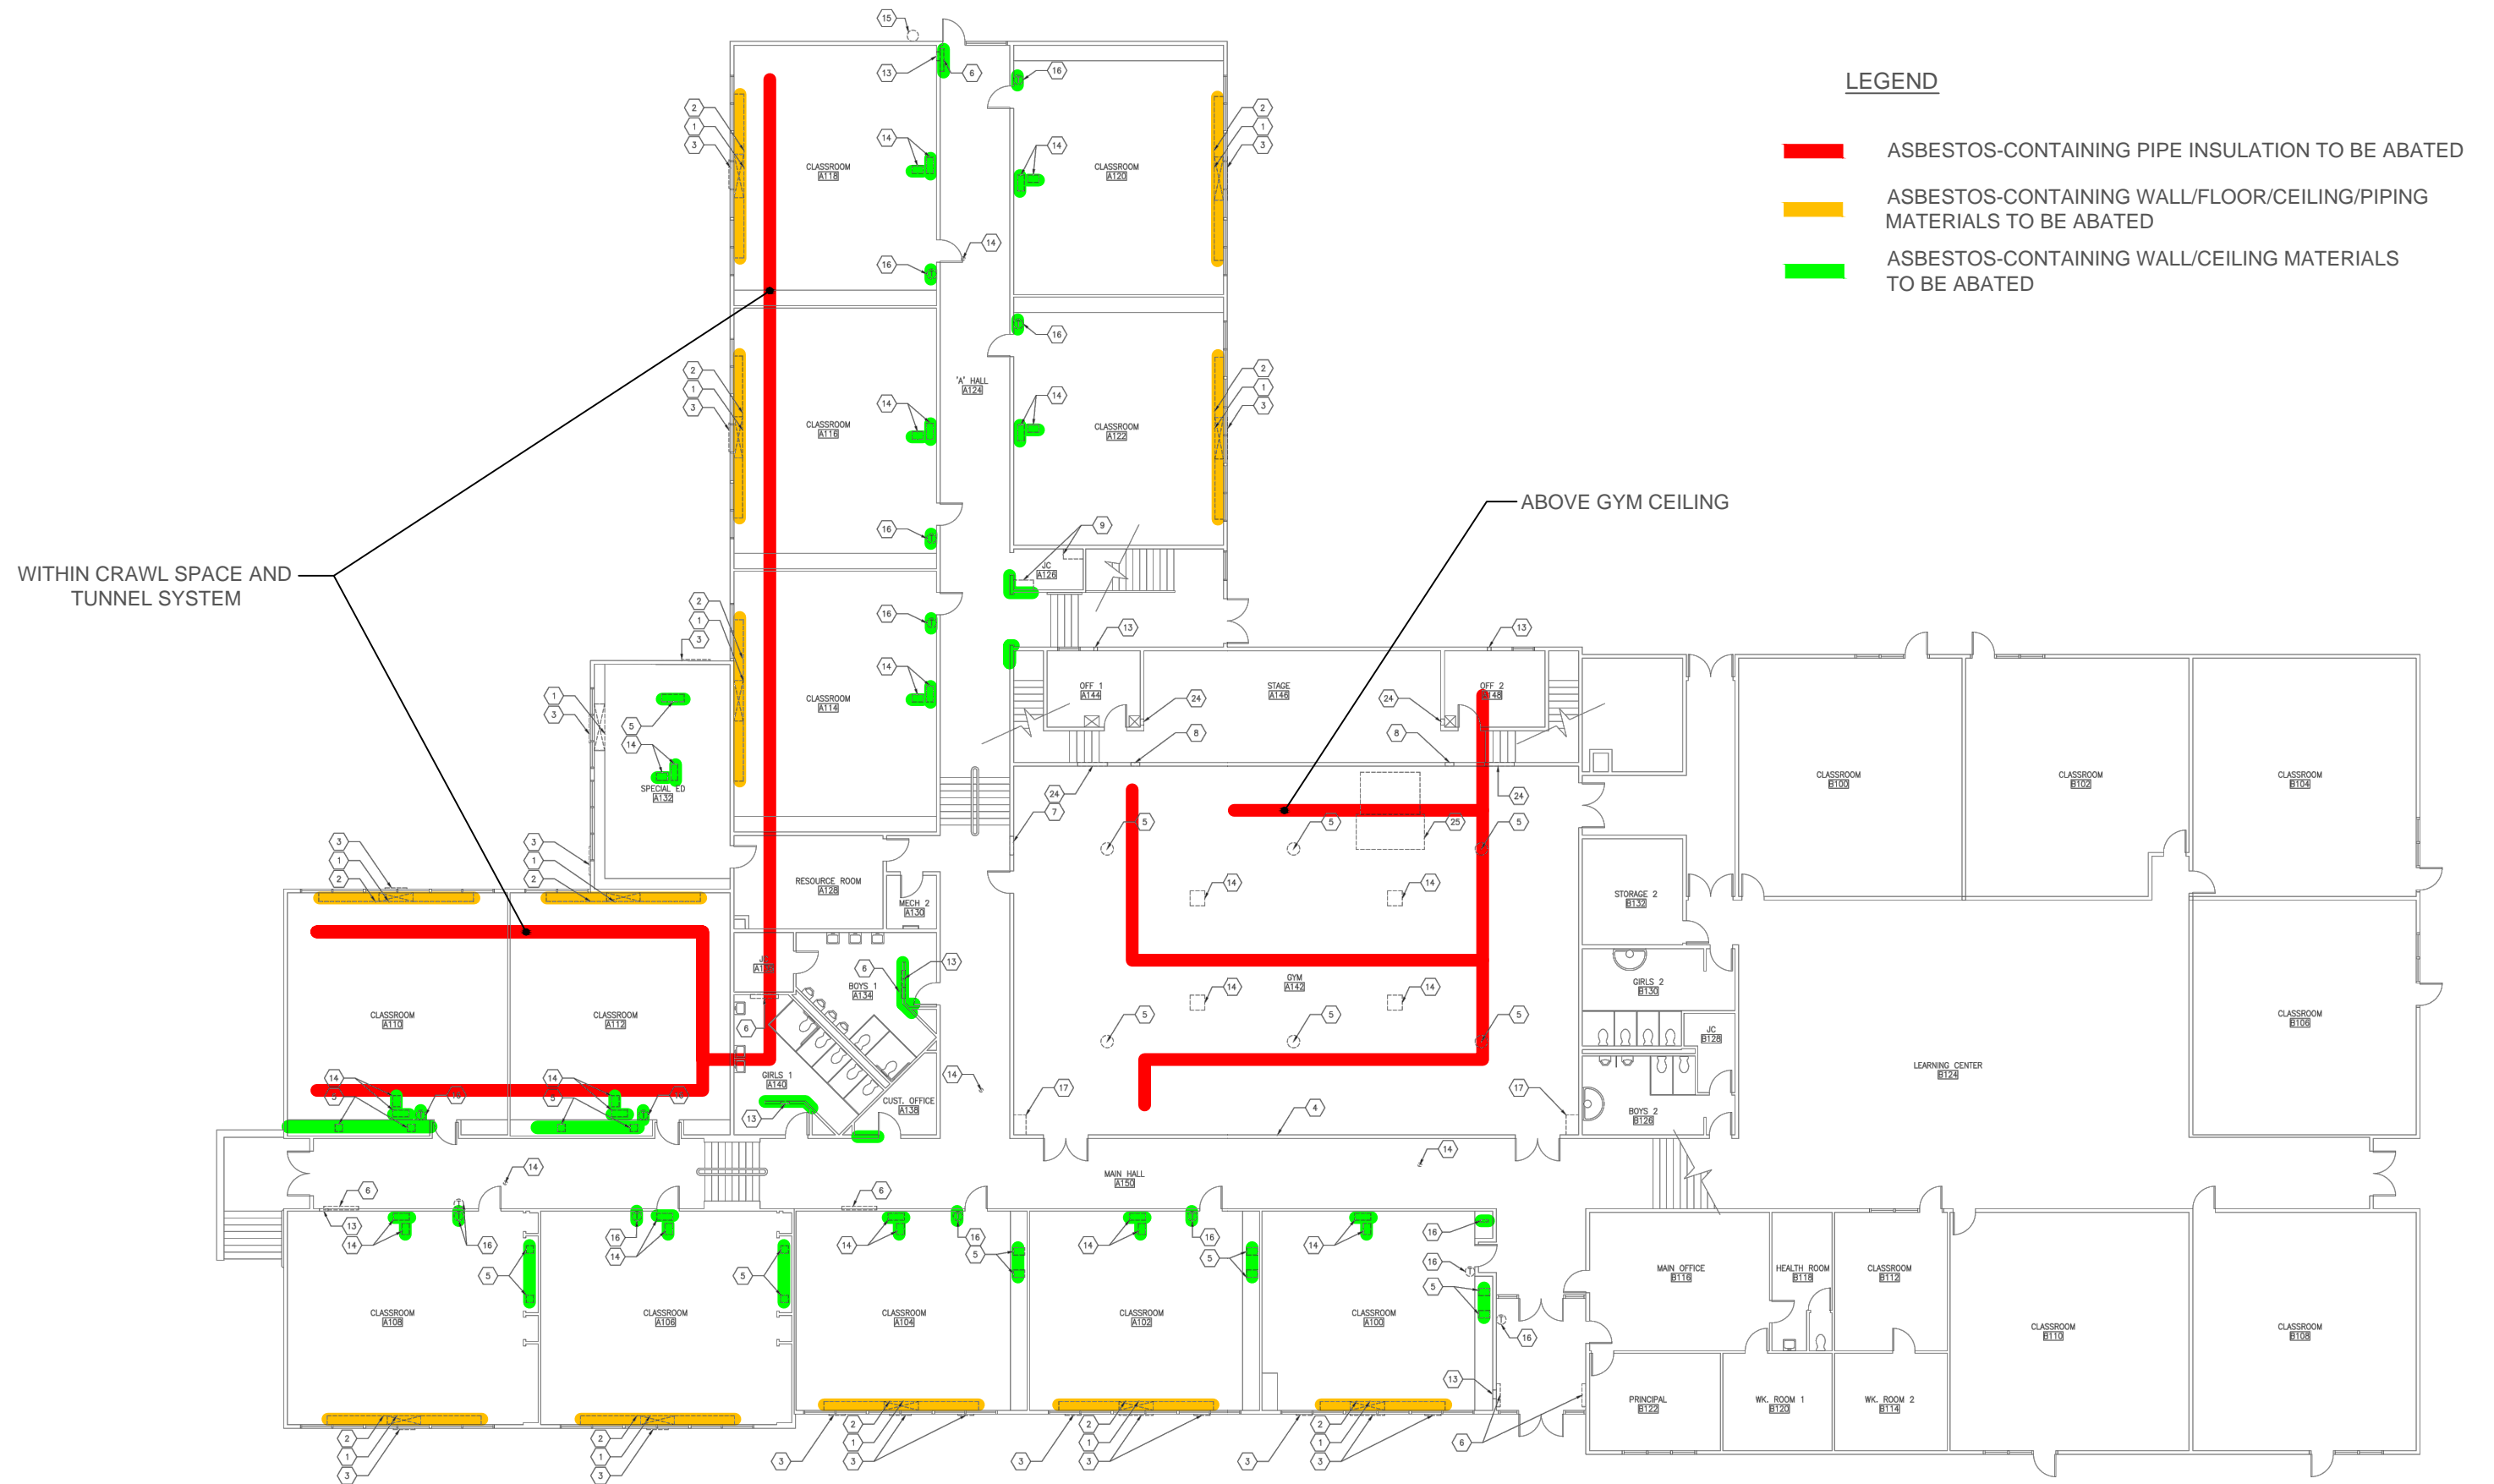
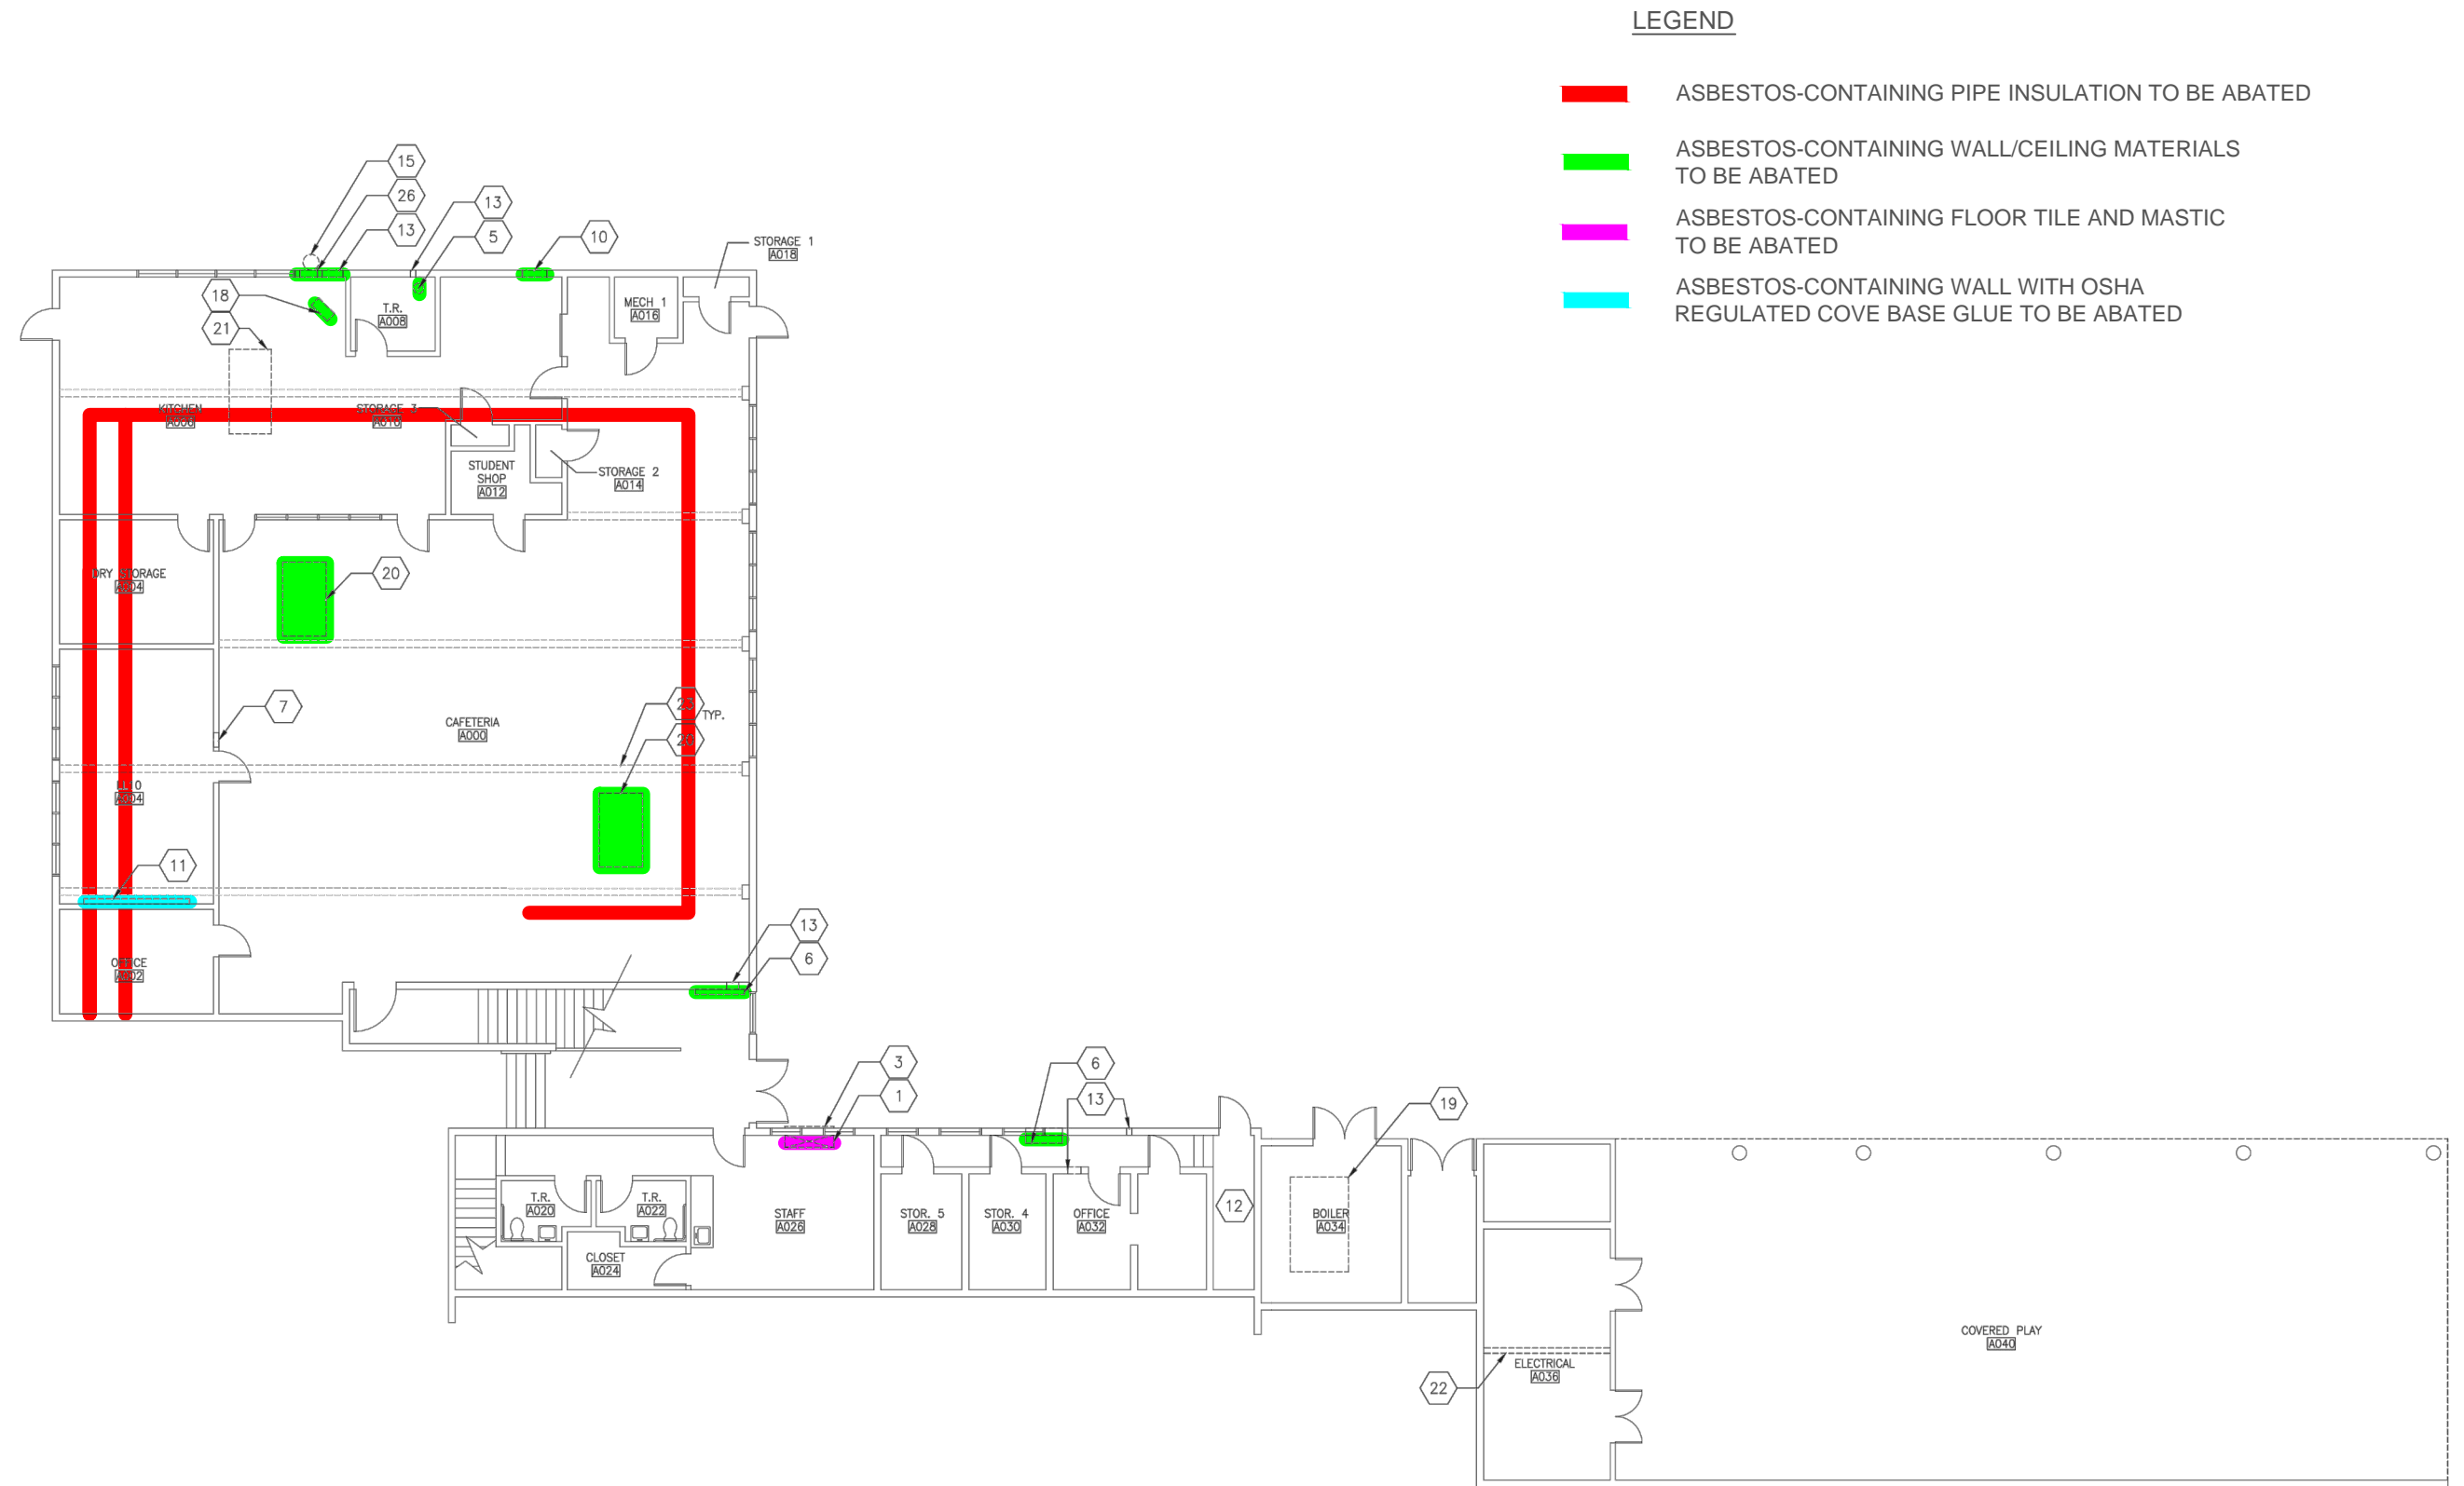
1.2

Description	Material Location(s)	Friable / non-Friable	Approximate Quantity
Plaster or Gypsum Board & Joint Compound Walls and Ceilings	Throughout Renovation Area – See Figures	Friable	1,220 SF
Vinyl Floor Tile and Mastic	Under and around HVAC Units	Non-Friable	550 SF
Pipe Insulation and Elbows	Behind HVAC Units, Within Wall/Ceiling Cavities & HVAC Units, Crawl Spaces and Tunnel System, and Gym Attic – See Figures	Friable	2,000 LF
Cove Base Glue – OSHA Regulated	Throughout w/ Wall & Floor Removal	Non-Friable	320 LF

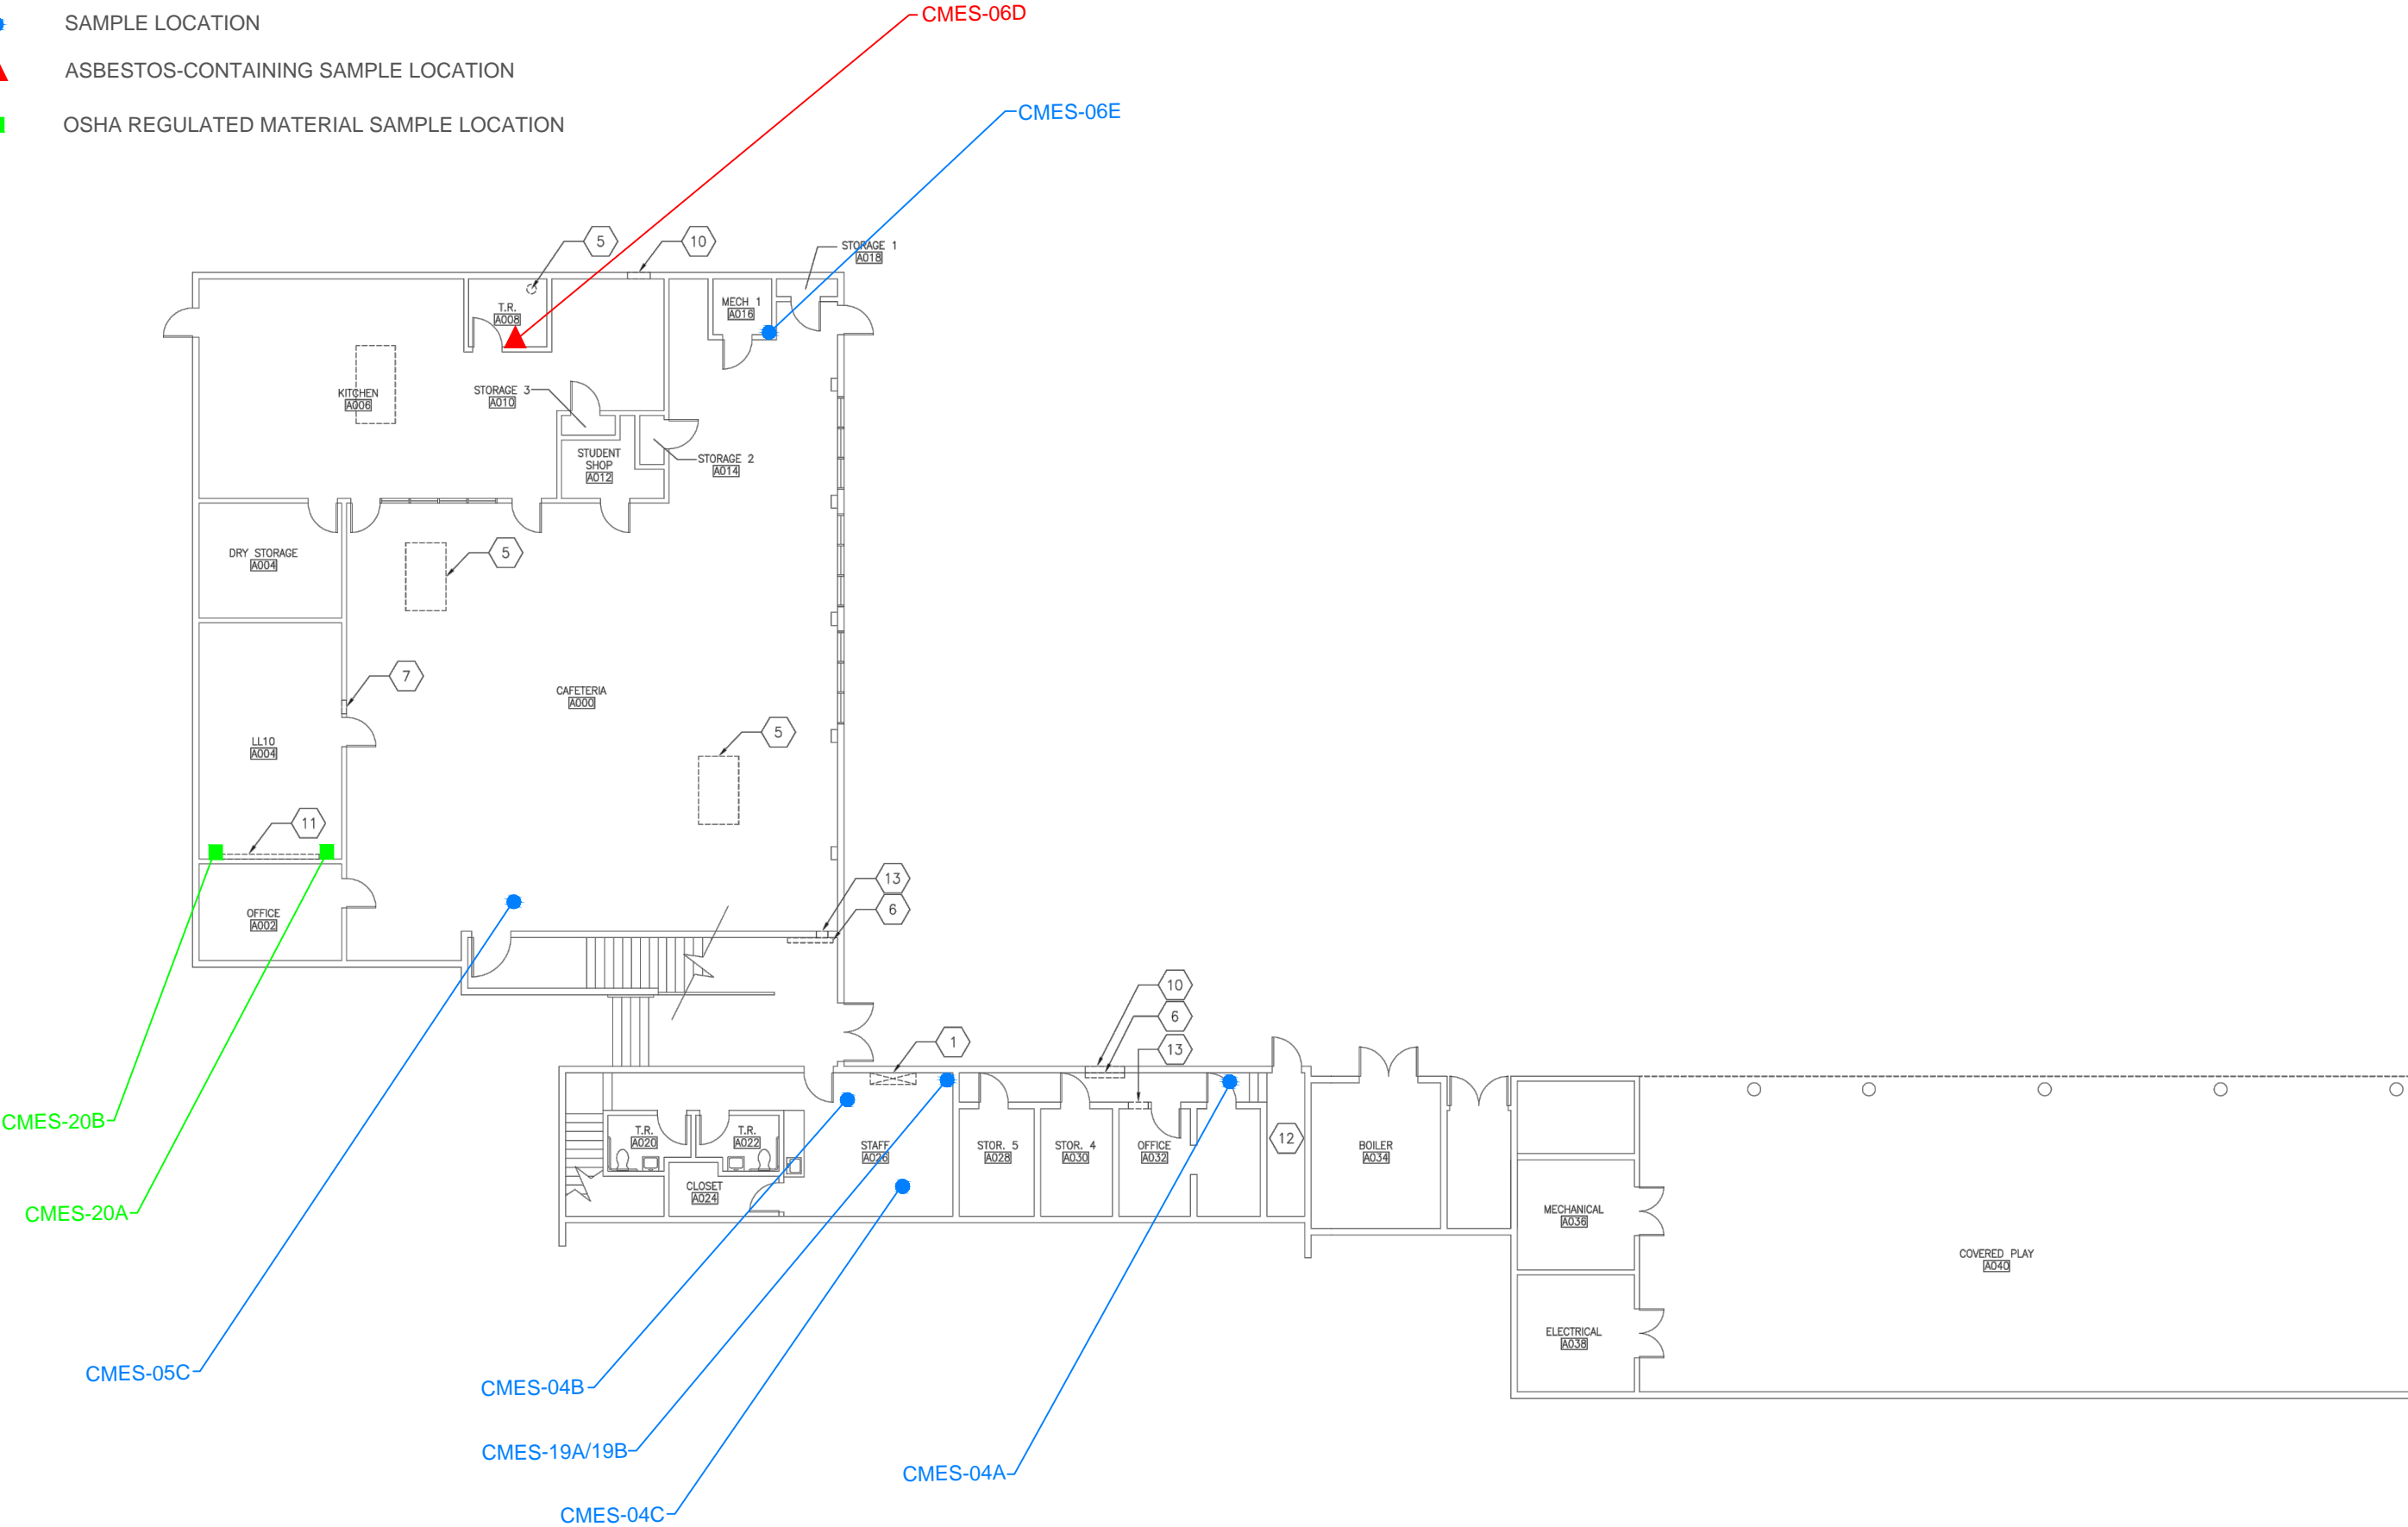
1.2

A supplemental asbestos and lead paint survey was conducted by TRC at Cedar Mill Elementary School, located at 10265 NW Cornell Road in Portland, Oregon. It was reported by the client that this limited hazardous materials survey is being conducted in conjunction with their HVAC and re-roof renovation project. The survey activities were performed on November 28<sup>th</sup>, 2018 and December 7<sup>th</sup>, 2018, and included the review of prior sampling documentation and reports as well as the inspection, assessment and bulk sampling of suspect asbestos containing building materials that had not previously been sampled. Sample locations are presented on the Sample Location Diagrams in Appendix A.
