ROSEHILL ELEMENTARY
FACILITY EVALUATION

OVERALL SUMMARY

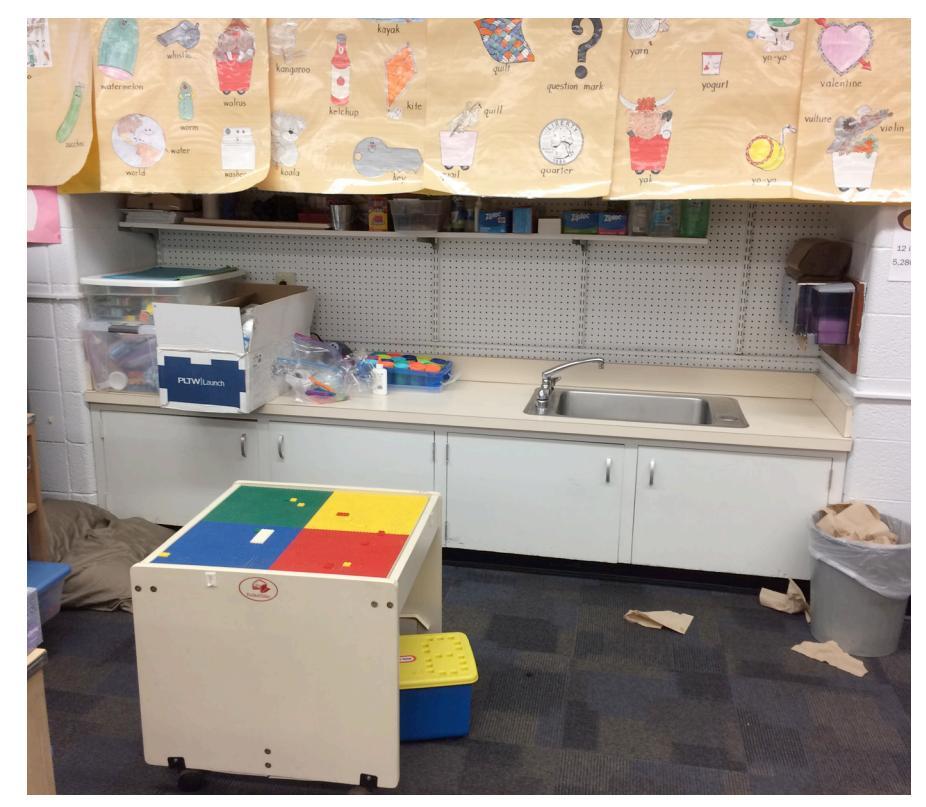
Kindergarten casework: upper cabinets need doors to hide clutter.

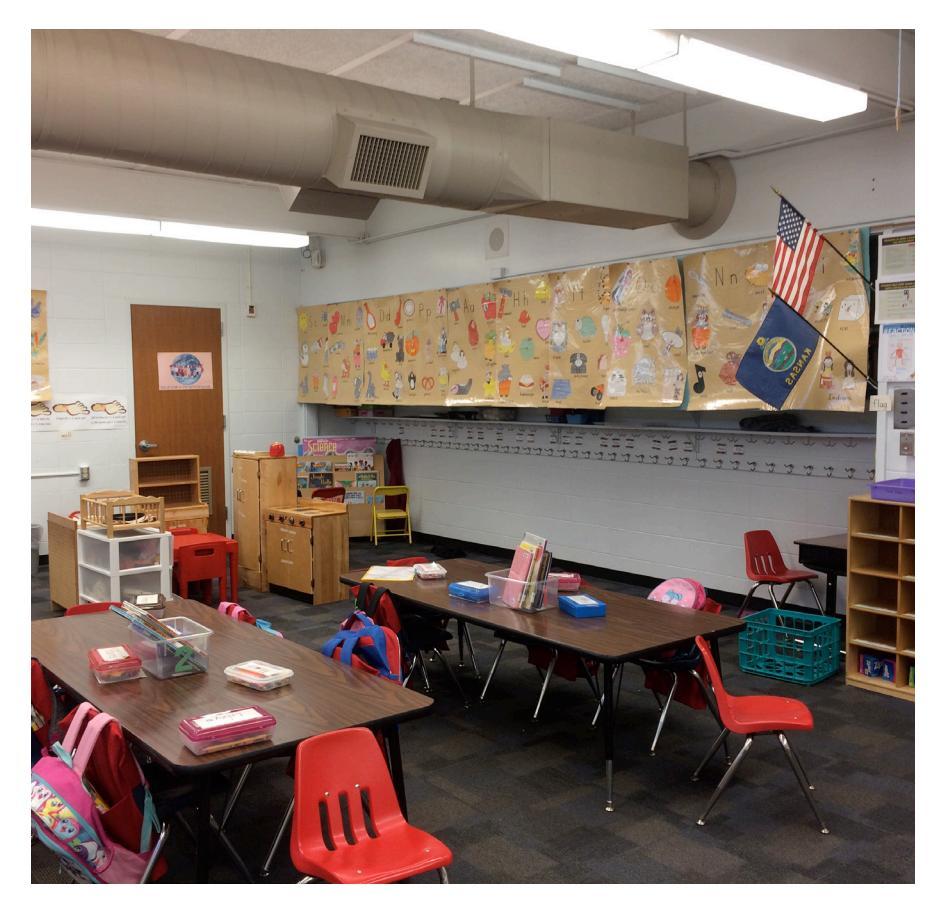
No individual cubby storage is provided in Kindergarten rooms, only coat hooks.

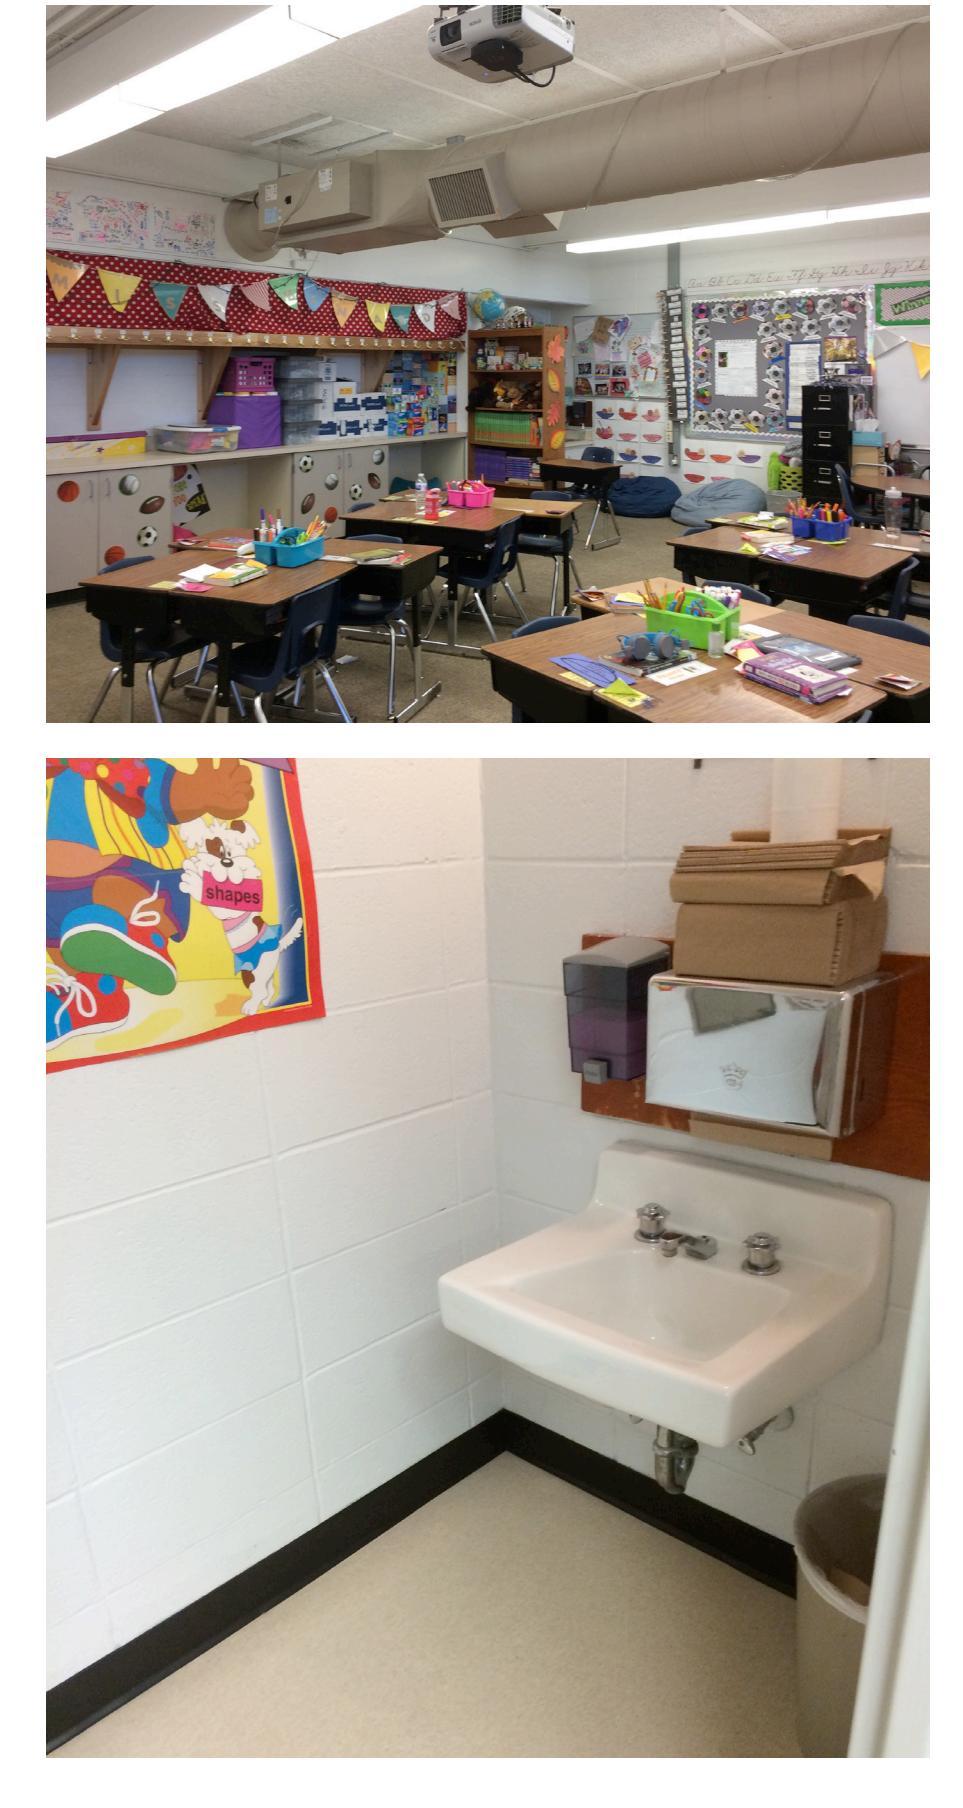
Classroom needs individual cubbies and different teaching areas.

Kindergarten toilets not ADA accessible.

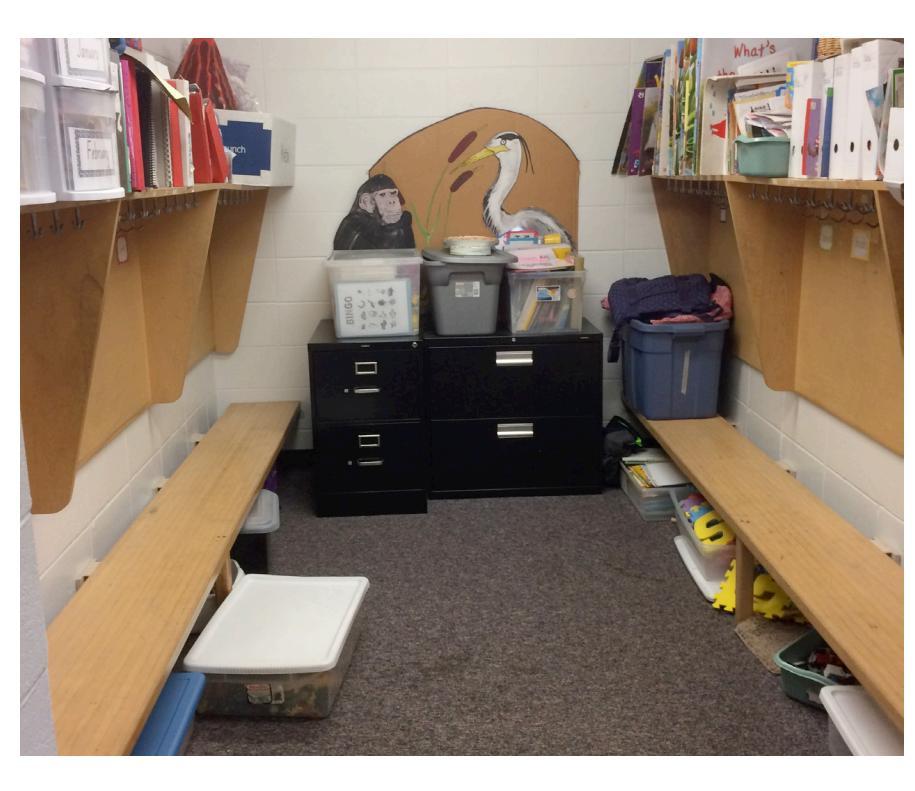
Kindergarten: Alcove with shelves and coat hooks instead of cubbies.

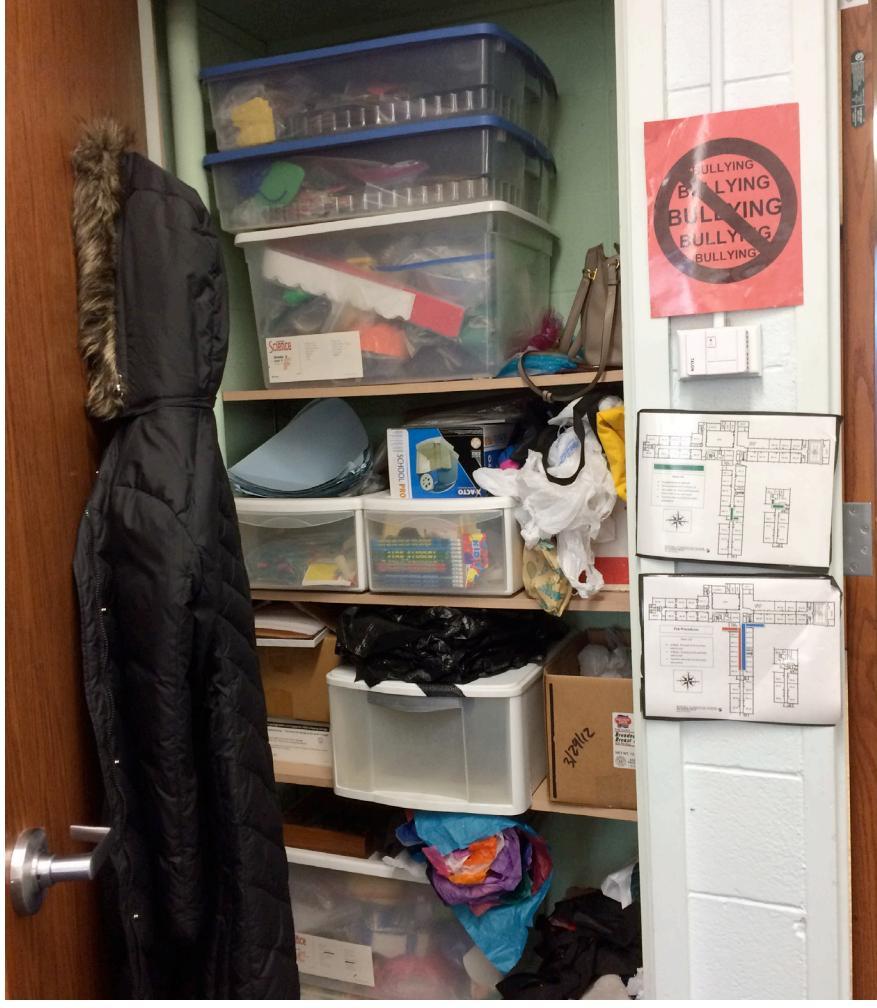
Small storage closet in classrooms.

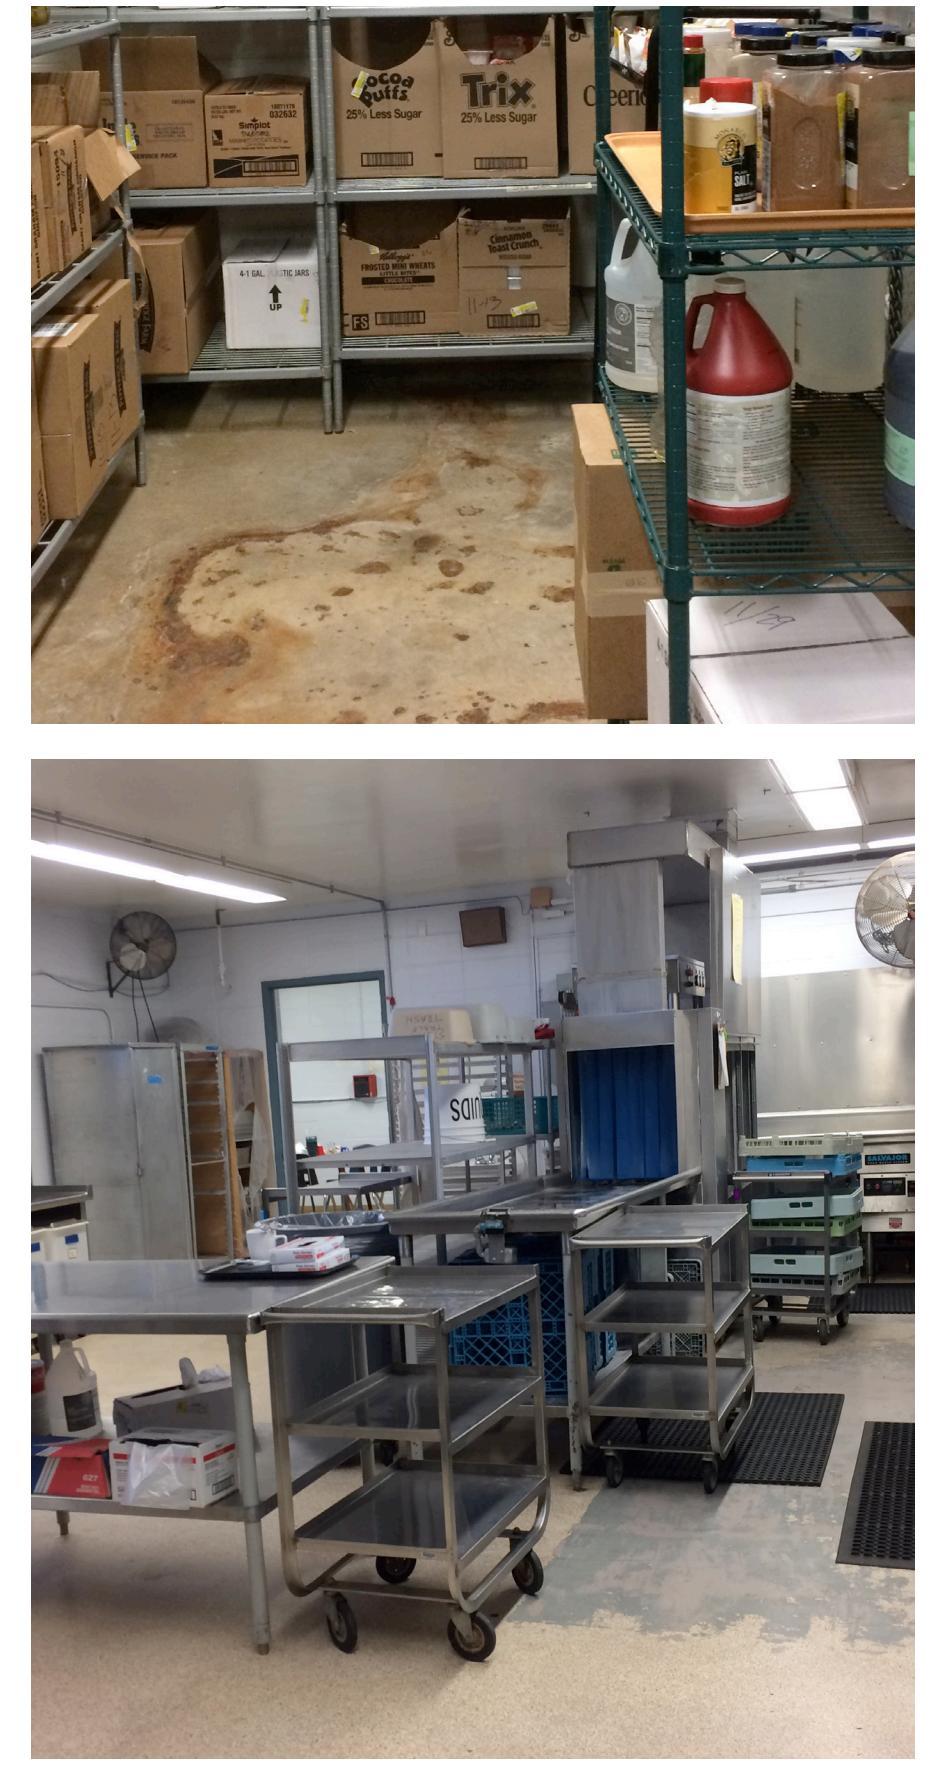
Need new flooring in Kitchen Dry Storage area.

Kitchen flooring needs updating. Old kitchen equipment.

- 24. Kitchen has old flooring that looks patched and rusty. There are fans in the kitchen. Need to verify if air circulation is a problem. Dry storage room has rust on the floors. Exterior door to Receiving is rusted and needs replacing.
