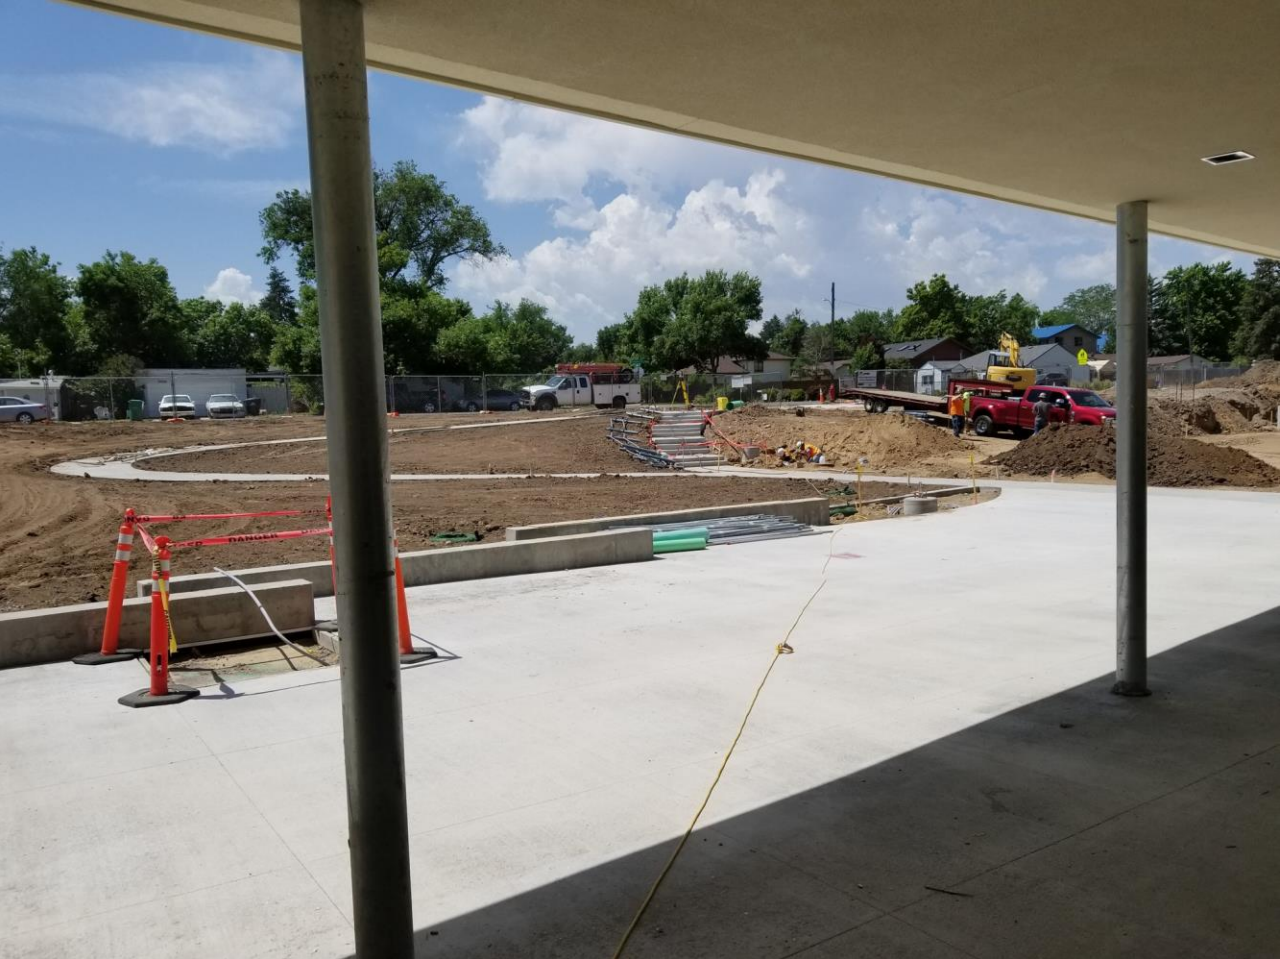
South Elevation – Main Entrance; Concrete and site work continues.

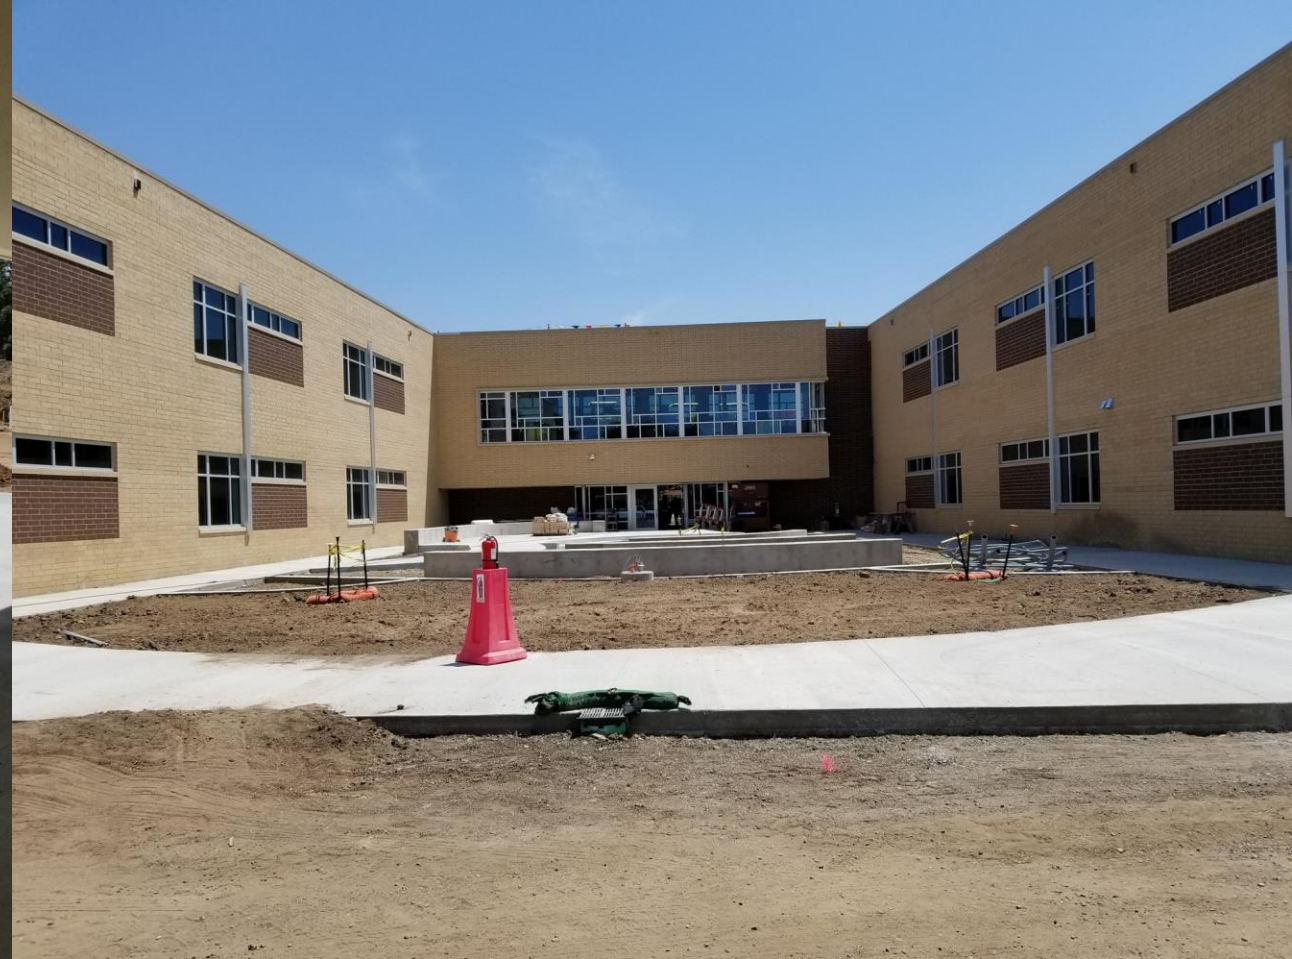
West Elevation – West Facing View; Concrete and site work continues.

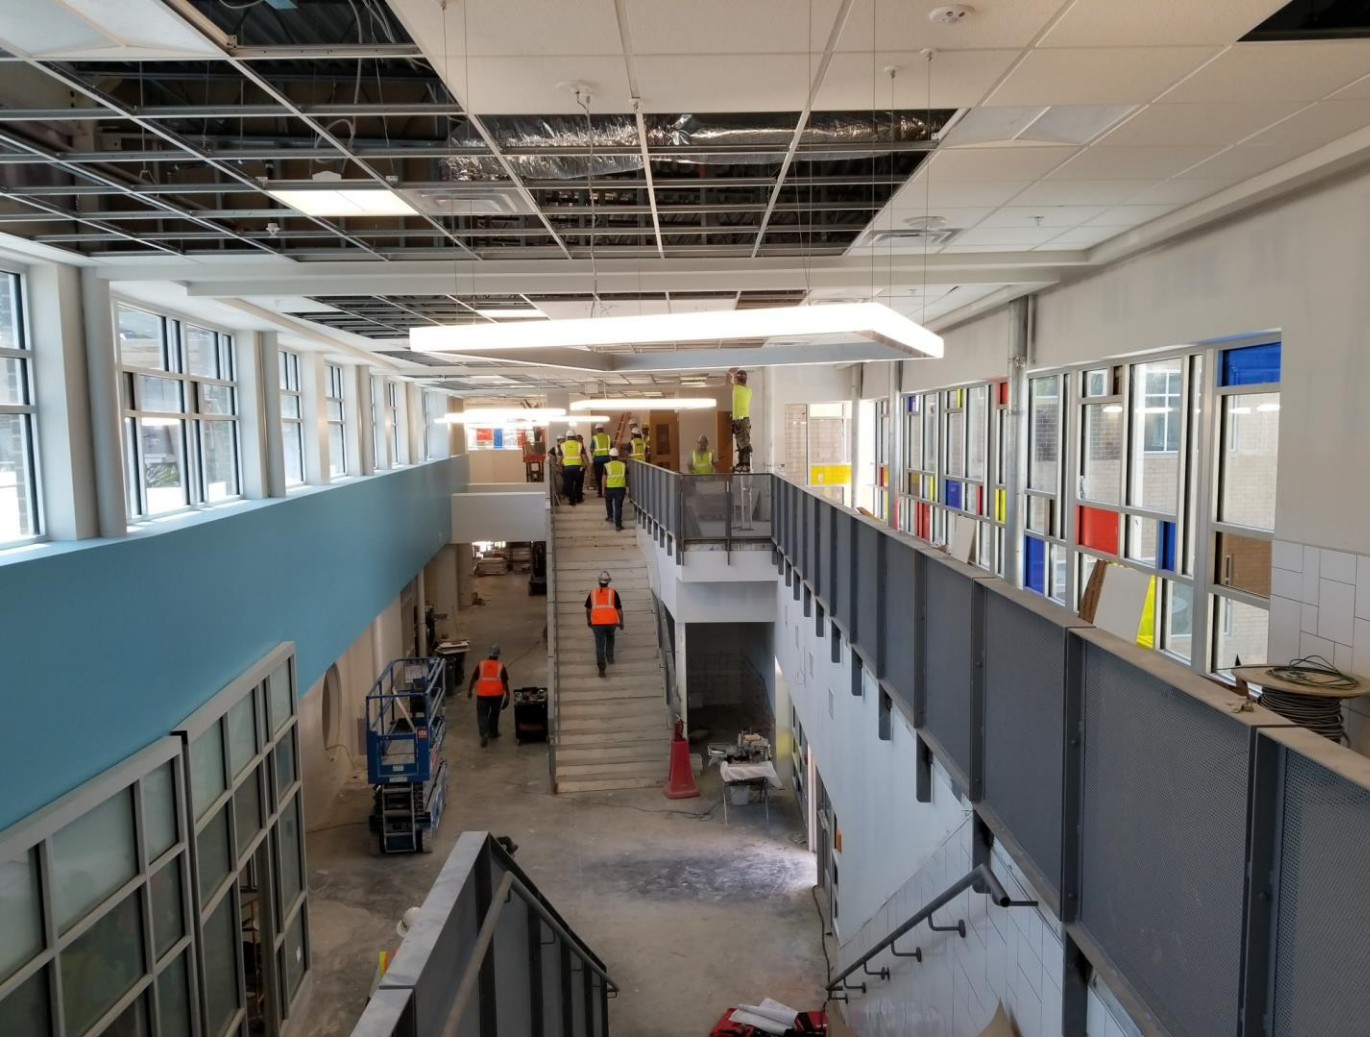
Grand Hall – South Facing View; Ceiling tile install and painting in progress.

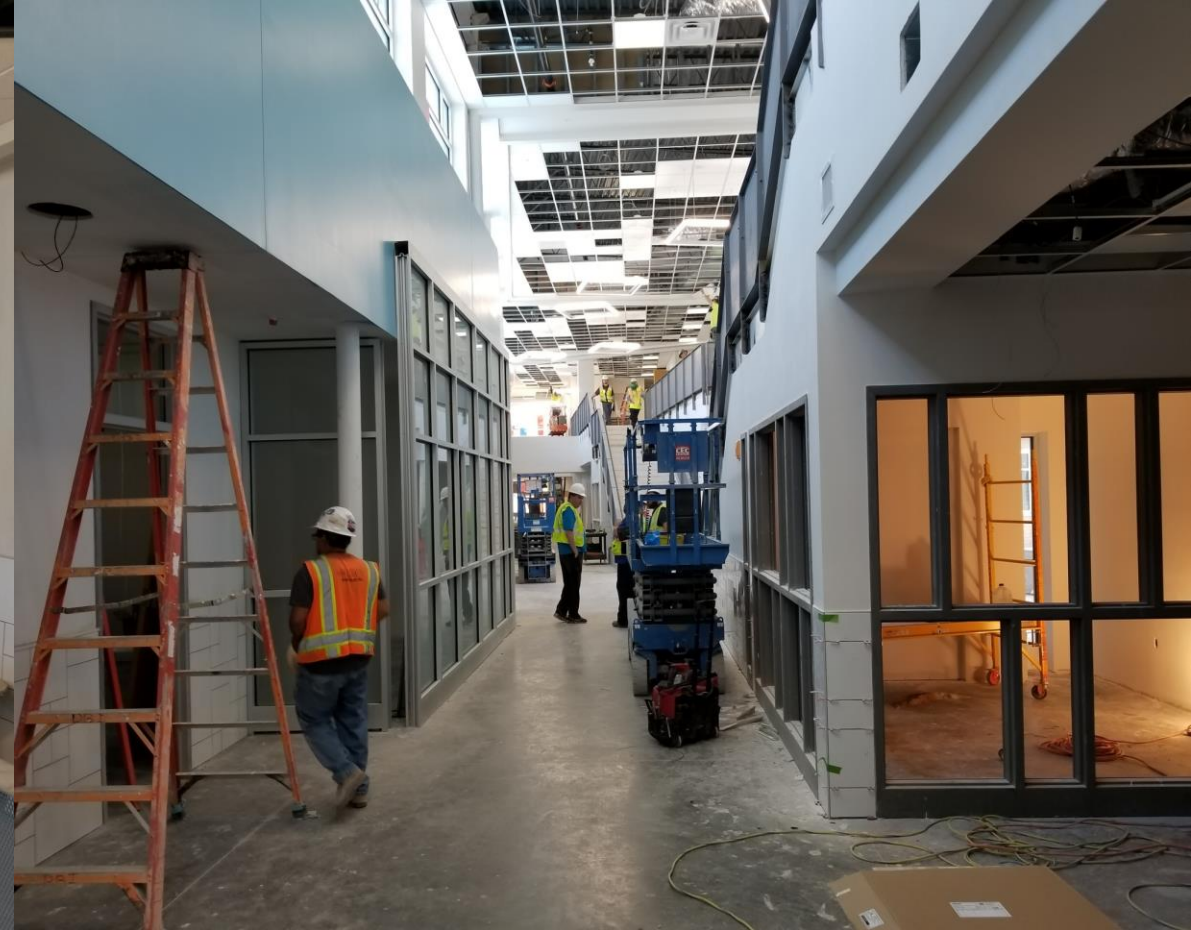
Grand Hall – South Facing View; Electrical work and painting in progress.

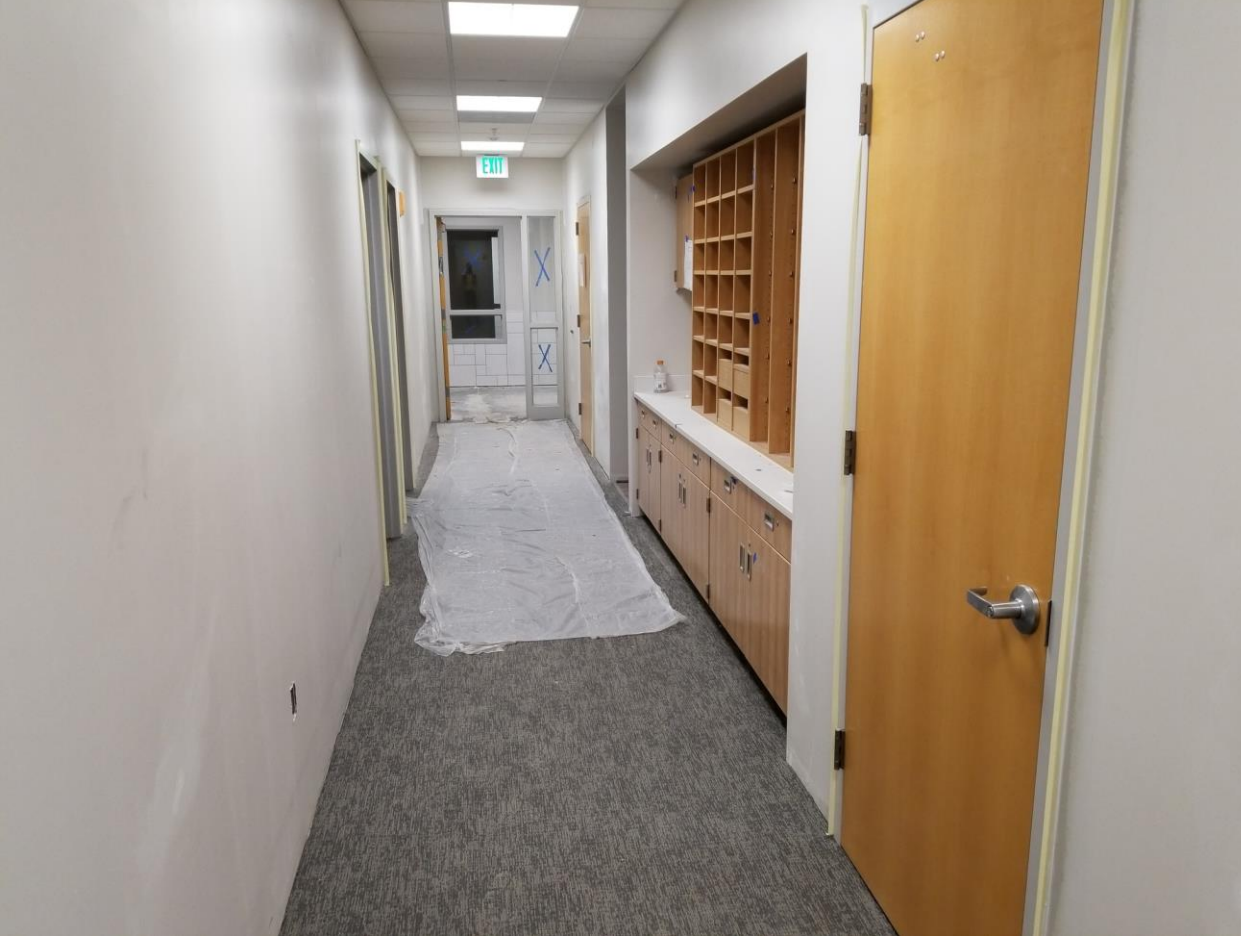
Office Area Hallway – Flooring newly installed.

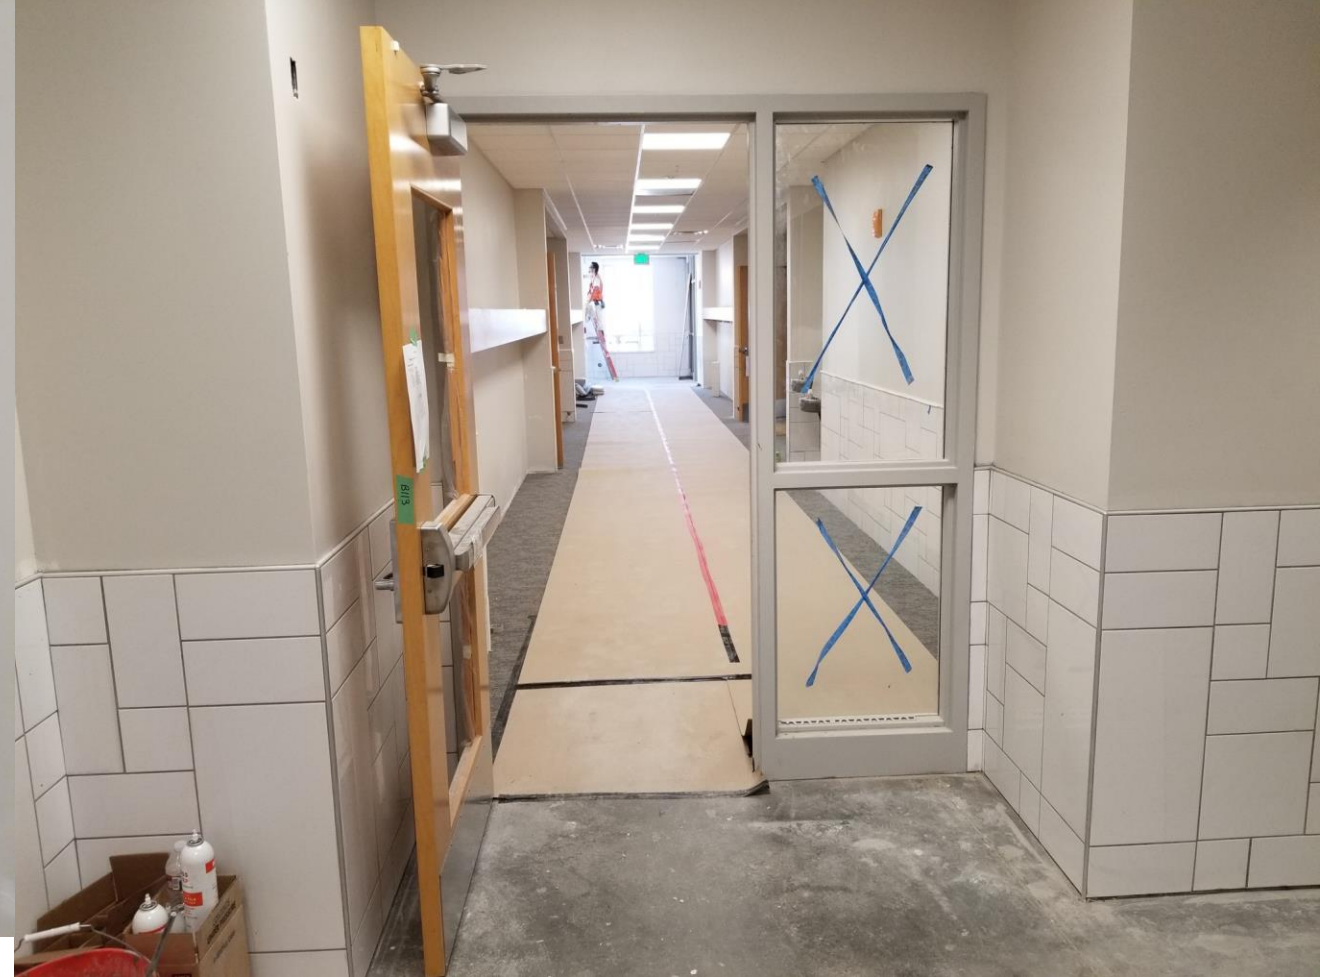
South Classroom Wing (L1) – Hallway; Floor being installed. Tile work recently completed.

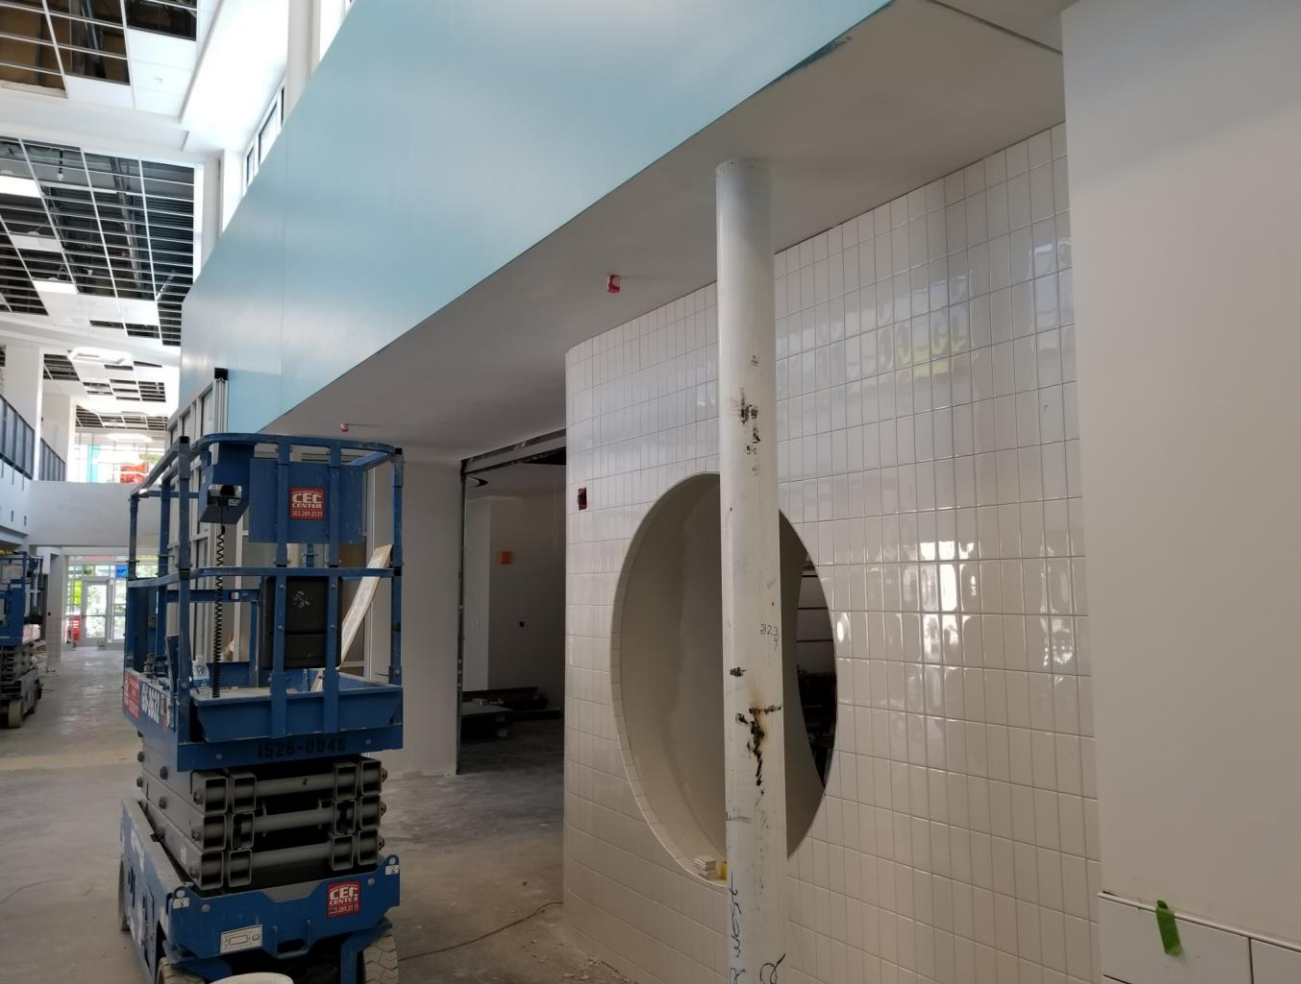
Learning Commons – Painting, HVAC and electrical work continues. Exterior tile recently completed.

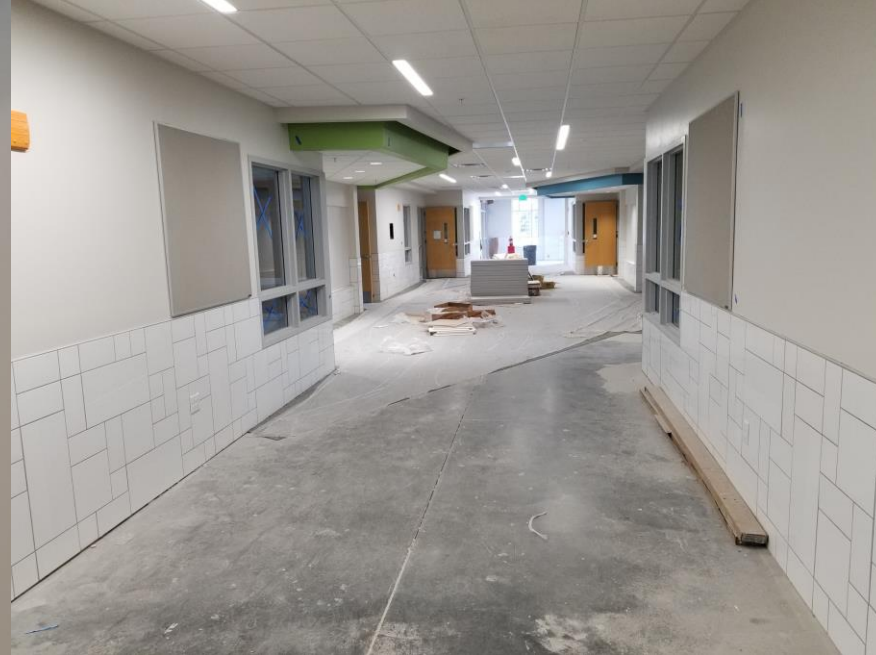
North Classroom Wing (L1) – Carpet install continues.

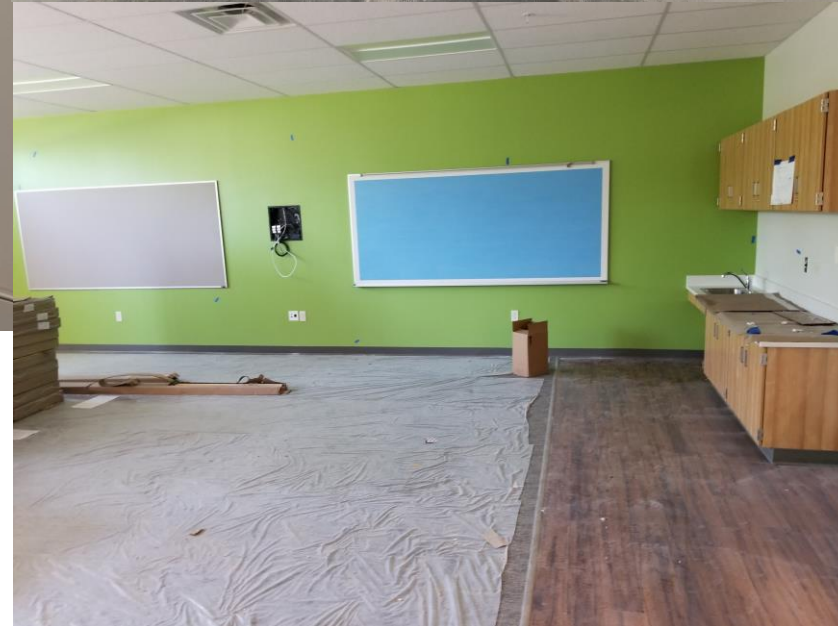
North Classroom Wing (L1) – Classroom; Boards recently installed.

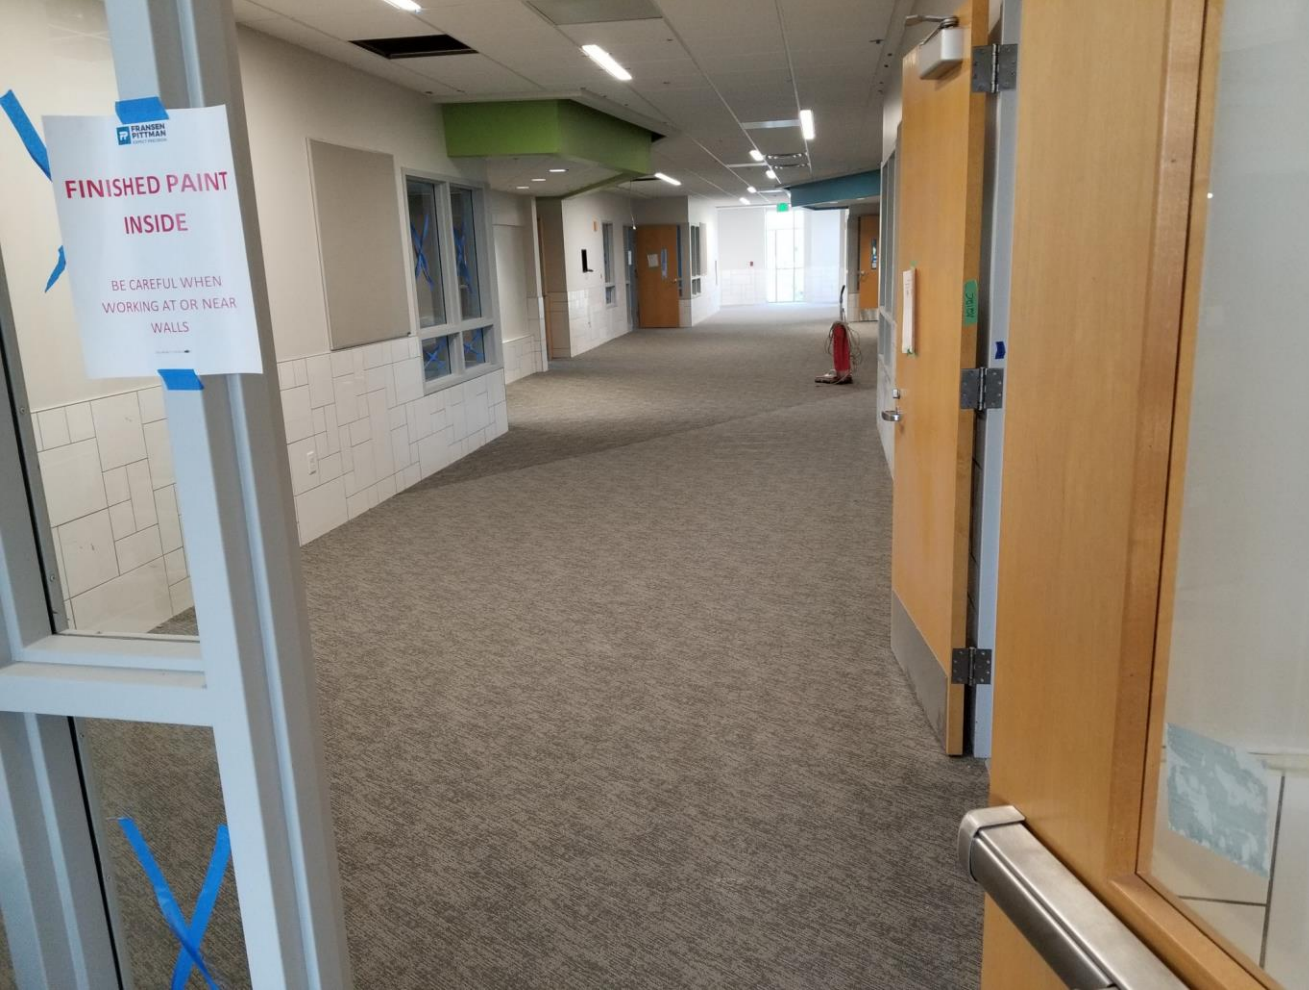
North Classroom Wing (upper level) – Carpet plastic cover recently removed.

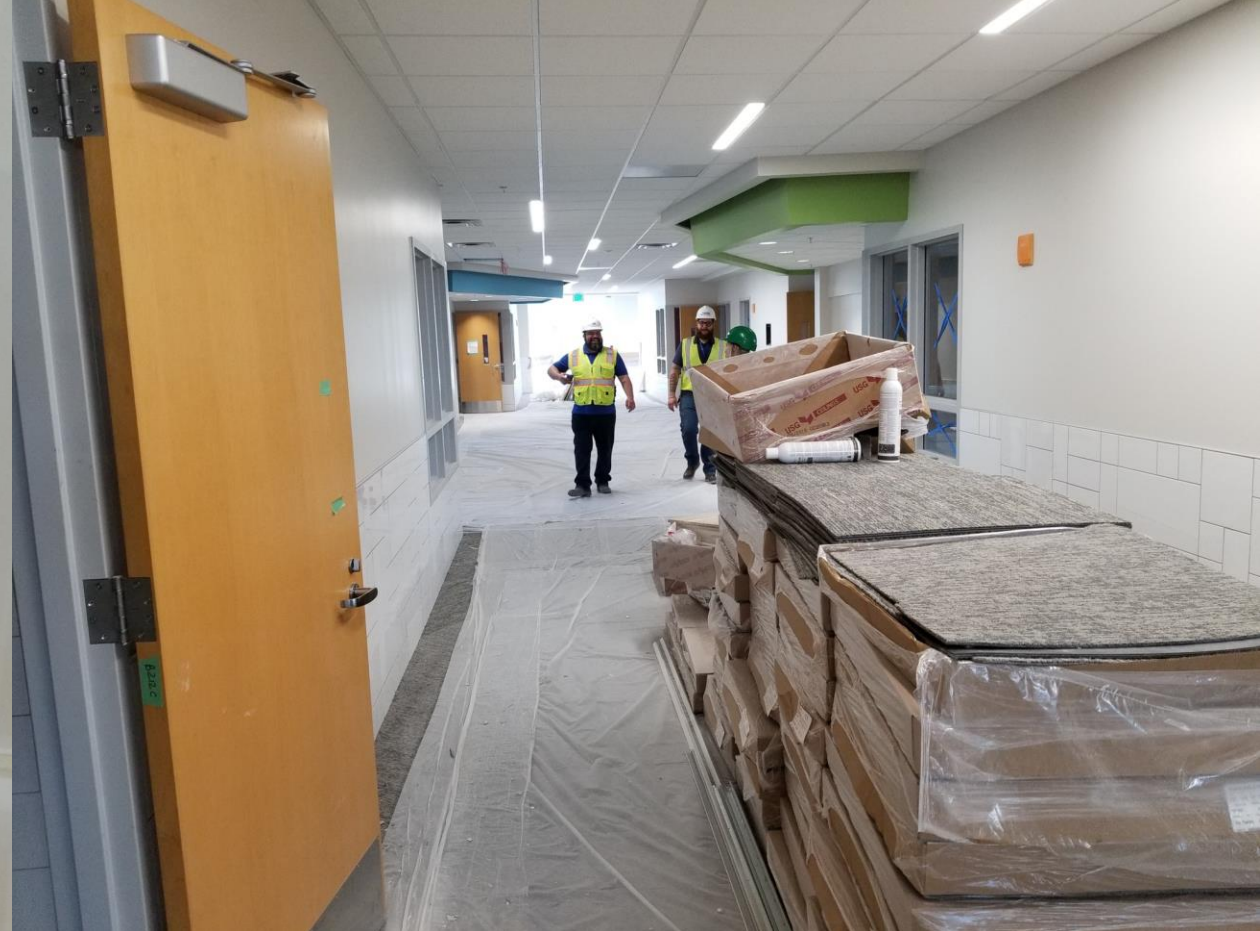
South Classroom Wing (upper level) – Carpet recently installed.
