March 13, 2019

PS 2019.014 - Suffield Town Hall Moisture Investigation Report

The following report covers Building Science Corporation's (BSC) evaluation of the moisture issues occurring at Suffield Town Hall, 83 Mountain Rd, Suffield, CT 06078, in preparation for a major renovation project at the building. The report is based on BSC's site investigation of March 7, 2019.

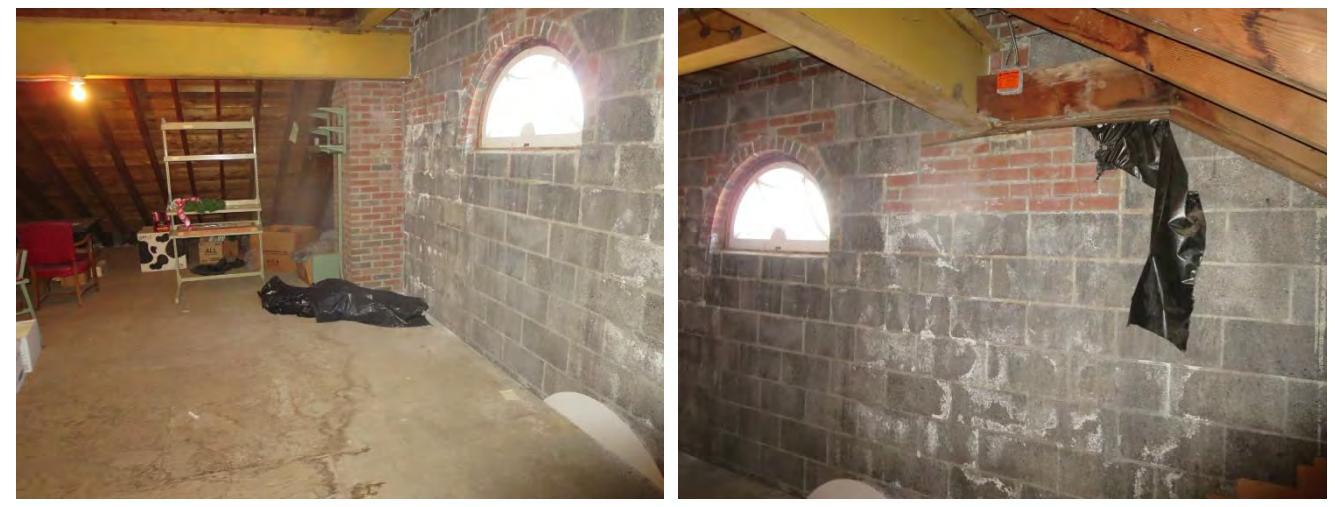
Figure 10: Interior efflorescence on CMU block wall

There is substantial efflorescence (white mineral) staining on the interior surface of the CMU wall. This efflorescence means that minerals are being transported by liquid water (rainfall) "wicking" through the wall, and evaporating on the interior. In other words, this is an indication of previous water penetration. However, no signs of active water penetration were obvious.

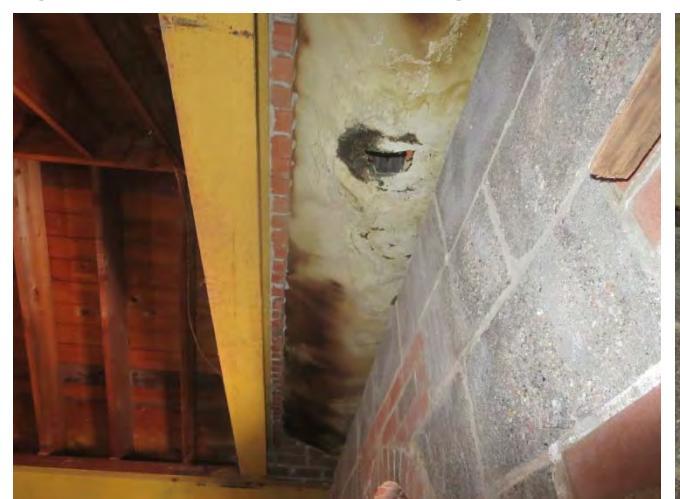
flashing spanning across the false chimney opening; this flashing is failing, with holes. The flashing is entirely removed at one false chimney on the east end of the building (Figure 16).

Figure 14: Failed flexible flashing at chimney

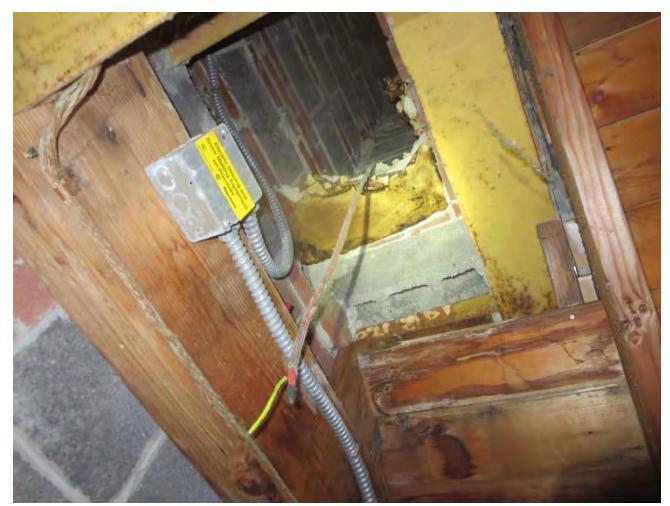
Figure 16: Failed flashing, looking up false chimney

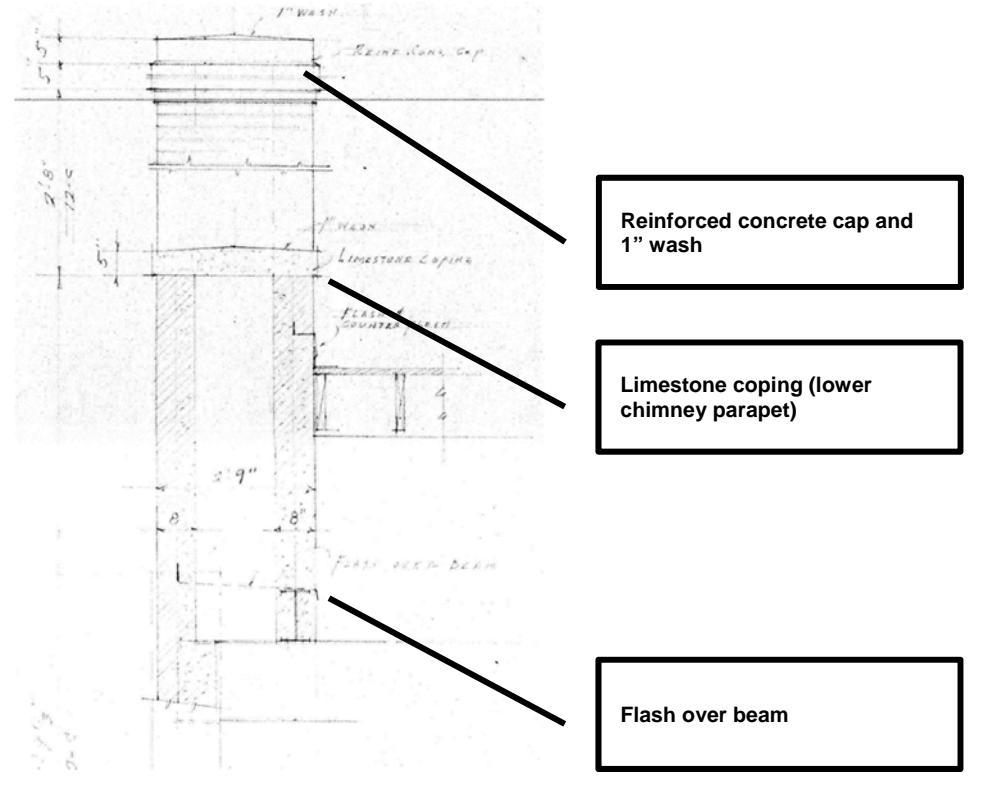
Figure 18: 1961 Plans chimney section detail

This detailing is consistent with the 1961 plans (Figure 18), which show the flashing spanning over the base of the chimney opening at the steel beam. In addition, the original detailing calls out a limestone or concrete cap at the chimneys; the current metal caps are likely retrofits to address previous water leakage problems. There is no clear indication whether water leakage at the false chimneys is an ongoing issue.

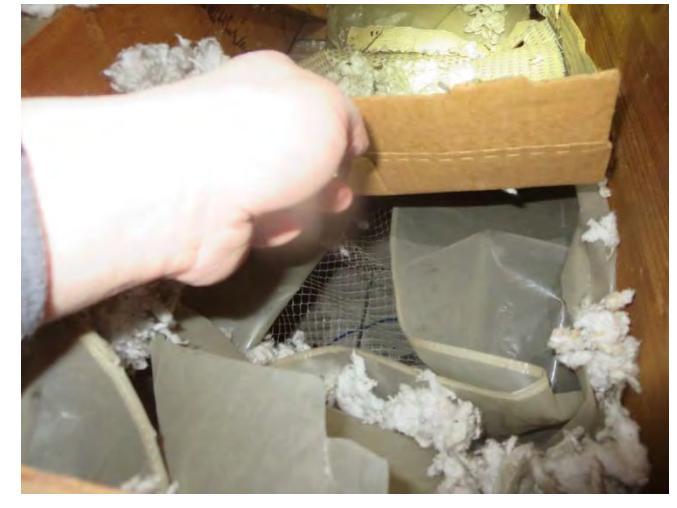
Closer examination of these areas revealed sections where the foil-faced fiberglass insulation had fallen or was missing. For instance, Figure 30 shows an area with the batt removed, and a polyethylene air/vapor barrier "patched in" with a large hole. Looking further downward reveals the upper side of the lay-in suspended ceiling tile grid (Figure 31). The 1961 plans (Figure 7) show this geometry: the batt insulation is in line with 2x10 ceiling joists, and the suspended ceiling tile lines up with the "hung ceiling" callout.

Figure 30: Failed insulation and air/vapor barrier

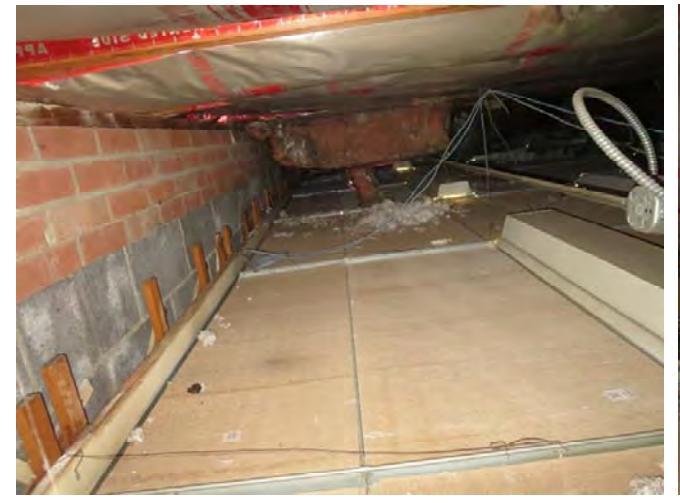
Conditions looking laterally at the cavity between the batt insulation and the ceiling tile are shown in Figure 32, Figure 33, Figure 34, and Figure 35. As shown in the latter two images, many of these batts are failing and have fallen from the ceiling joists. The fiberglass batts are "inset stapled" (stapled to the sides of the joists), with no attempt at air sealing the seams.

Figure 32: Conditions above suspended ceiling

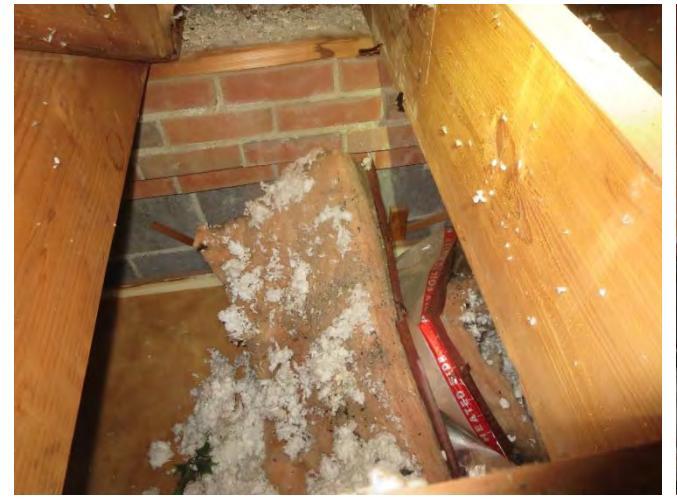
Figure 34: Failed insulation batts at ceiling

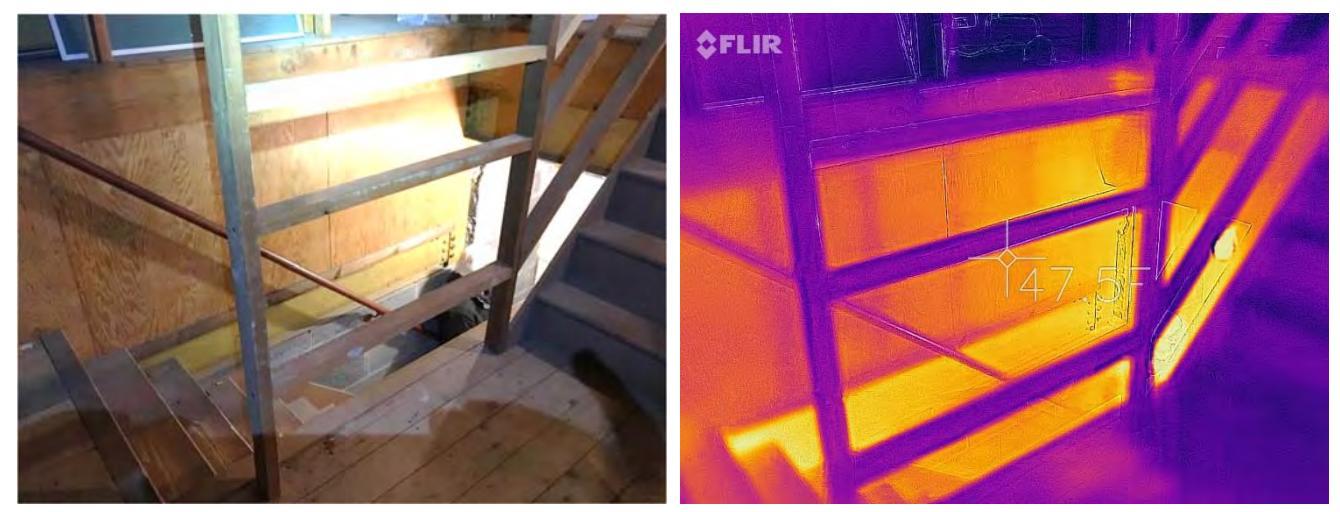
For instance, the stairs from the second floor to the attic are a significant source of heat loss (Figure 38), both at the door, walls of the stairs, and kneewalls. It is unlikely that the second floor walls between the staircase and the adjacent rooms are insulated.

Figure 38: Visual and infrared image of heat loss from stairwell down to second floor

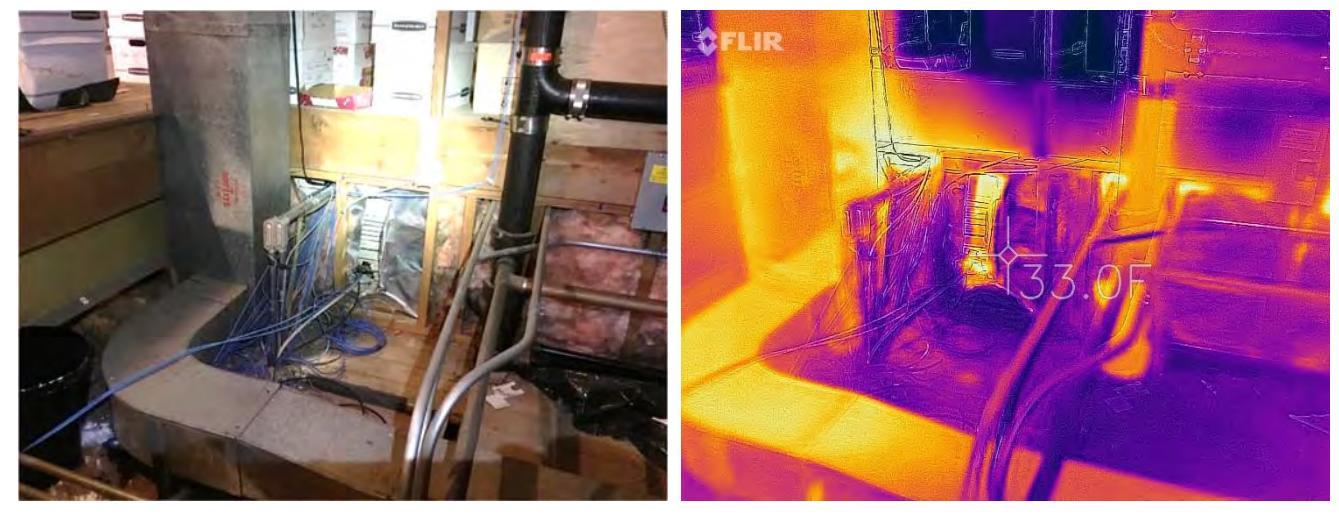
The exhaust ductwork has warm surfaces, consistent with exhausting interior conditioned air (Figure 39). In addition, air leakage is occurring at the top plate of the kneewall. This is shown more closely in Figure 40; the air leak occurs between the kneewall top plate and the ceiling joist.

Figure 39: Visual and infrared image of exhaust ductwork and kneewall air leakage/heat loss

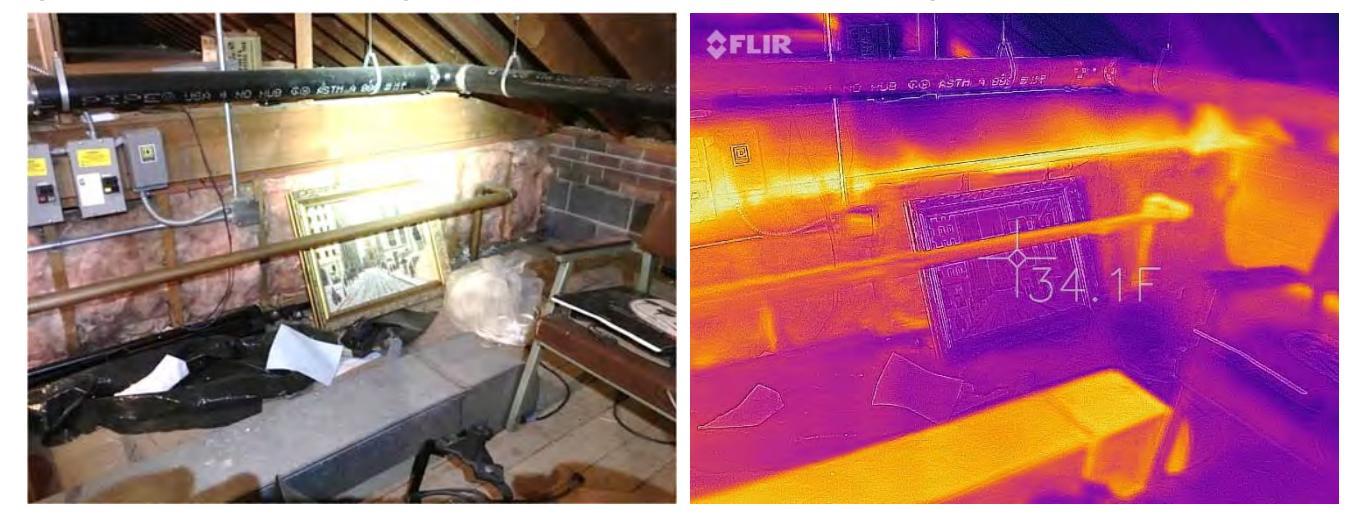
Figure 40: Visual and infrared image of exhaust ductwork and kneewall air leakage/heat loss

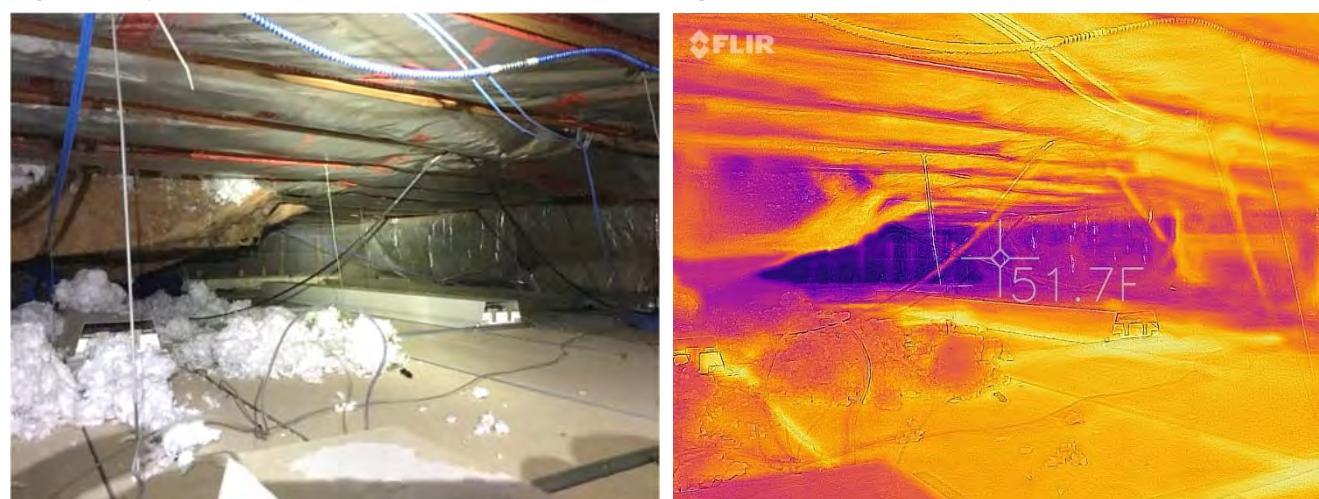
Figure 45: Visual and infrared image of failed insulation at IT room; batt foil facer shows "reflection" of temperature

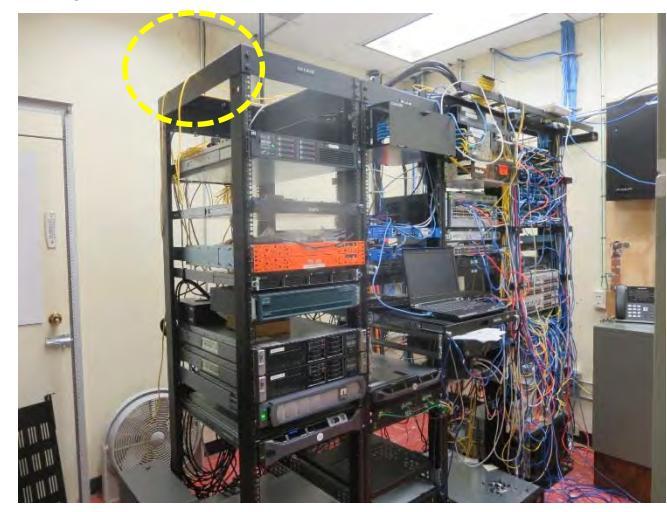
An overview of the server room is shown in Figure 46; it is a "landlocked" (no exterior wall) room on the second floor. An example of moisture issues seen here is apparent mold staining near the ceiling at the east wall (yellow circle in Figure 46 and Figure 47).

Figure 46: Overview of server room, facing east

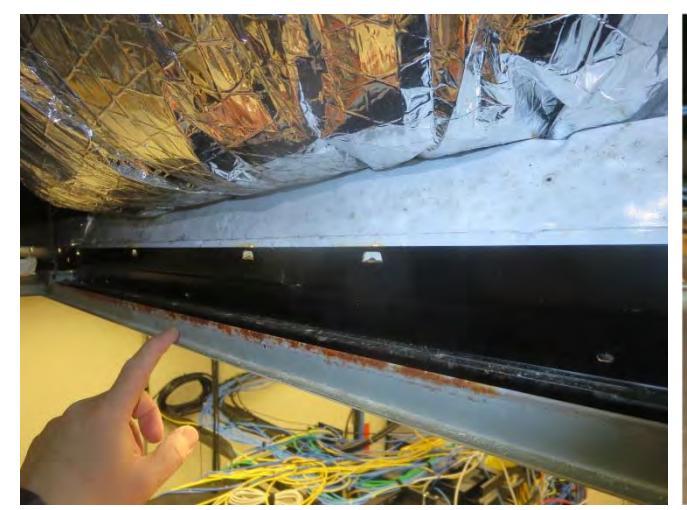
Figure 50: Rust on T-bar suspended ceiling

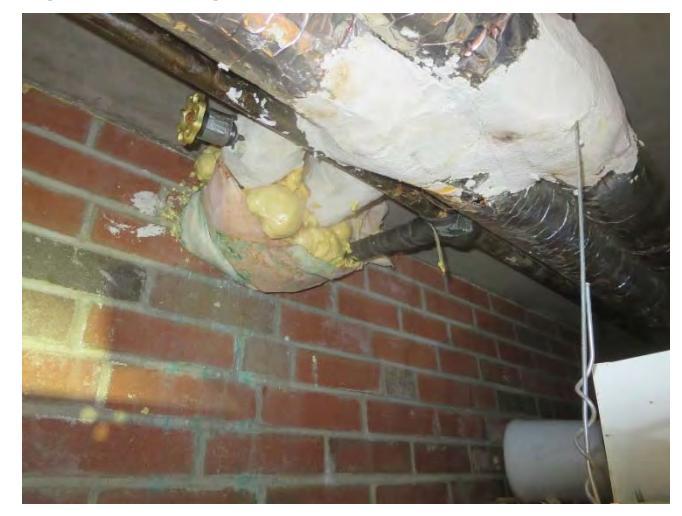
Figure 73: Mechanical piping at left-hand stain

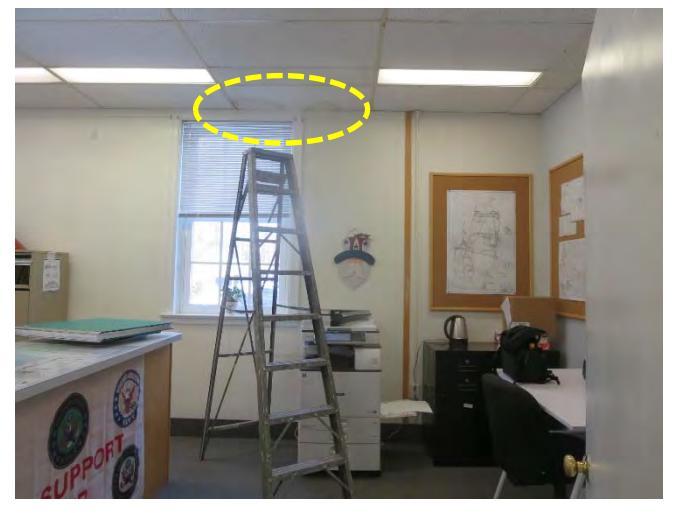
Figure 77: Ceiling tile stains, Tax Collector office

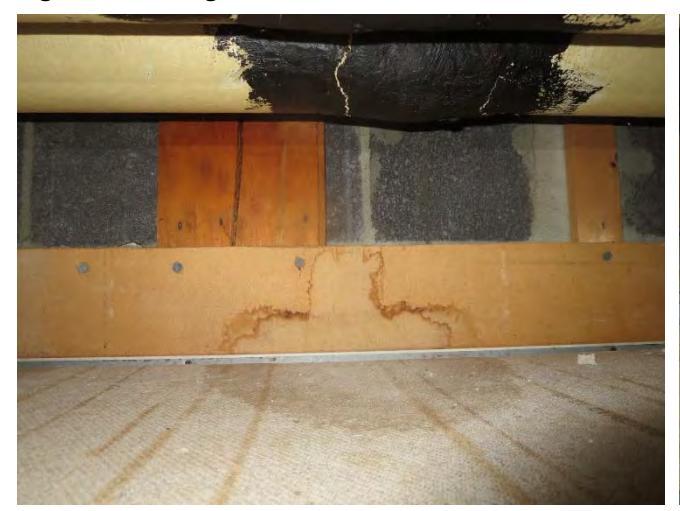
Figure 79: Stains on wall finishes, Tax Collector office

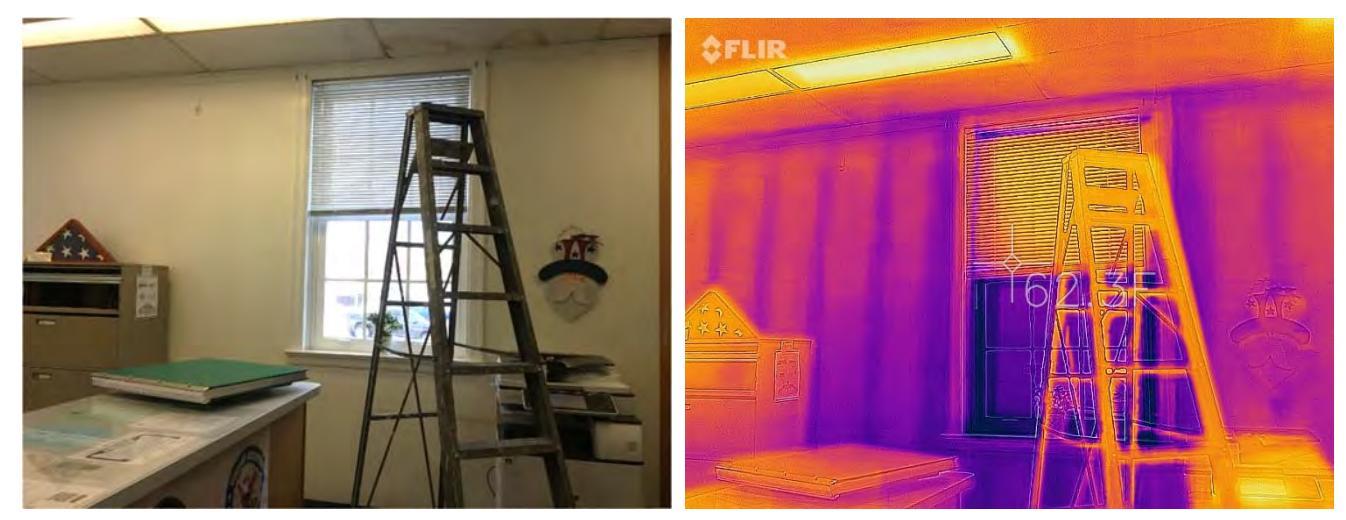
Figure 85: Visual and infrared image of east-facing wall, Tax Collector office

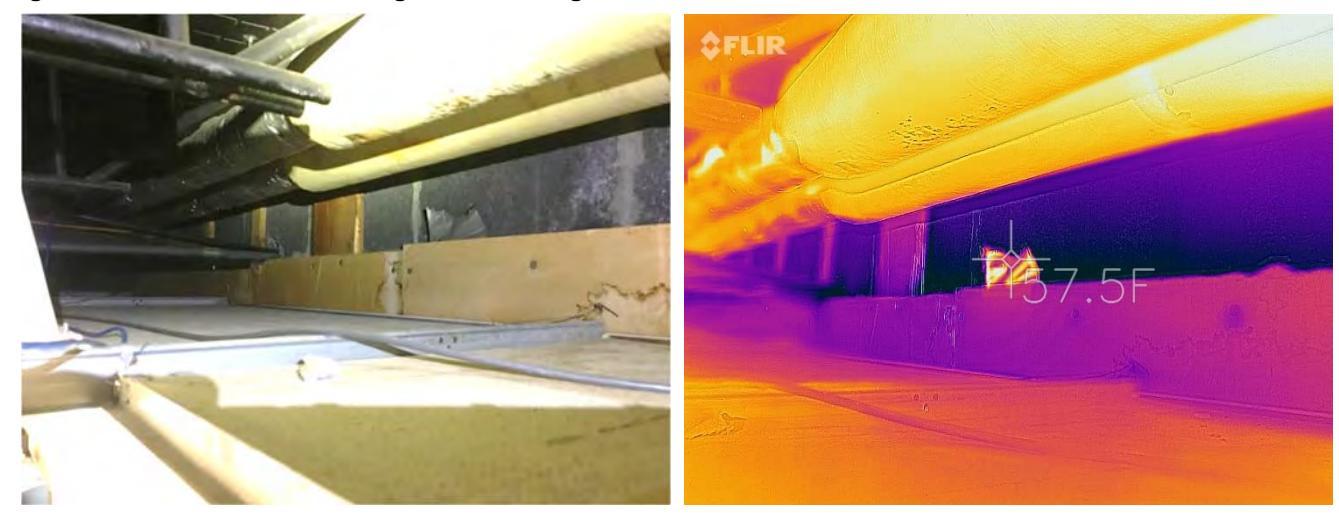
Figure 86: Visual and infrared image over suspended ceiling, Tax Collector office

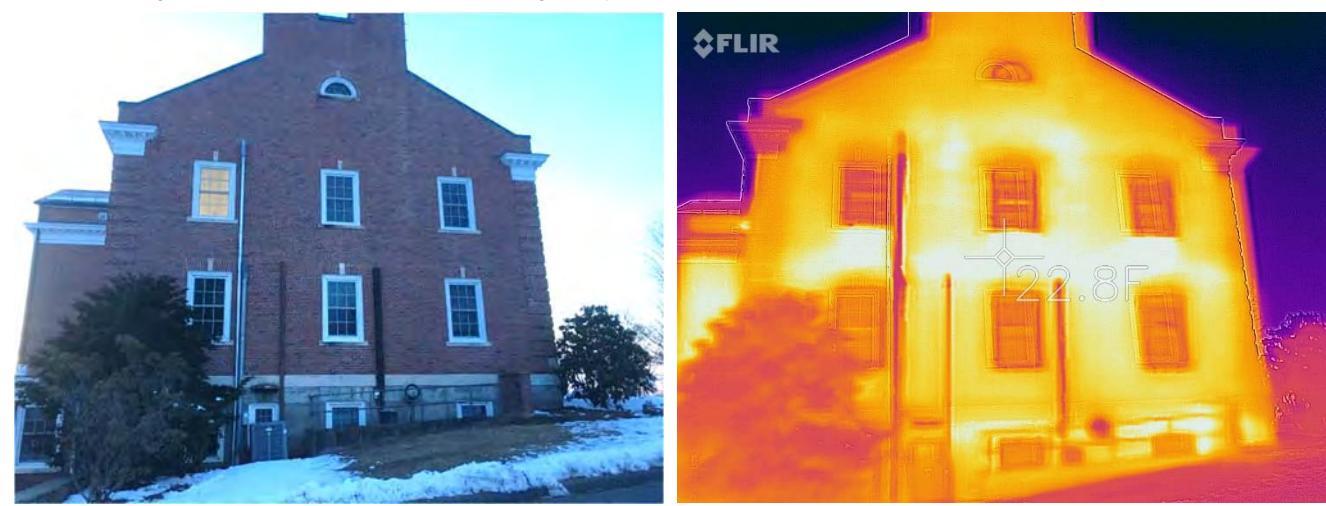
The net effect of these two conditions can be seen from the exterior (Figure 87): there are warmer surface temperatures at the wall heating units, and at the uninsulated ceiling cavity.

Figure 87: Visual and infrared image of east wall of building; thermal anomalies at 1st-2nd ceiling line

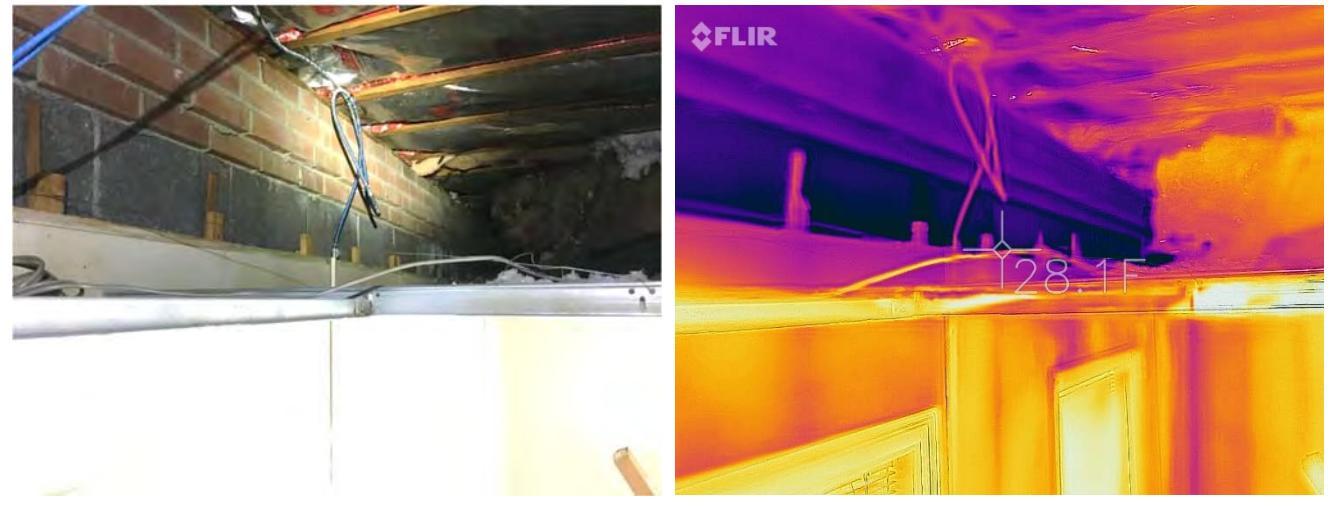
Similar behavior was seen on the second floor: Figure 88 shows conditions at the IT room, where the surface temperatures of the wall above and below the suspended ceiling can be contrasted.

Figure 88: Visual and infrared image over suspended ceiling, second floor IT room

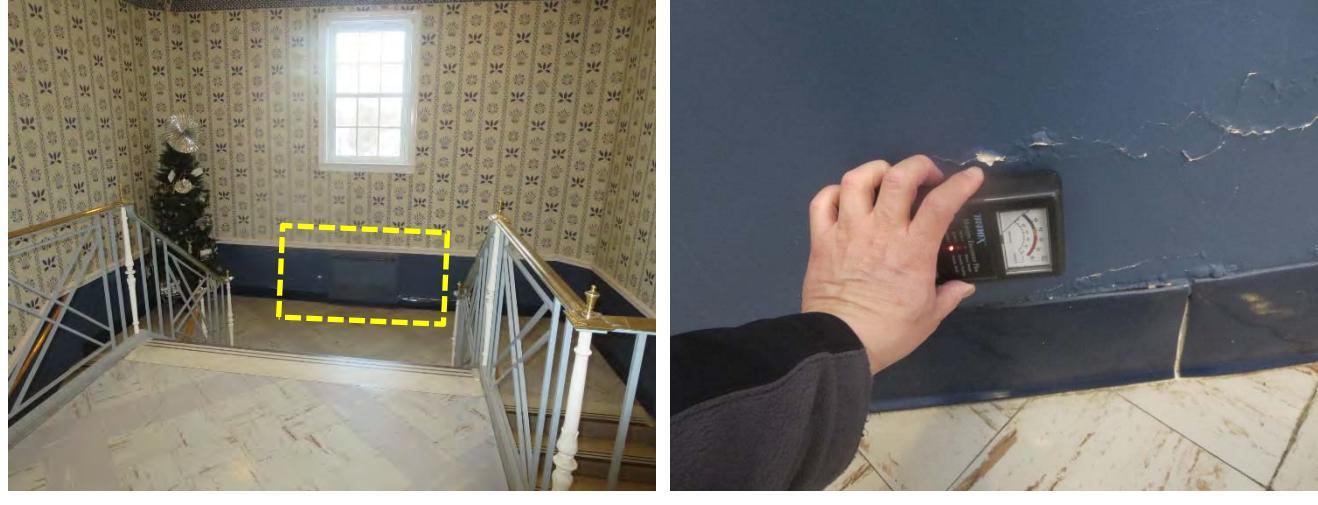
The team also pointed out multiple areas with damaged interior finishes consistent with water leakage. An example was found at the second floor stairwell, around the heating/cooling fancoil unit (Figure 89), where the interior plaster and paint had bubbled and cracked.

Figure 89: Second floor stairwell; staining at fancoil

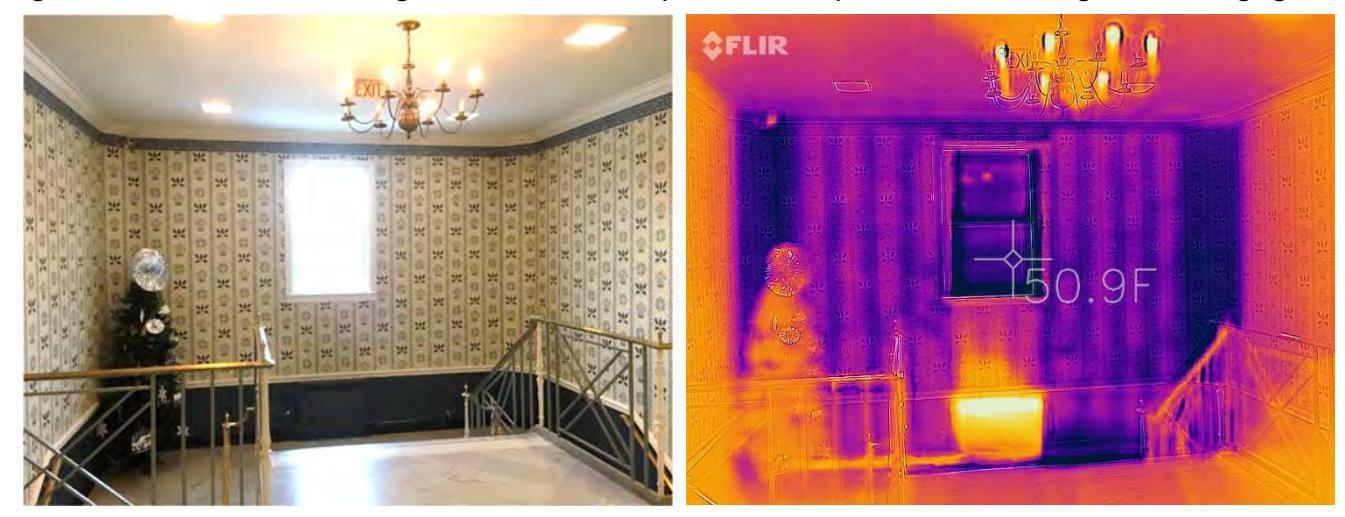
Figure 97: Visual and infrared image of second floor stairwell walls, showing thermal bridging

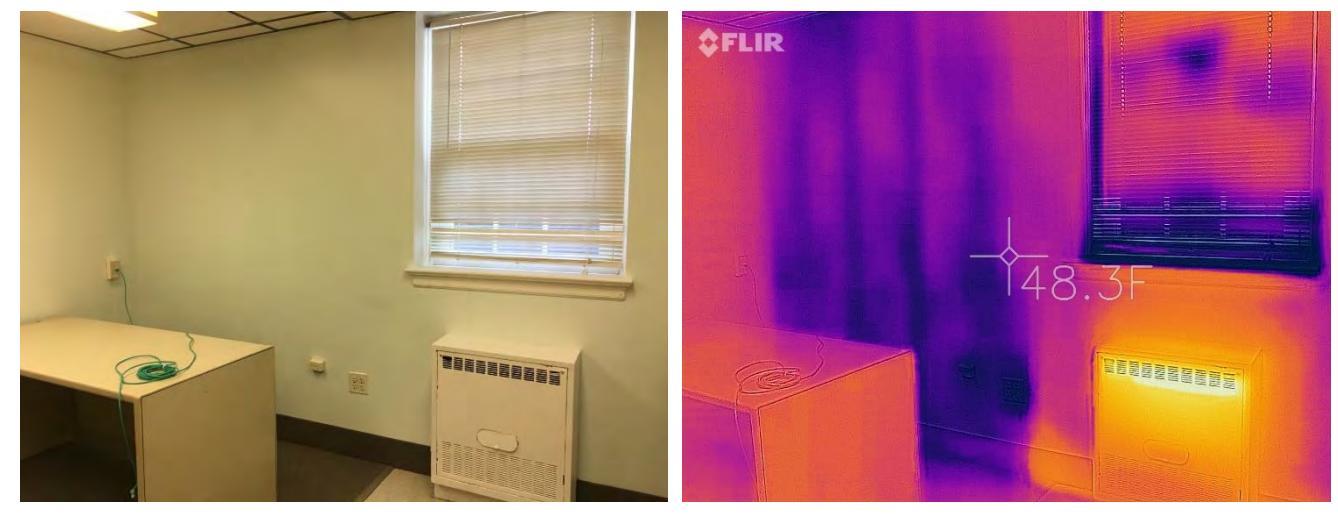
Figure 104: Visual and infrared image of P&R office east wall, thermal bridging and air leakage

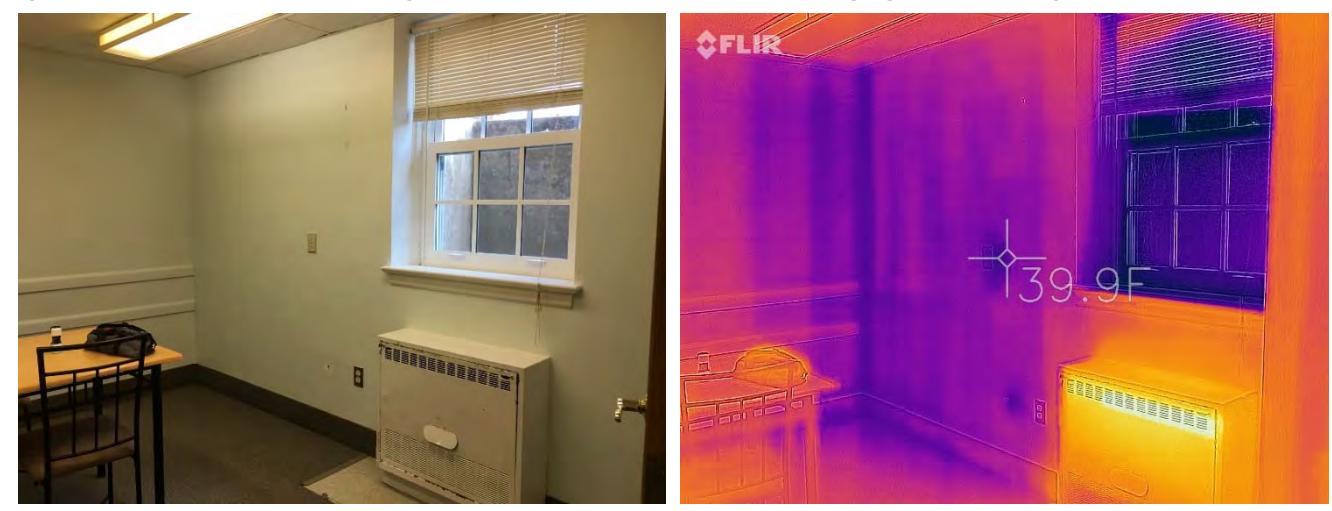
Figure 105: Visual and infrared image of P&R office east wall, thermal bridging and air leakage

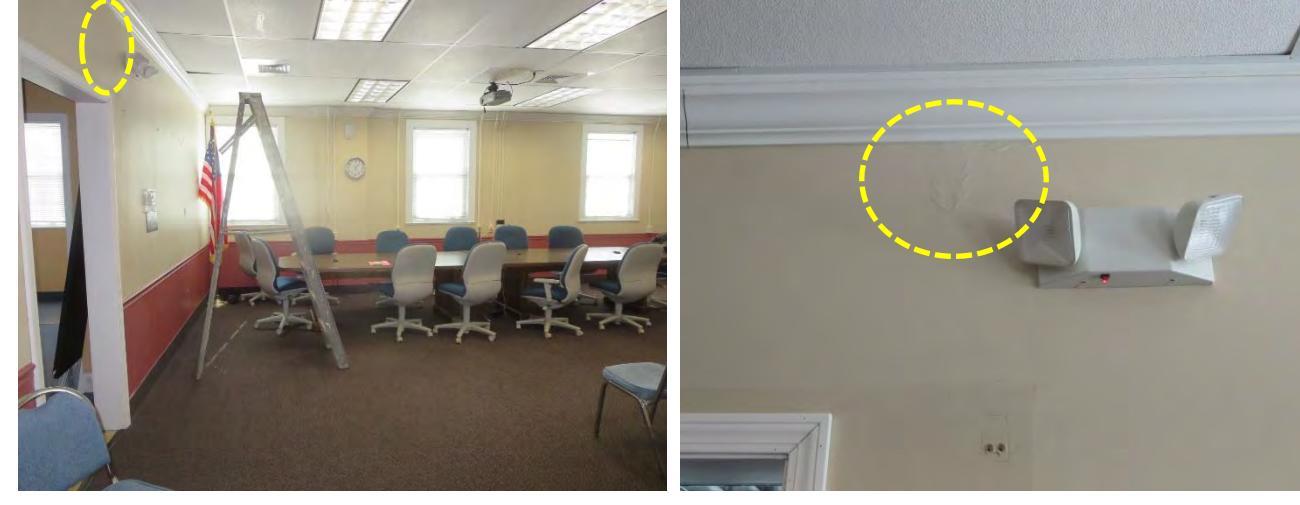
- The most notable issue was paint bubbling/peeling at an interior wall of the meeting room. The moisture issues observed could not be investigated further without attic access. Suspected causes of the moisture problems include bulk water (rain) penetration, wintertime roof condensation or frosting, summer duct condensation, and/or summertime HVAC condensate leakage. Visual inspection of the roof above the ceiling is recommended. PRIORITY: HIGH

Figure 129: Meeting room, with water leak highlighted

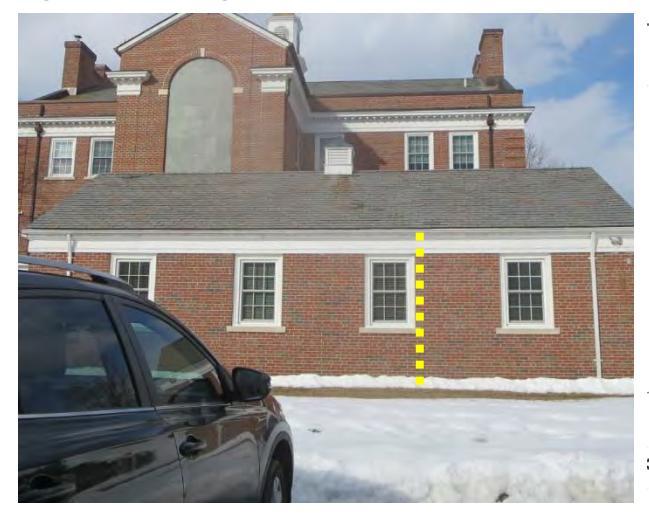
Figure 133: Line of water stain relative to exterior

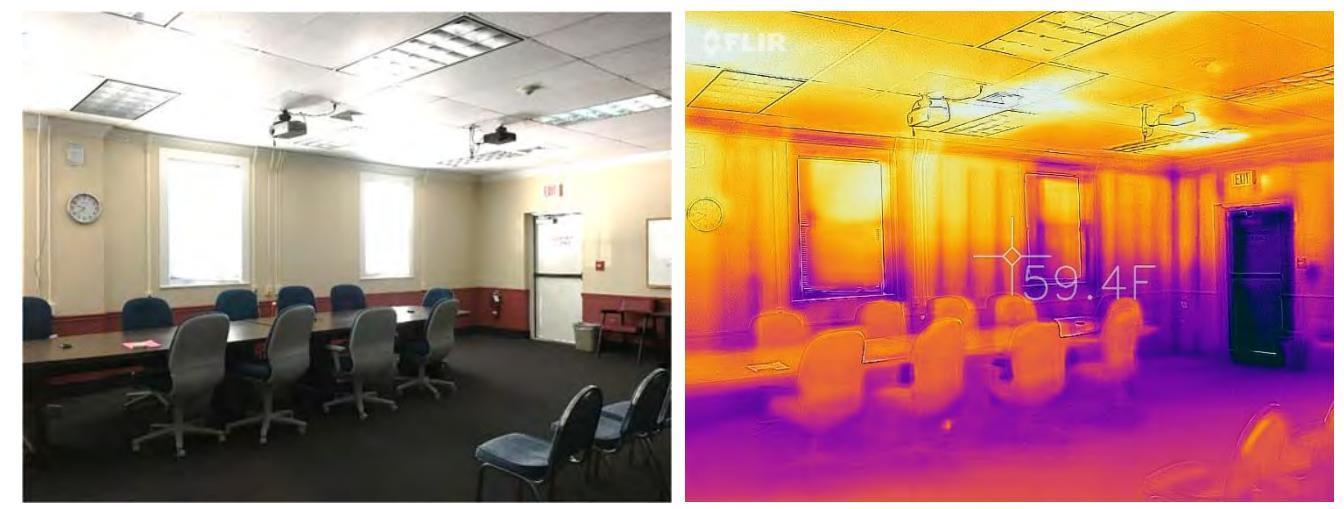
- Thermal stratification, or collection of warm air near the top of the room, and cool air at the bottom, was noted during infrared observations. This stratification contributes to discomfort and higher energy use. This might be addressed by changing the type of ceiling diffuser at the meeting room and offices.
 PRIORITY: MEDIUM

Figure 145: Visual and infrared image of meeting room; thermal bridging at furring, and thermal stratification

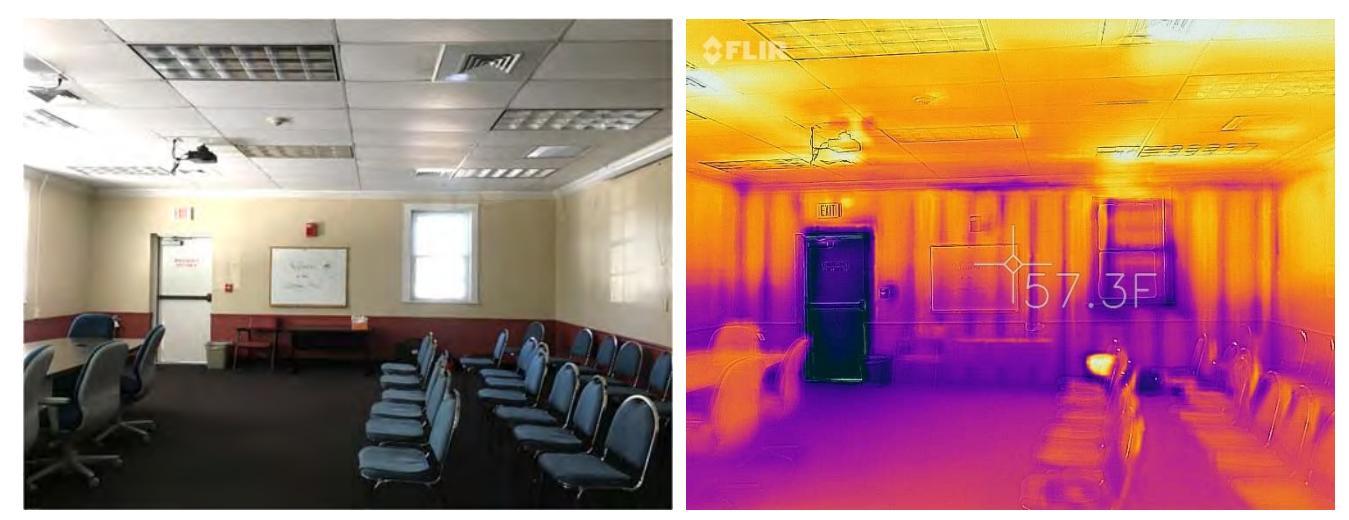
Figure 146: Visual and infrared image of meeting room; thermal bridging at furring, and thermal stratification

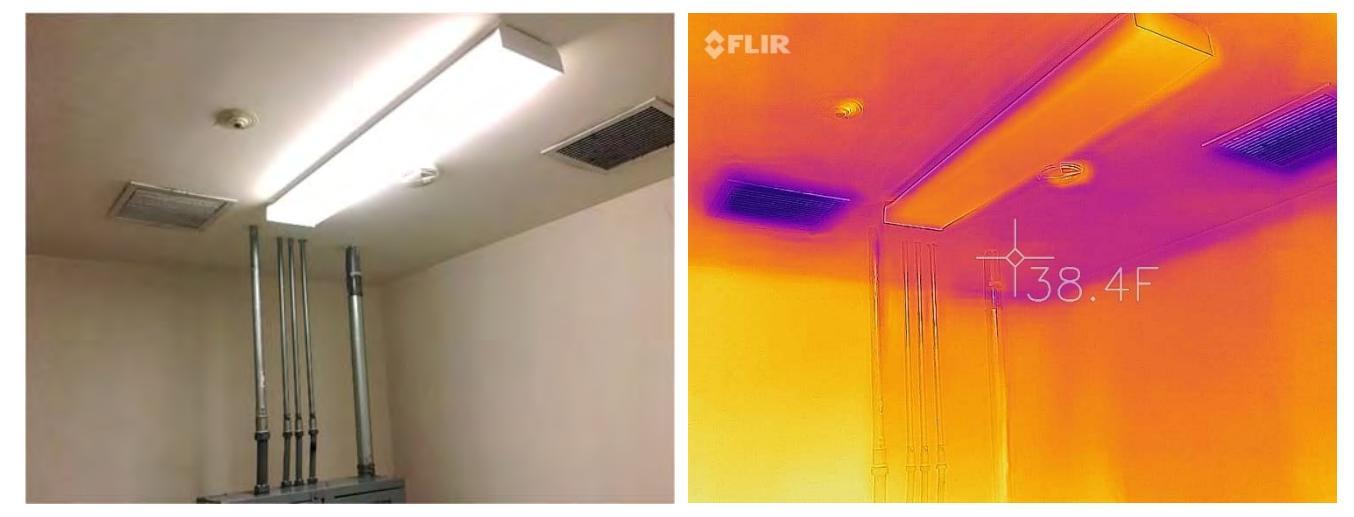
- Elevator Machine Room
 - A consistent complaint at the elevator machine room is cold temperatures in wintertime; a small electric space heater is located in this room, despite the heat generated by elevator machinery.
 - There is cold air leakage occurring through the ceiling registers, with the associated fan not in operation. At a minimum, the fan system should be inspected, to ensure that motorized dampers are installed, and operating properly with fan operating (opening/closing and sealing tightly). As an alternate system, the elevator machine room could be conditioned with a mini-split heat pump (MSHP) head, which would eliminate this cold air leakage problem. The ductwork would ideally be sealed off in an airtight manner and abandoned in place. PRIORITY: MEDIUM

Figure 155: Visual and infrared image of elevator machine room ceiling; inward airflow at both ceiling registers
