# Marlborough

1300 E. 75<sup>th</sup> Street

## REUSE ASSESSMENT

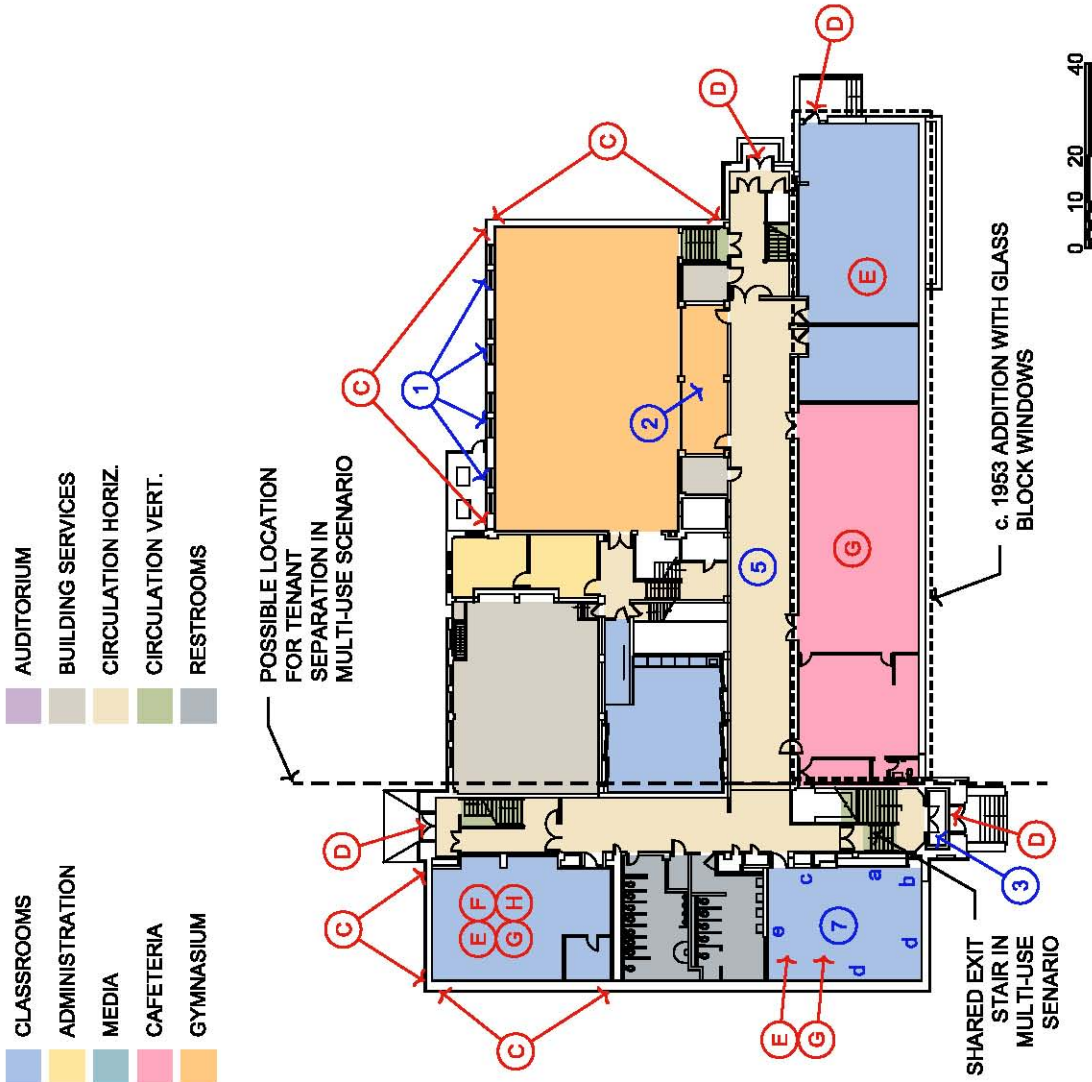
Ground Floor

- Poor condition of roof has allowed plaster ceilings and walls to become damaged
- Exterior masonry is good condition
- Typical classroom size is 750-850 SF. This size of classroom converts well into a single bedroom apartment or combines well into two bedroom apartments
- Large operable windows in older portion of building allow natural light and ventilation
- Glass block with smaller operable windows used in later addition allow natural light and ventilation
- Sufficient parking with easy access
- Large gymnasium and auditorium in good condition
- Building could be divided into multiple uses, for example it could be divided vertically into multiple areas or horizontally providing separation between lower floors and upper floors

1. Multi-light steel windows
  2. Gym balcony
  3. Historic wood vestibule
  4. Metal stair
  5. Wide corridors & stairs
  6. Office area modern finishes
  7. Typical classroom:  
a. Coat area with pivot doors  
b. Built-in cabinet  
c. Closet  
d. Marble window sills  
e. Wood framed chalk board
  8. Auditorium  
a. Wood stage  
b. Affixed seats  
c. Art deco plaster motifs
  9. Raised platform
  10. Historic wood skylight
- ## CONDITION NOTES
- A. Clogged roof drains
  - B. Damaged roof membrane at south and east parapet
  - C. Minor repointing of masonry mortar joints is needed
  - D. Entry doors are in poor condition
  - E. Water damage at ceiling
  - F. Plaster damage at walls
  - G. Water damage at floor
  - H. Mold present
  - I. Broken window

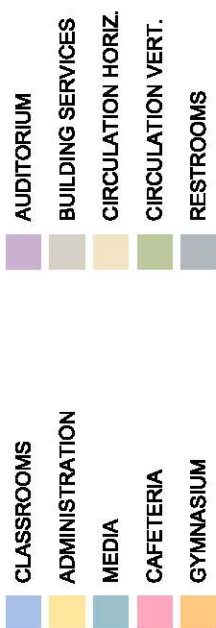
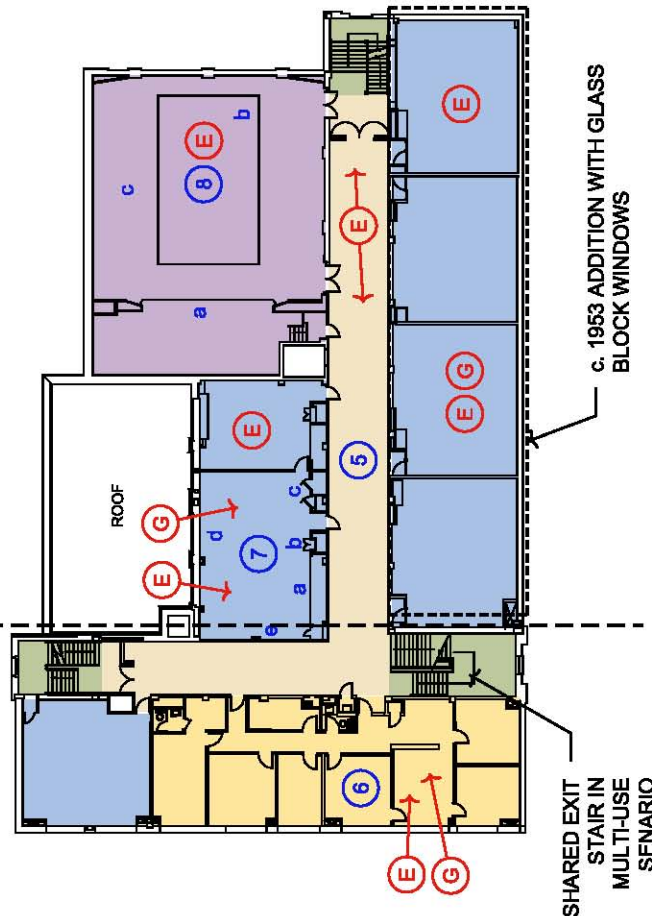
First Floor

- Poor condition of roof has allowed plaster ceilings and walls to become damaged
- Exterior masonry is good condition
- Typical classroom size is 750-850 SF. This size of classroom converts well into a single bedroom apartment or combines well into two bedroom apartments
- Large operable windows in older portion of building allow natural light and ventilation
- Glass block with smaller operable windows used in later addition allow natural light and ventilation
- Sufficient parking with easy access
- Large gymnasium and auditorium in good condition
- Building could be divided into multiple uses, for example it could be divided vertically into multiple areas or horizontally providing separation between lower floors and upper floors

1. Multi-light steel windows
  2. Gym balcony
  3. Historic wood vestibule
  4. Metal stair
  5. Wide corridors & stairs
  6. Office area modern finishes
  7. Typical classroom:  
a. Coat area with pivot doors  
b. Built-in cabinet  
c. Closet  
d. Marble window sills  
e. Wood framed chalk board
  8. Auditorium  
a. Wood stage  
b. Affixed seats  
c. Art deco plaster motifs
  9. Raised platform
  10. Historic wood skylight
- ## CONDITION NOTES
- A. Clogged roof drains
  - B. Damaged roof membrane at south and east parapet
  - C. Minor repointing of masonry mortar joints is needed
  - D. Entry doors are in poor condition
  - E. Water damage at ceiling
  - F. Plaster damage at walls
  - G. Water damage at floor
  - H. Mold present
  - I. Broken window

POSSIBLE LOCATION FOR TENANT SEPARATION IN MULTI-USE SCENARIO

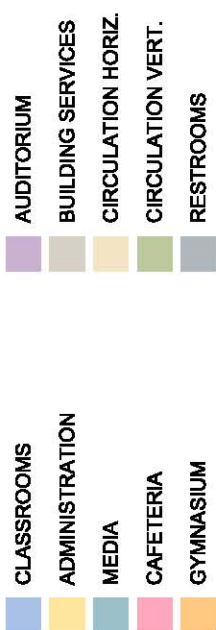
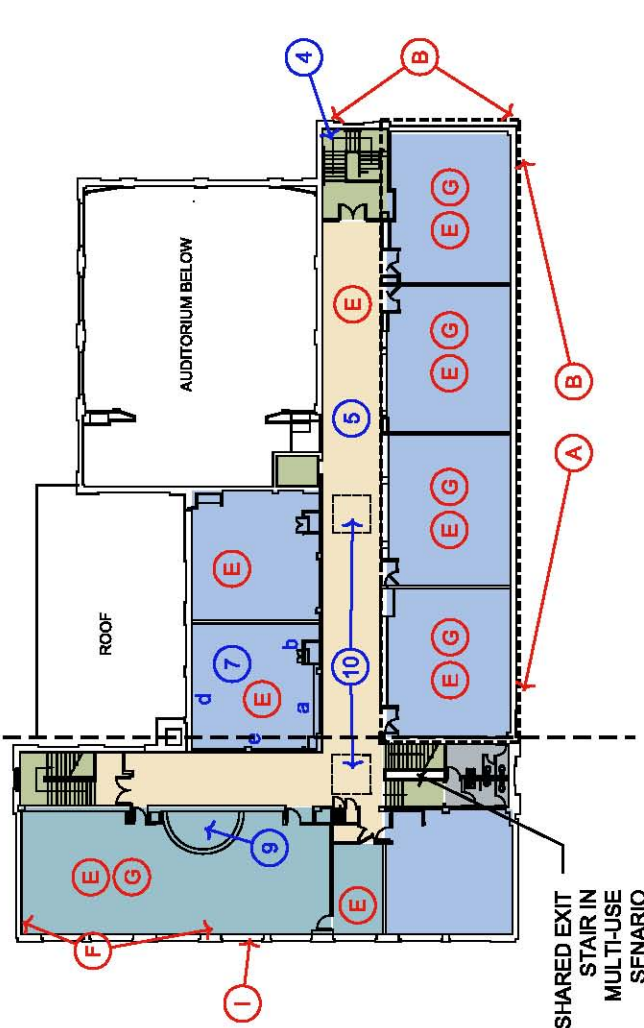
Second Floor

- Poor condition of roof has allowed plaster ceilings and walls to become damaged
- Exterior masonry is good condition
- Typical classroom size is 750-850 SF. This size of classroom converts well into a single bedroom apartment or combines well into two bedroom apartments
- Large operable windows in older portion of building allow natural light and ventilation
- Glass block with smaller operable windows used in later addition allow natural light and ventilation
- Sufficient parking with easy access
- Large gymnasium and auditorium in good condition
- Building could be divided into multiple uses, for example it could be divided vertically into multiple areas or horizontally providing separation between lower floors and upper floors

1. Multi-light steel windows
  2. Gym balcony
  3. Historic wood vestibule
  4. Metal stair
  5. Wide corridors & stairs
  6. Office area modern finishes
  7. Typical classroom:  
a. Coat area with pivot doors  
b. Built-in cabinet  
c. Closet  
d. Marble window sills  
e. Wood framed chalk board
  8. Auditorium  
a. Wood stage  
b. Affixed seats  
c. Art deco plaster motifs
  9. Raised platform
  10. Historic wood skylight
- ## CONDITION NOTES
- A. Clogged roof drains
  - B. Damaged roof membrane at south and east parapet
  - C. Minor repointing of masonry mortar joints is needed
  - D. Entry doors are in poor condition
  - E. Water damage at ceiling
  - F. Plaster damage at walls
  - G. Water damage at floor
  - H. Mold present
  - I. Broken window

POSSIBLE LOCATION FOR TENANT SEPARATION IN MULTI-USE SCENARIO
